Re: Bridge 016355 CR 49 over Magnolia River

EXECUTIVE SUMMARY

The following information relates to the recent routine (24 month) safety inspection (hands-on) and underwater dive for the above referenced in-service bridge:

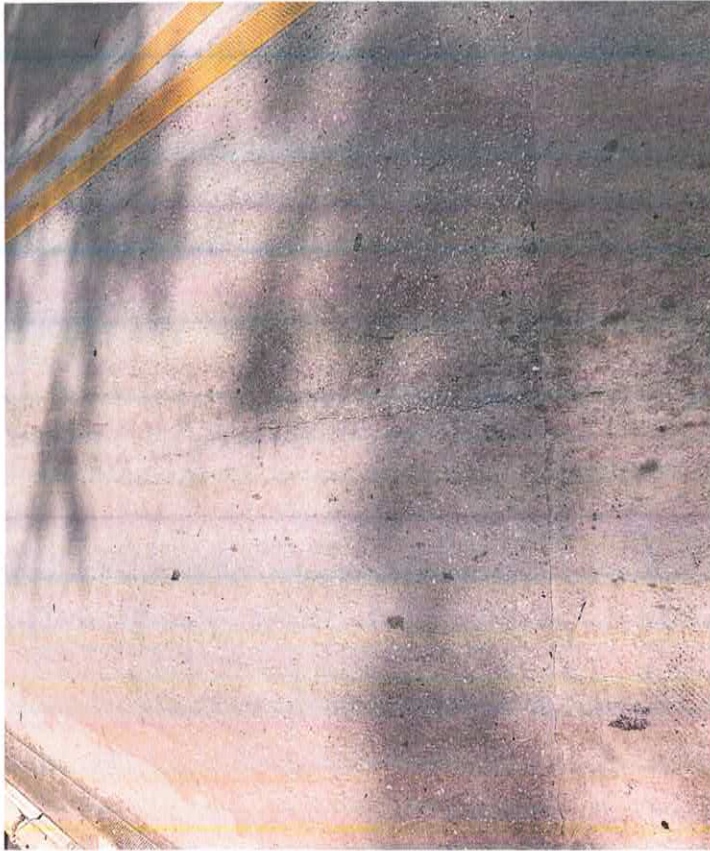
1. The deck shows numerous hairline to 1/8" wide cracks located throughout with some map cracking.
2. Two longitudinal cracks that run parallel to the centerline may be full depth. The cracks show some efflorescence on underside of deck. Sounding does not indicate any problems at this time but should be monitored on a routine basis.

CS3 crack on deck

NC: _____ REMARK: CLEAN/EPOXY ALL CRACKS ON TOP OF AND UNDERSIDE OF BRIDGE DECK AS NEEDED.

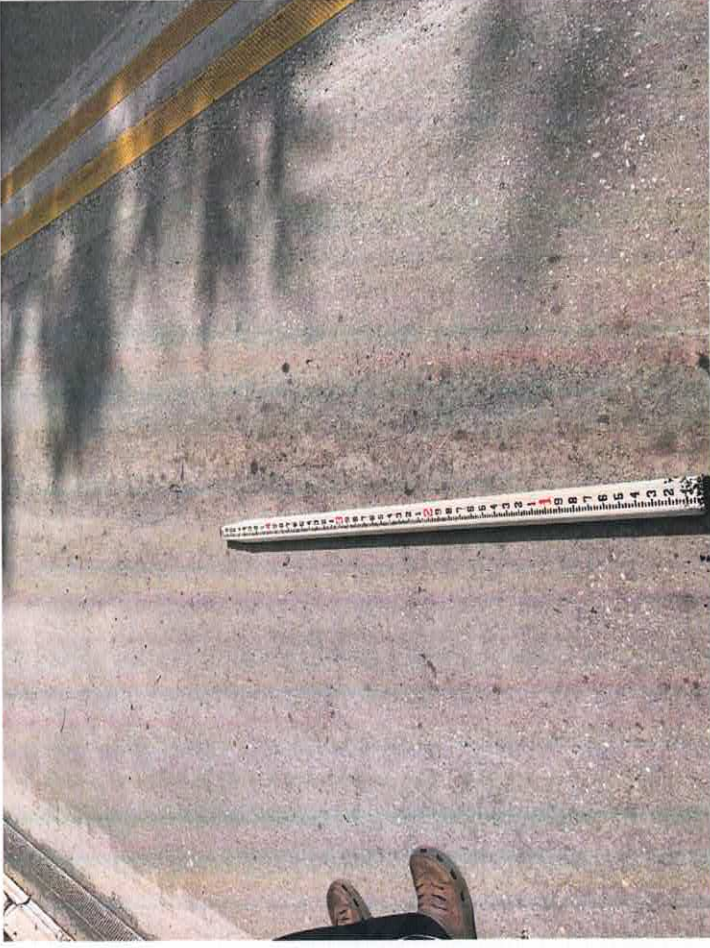
3. The remainder of the deck cracking appears to be shrinkage cracks from the concrete curing process. There is some map cracking in both lanes over Bents 2-8. Cracking at Spans 3 & 5 has increased to 1/8" wide.

Deck cracking

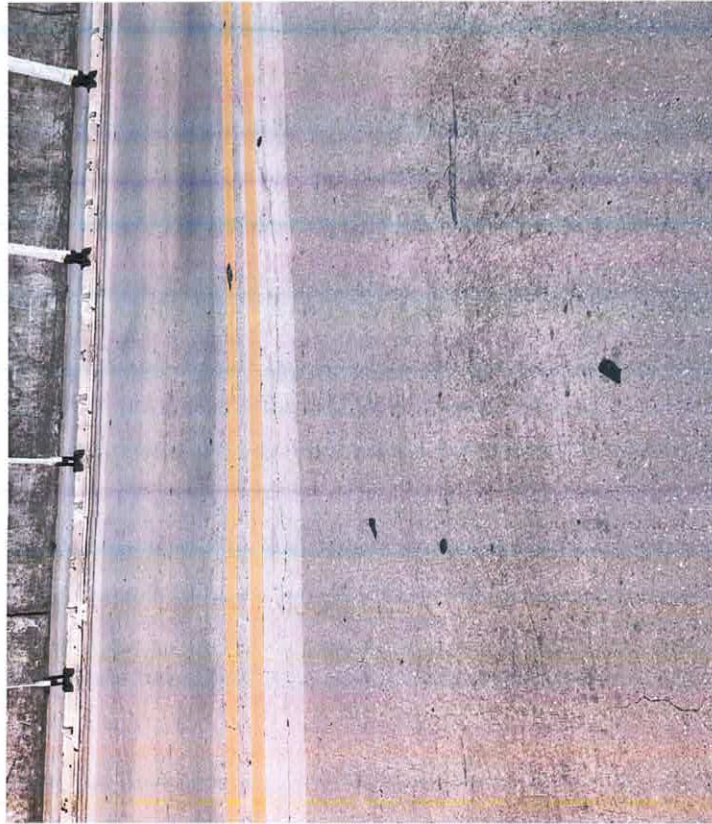
Map cracking on deck throughout

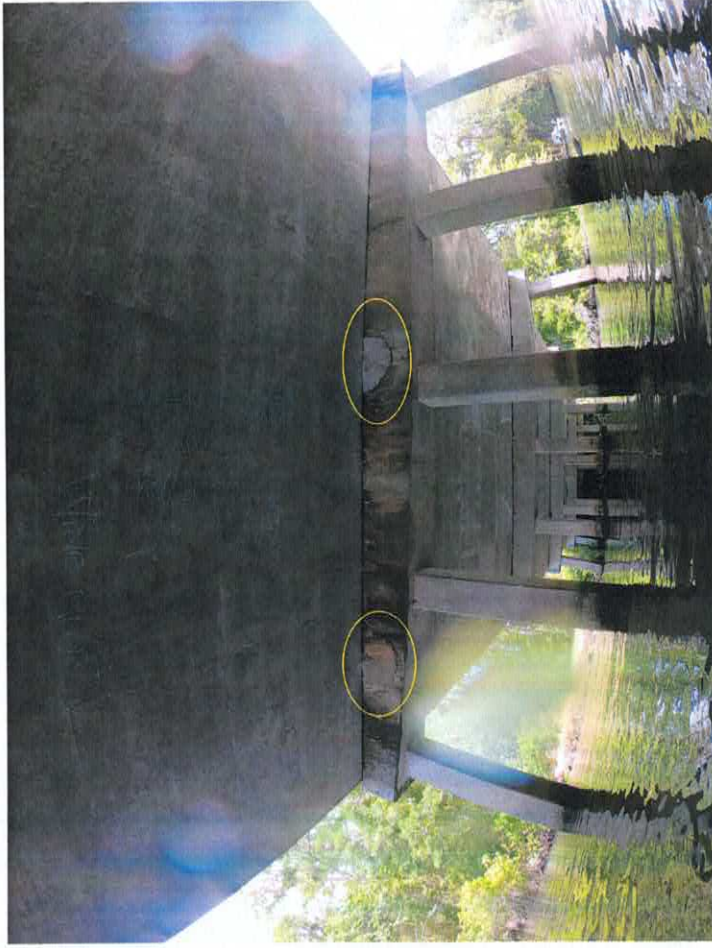
4. The patch on the piling cap at Bent 5 over Pile C shows some failure of the patching material. Although the patch is crumbling there is no exposure of the reinforcing steel at this time.

Bent 5 patch and spall

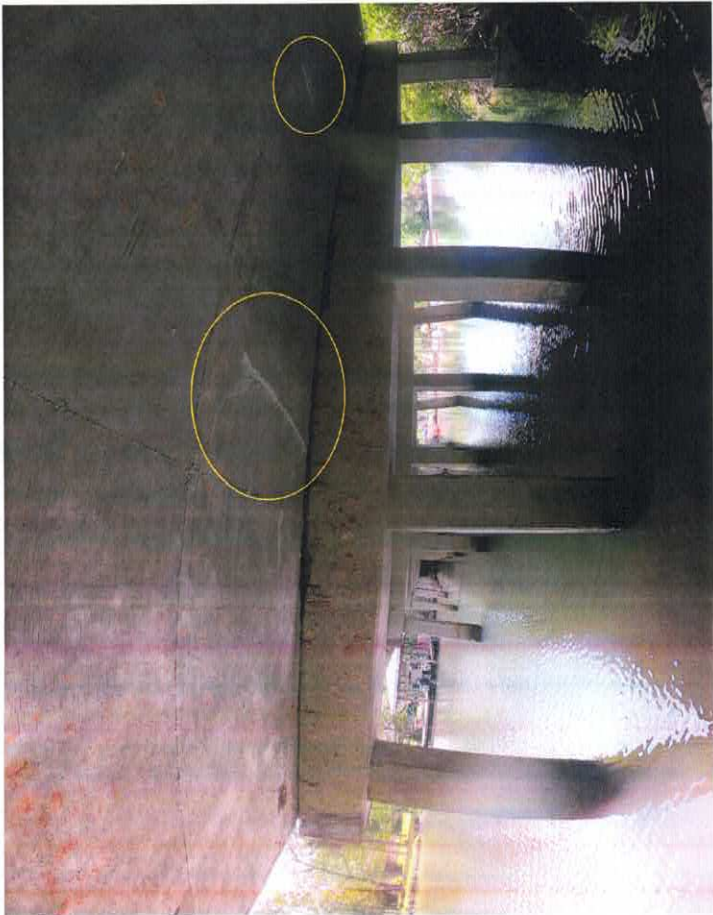
Eff on ceiling

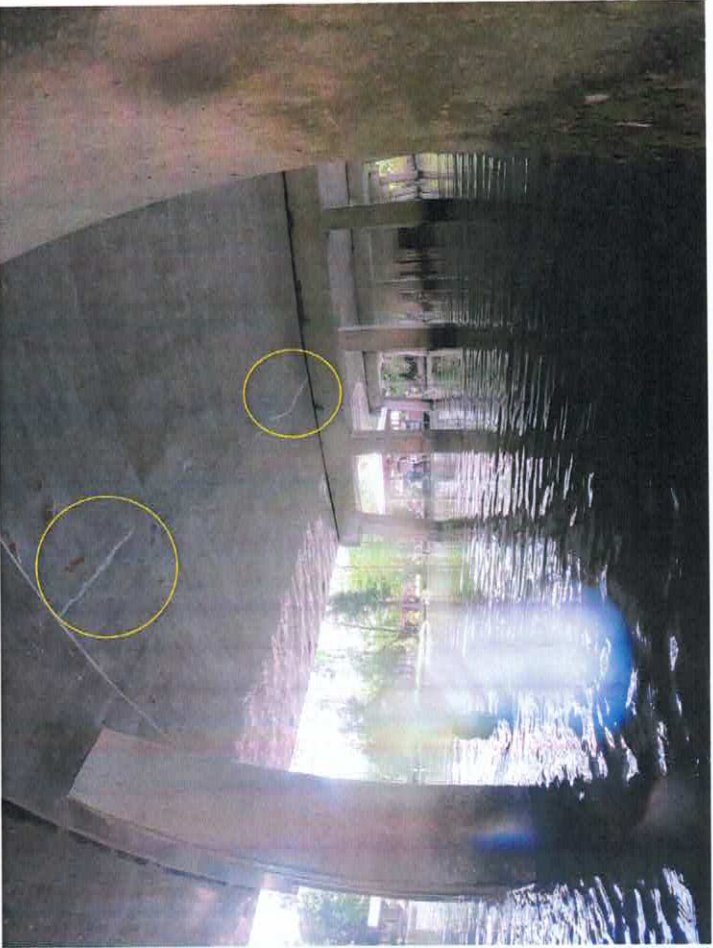
Eff on ceiling (2)

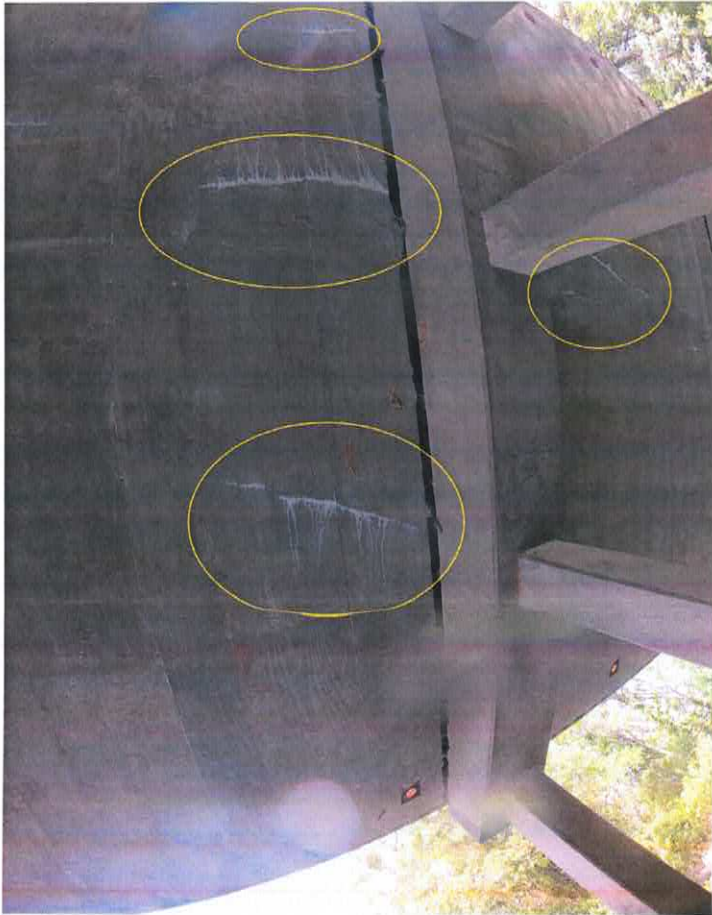
Eff on ceiling (3)

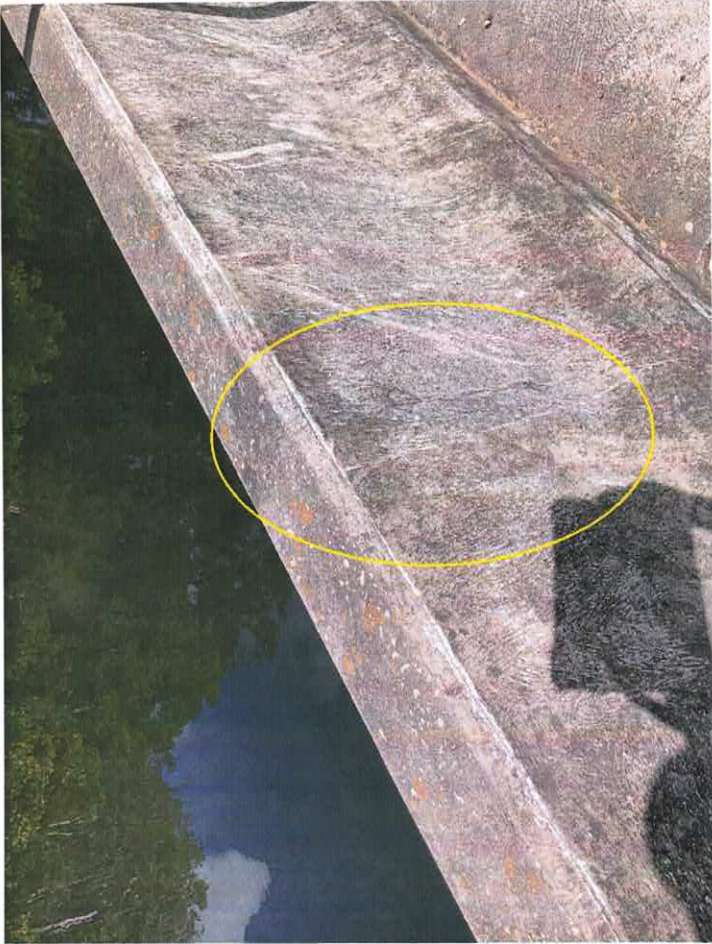
Hairline cracking on concrete railing

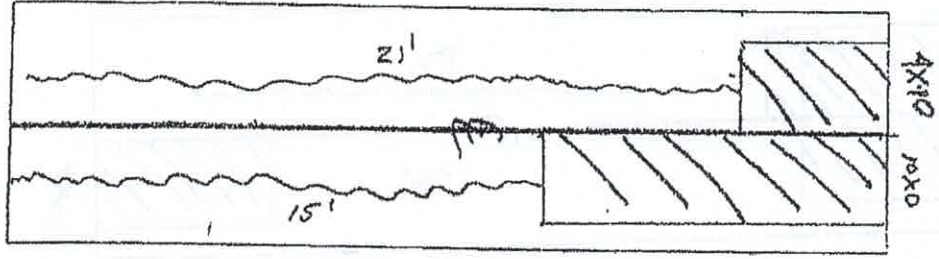
Note/Comments: SPAN 1 176 SF OF CRACKING

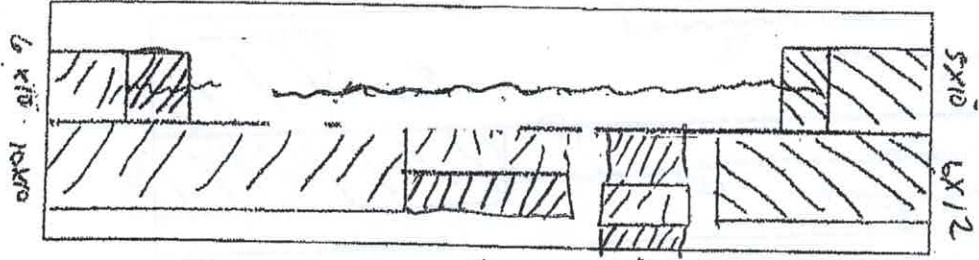
Note/Comments: SPAN 2 372 SF OF CRACKING

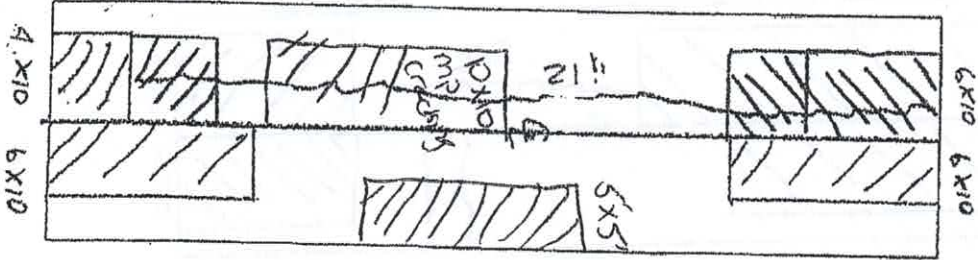
Note/Comments: SPAN 3 366 SF OF CRACKING

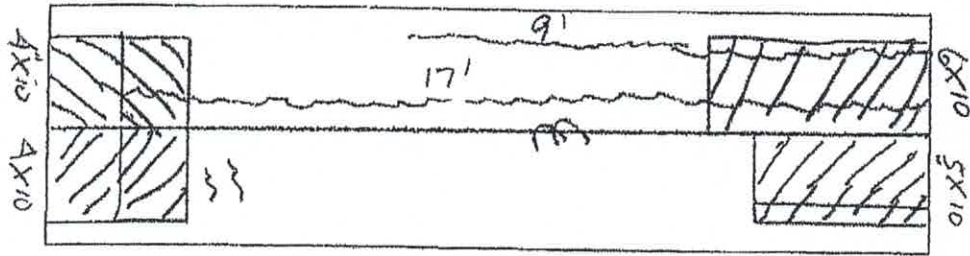
Note/Comments:
SPAN 7 254 SF OF
CRACKING

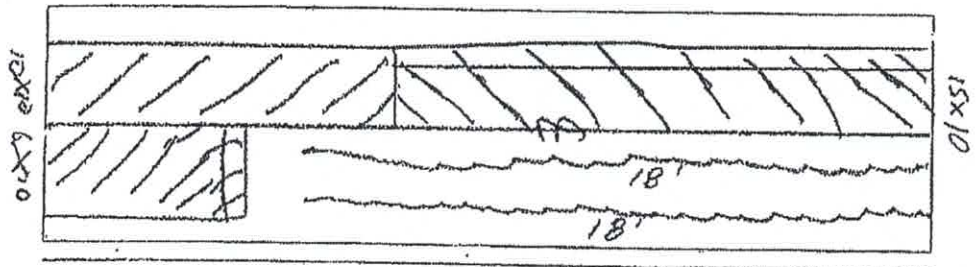
Note/Comments:
SPAN 8 346 SF OF
CRACKING
