Town of Magnolia Springs Comprehensive Drainage Masterplan

Town of Magnolia Springs
Magnolia Springs, Baldwin County, Alabama

VOLKERT

March 2023

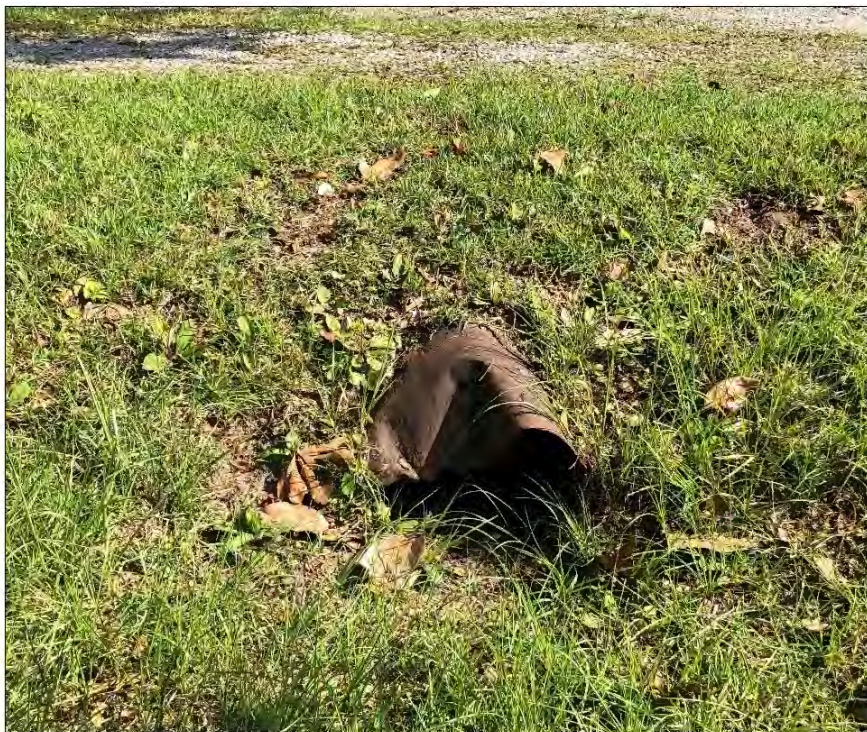
Figure 1. General view of a damaged culvert.

Category 1 improvements include immediate action items such as areas that have visible flooding issues and/or are a threat to public safety. These improvements also include structures that require routine maintenance such as replacing damaged pipes, sediment/debris removal and erosion control. Figures 1-2 below show examples of areas where category 1 improvements are recommended.

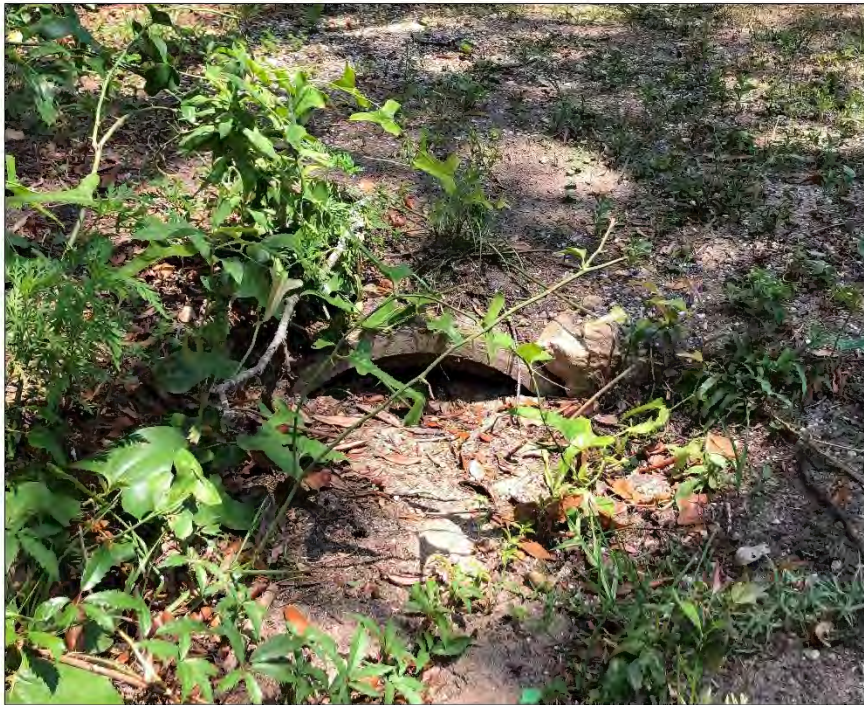
Figure 2. General view of sediment accumulation blocking pipe.

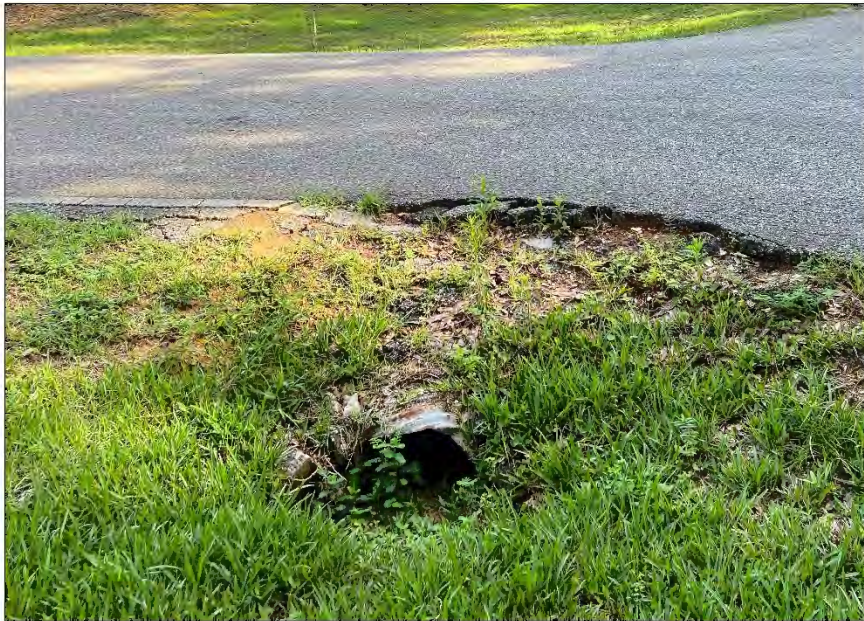
Figure 3. General view of asphalt edge raveling.

Category 2 improvements are items that should be completed in the near future but are not an immediate concern. These improvements include pipe replacements, pipe end treatments and ditch regrading to provide adequate flow capacity and minimize erosion and siltation. Figures 3-5 below show examples of areas where category 2 improvements are recommended.

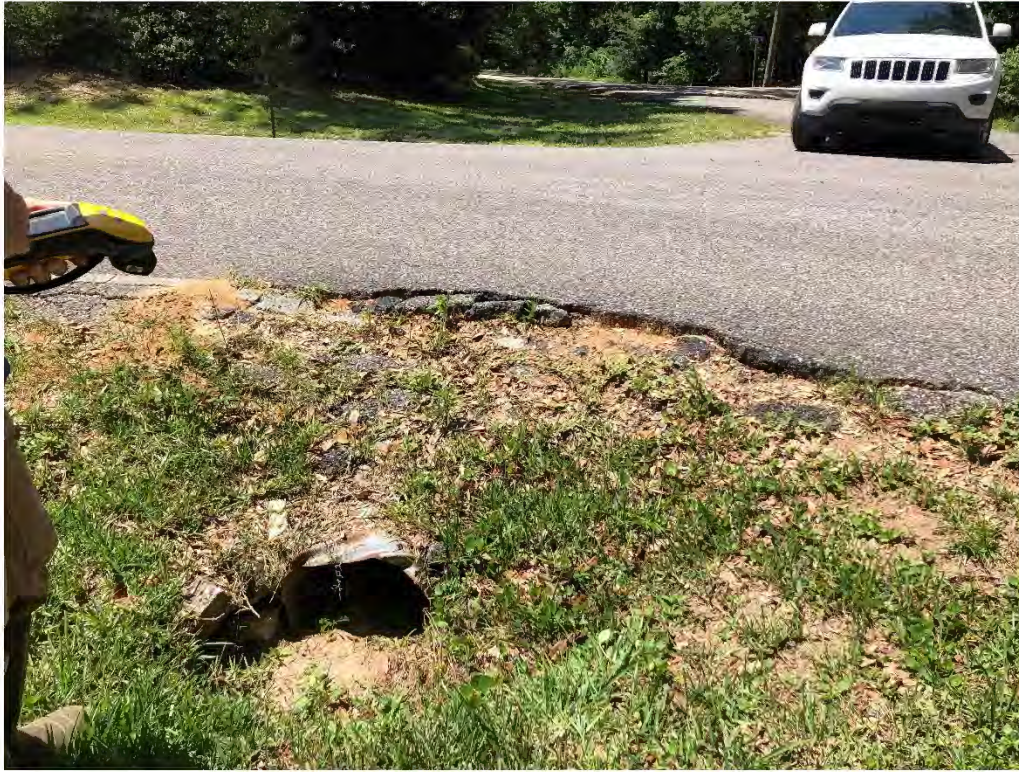
Figure 9046:
Photo taken facing South toward a silted W-CO-1 at the intersection of Woodland Ave and Oak St.

It is recommended to provide maintenance of silted in pipes and ditches, as noted in the photo pages provided in Appendix C. In addition to general maintenance of existing infrastructure, the proposed drainage improvements were consolidated into projects based on category and location. The projects were then ranked based on priority using a MCDA Matrix. All proposed improvements and correlating projects are provided in detail in Appendix H and the proposed projects are summarized below.

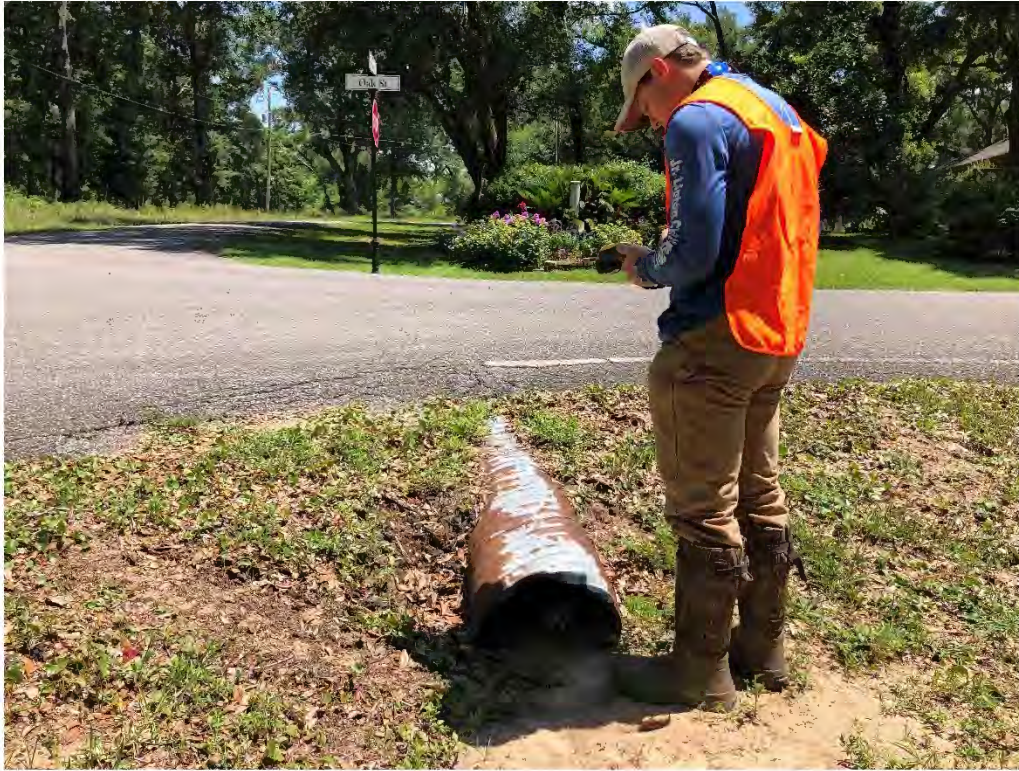
Figure 9049:

Photo taken facing North toward a silted W-CO-1 at the intersection of Woodland Ave and Oak St.

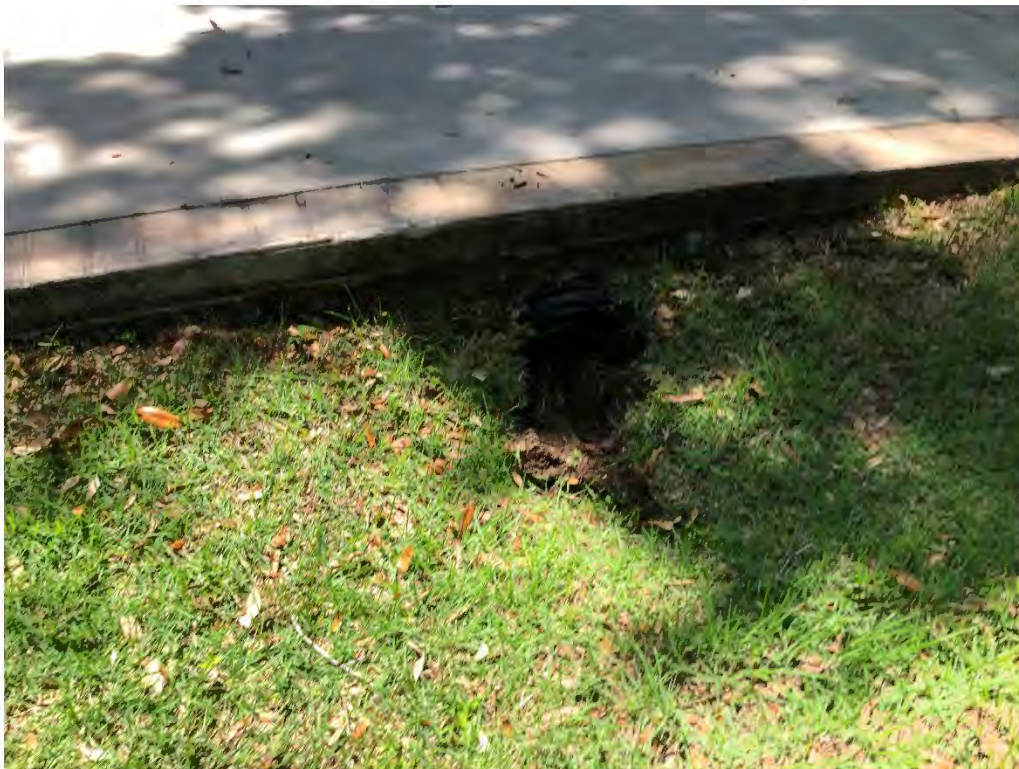
Figure 9060:
Photo taken facing West toward a damaged P-CO-29 along Oak St.

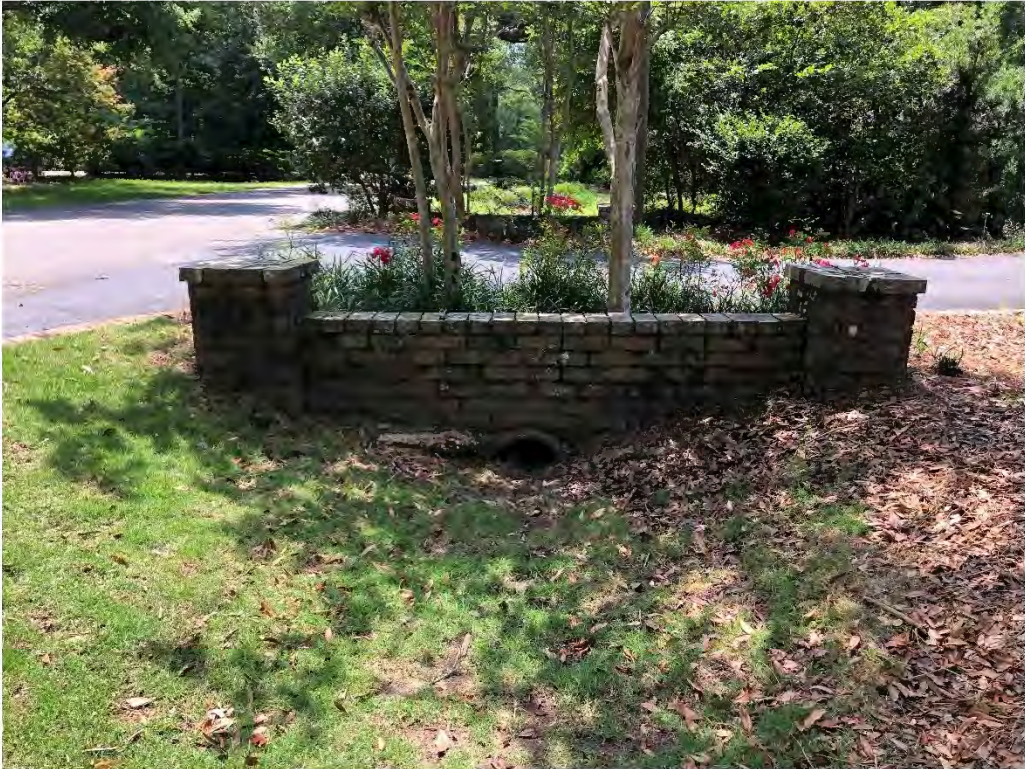
Figure 9069:
Photo taken facing East toward a silted P-CO-32 along Oak St.

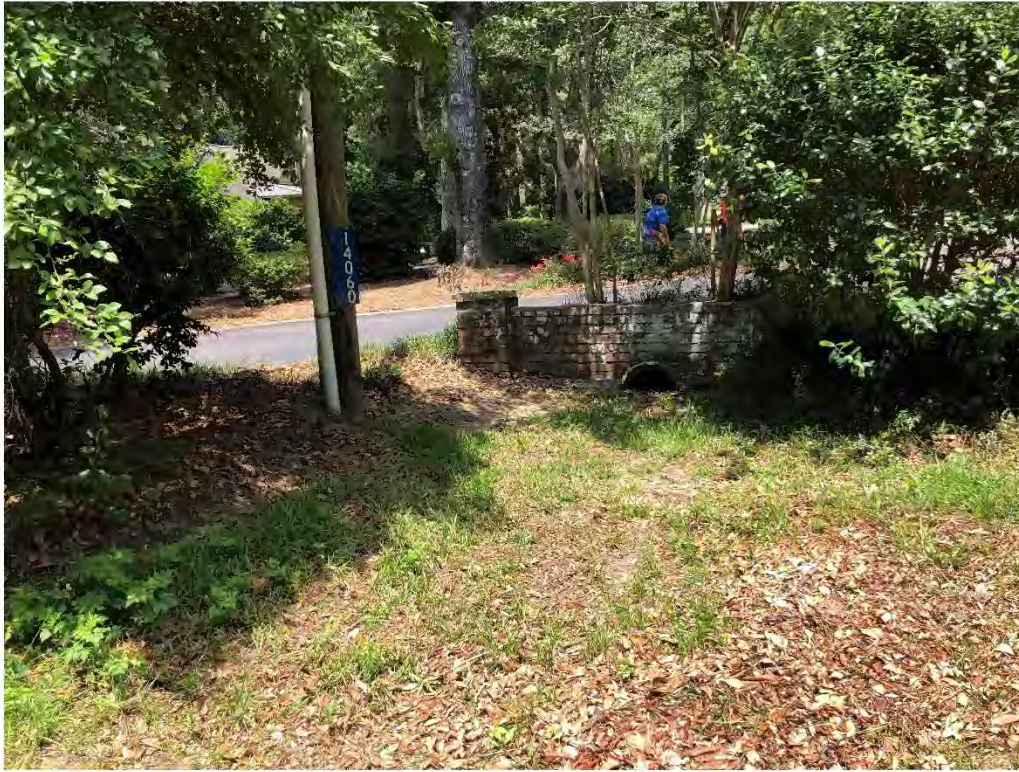
Figure 9071:
Photo taken facing West toward a silted P-CO-32 along Oak St.

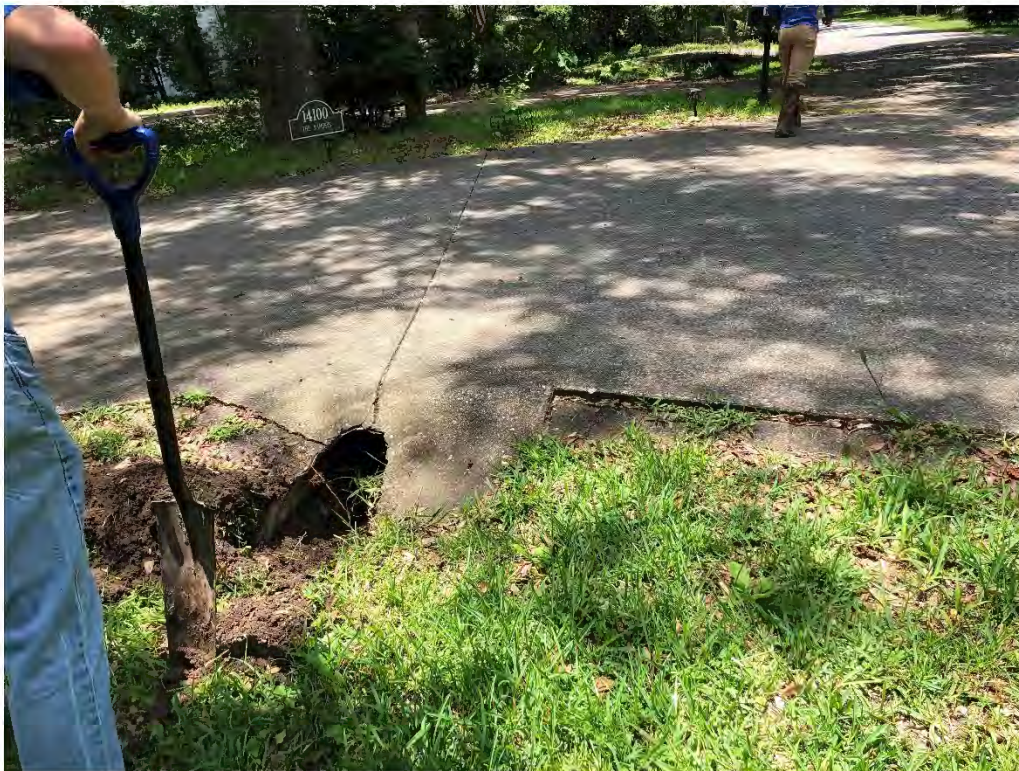
Figure 9075:
Photo taken of a small, silted pipe along Oak St.

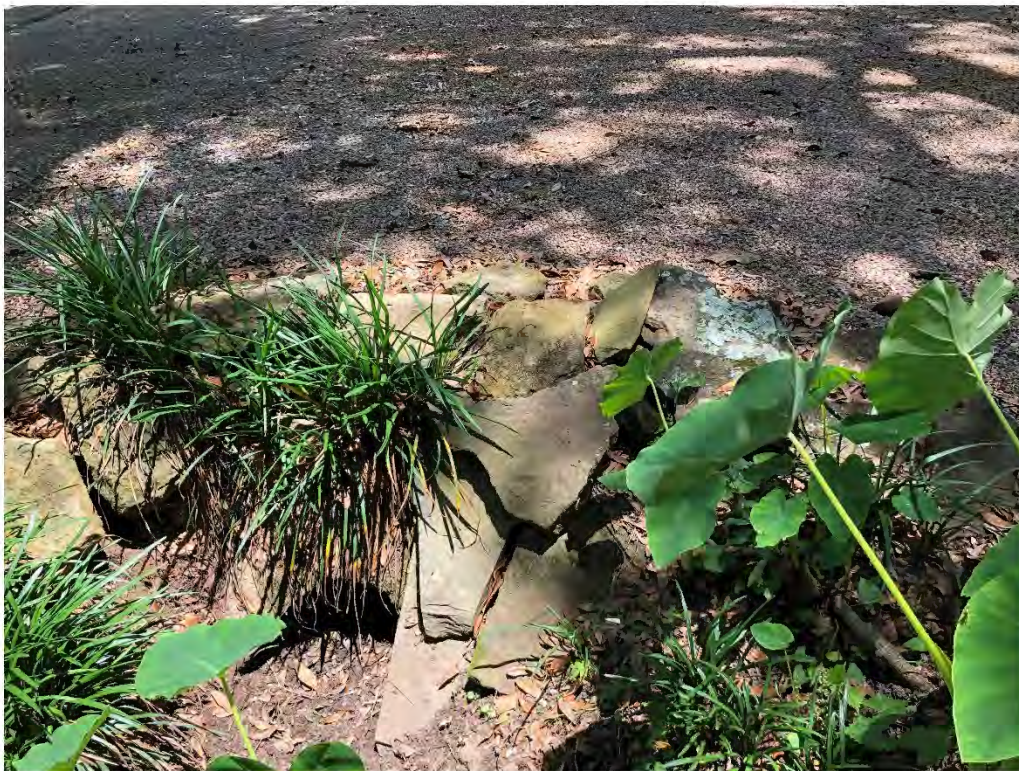
Figure 9077:
Photo taken facing West toward a small, silted P-CO-25 along Oak St.

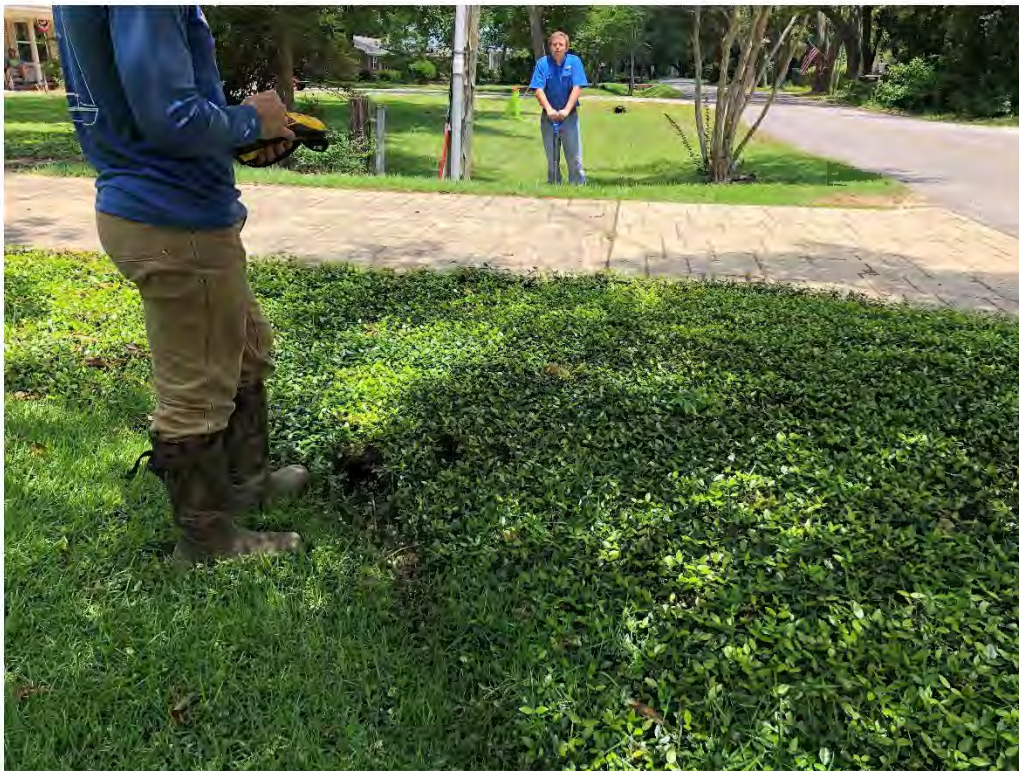
Figure 9087:
Photo taken facing East toward an overgrown P-CO-26 along Oak St.

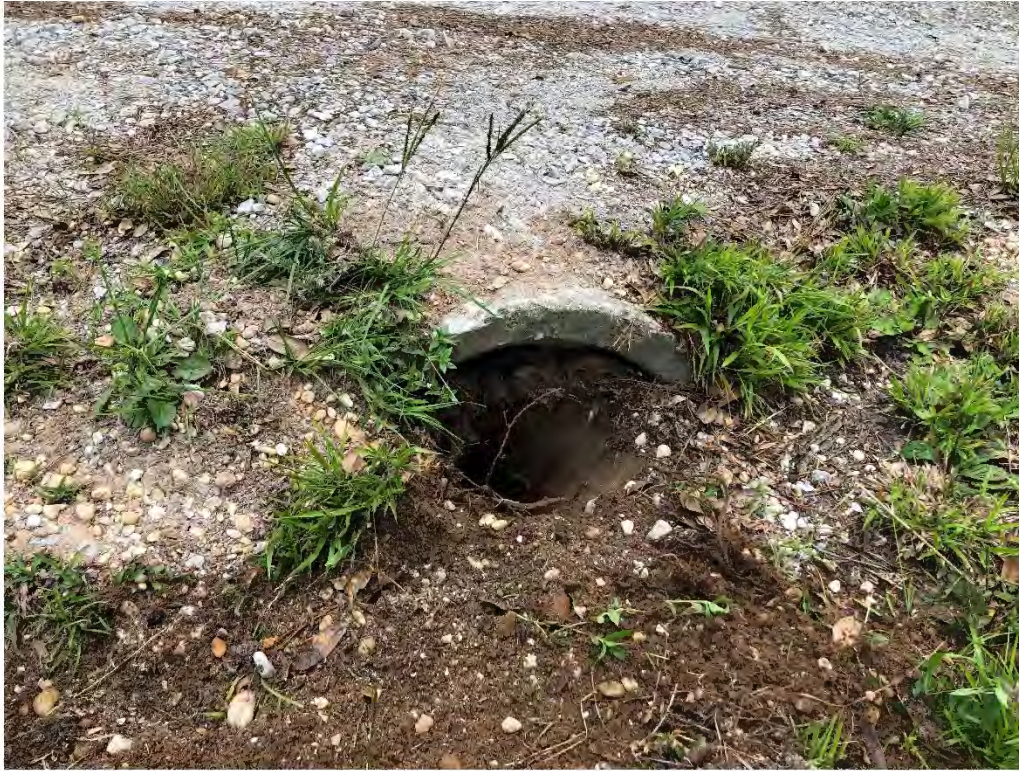
Figure 9096:
Photo taken of a very silted P-CO-26 along Oak St.

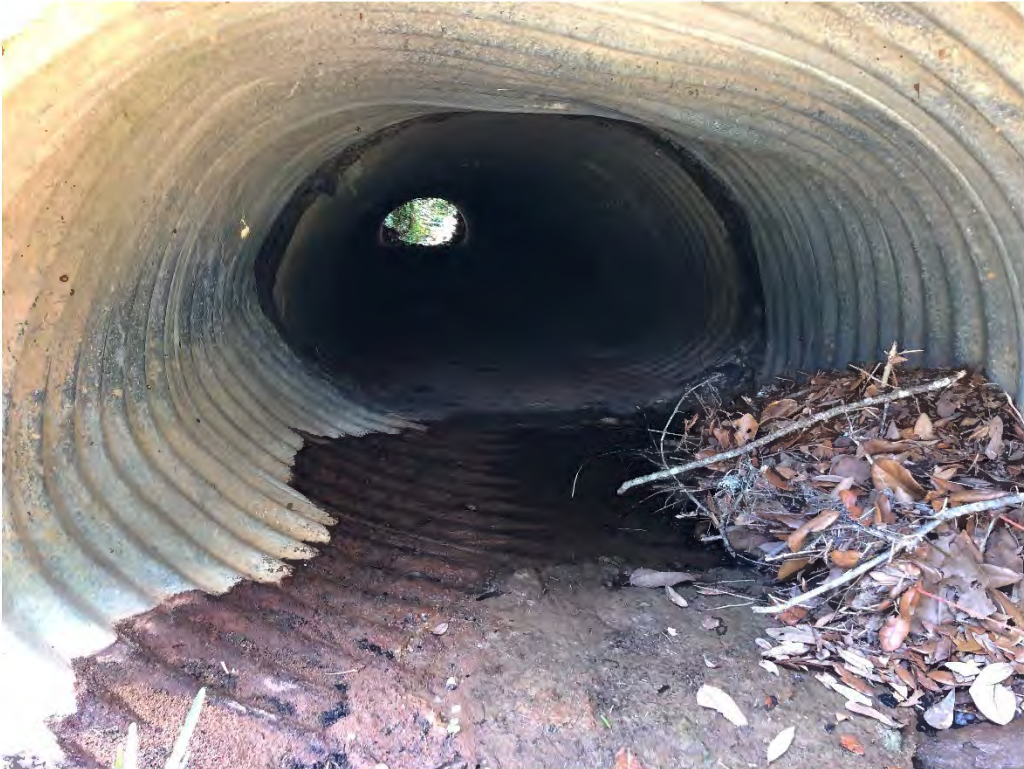
Figure 9109:
Photo taken facing West toward a crushed corrugated metal P-CH-28 along Oak St.

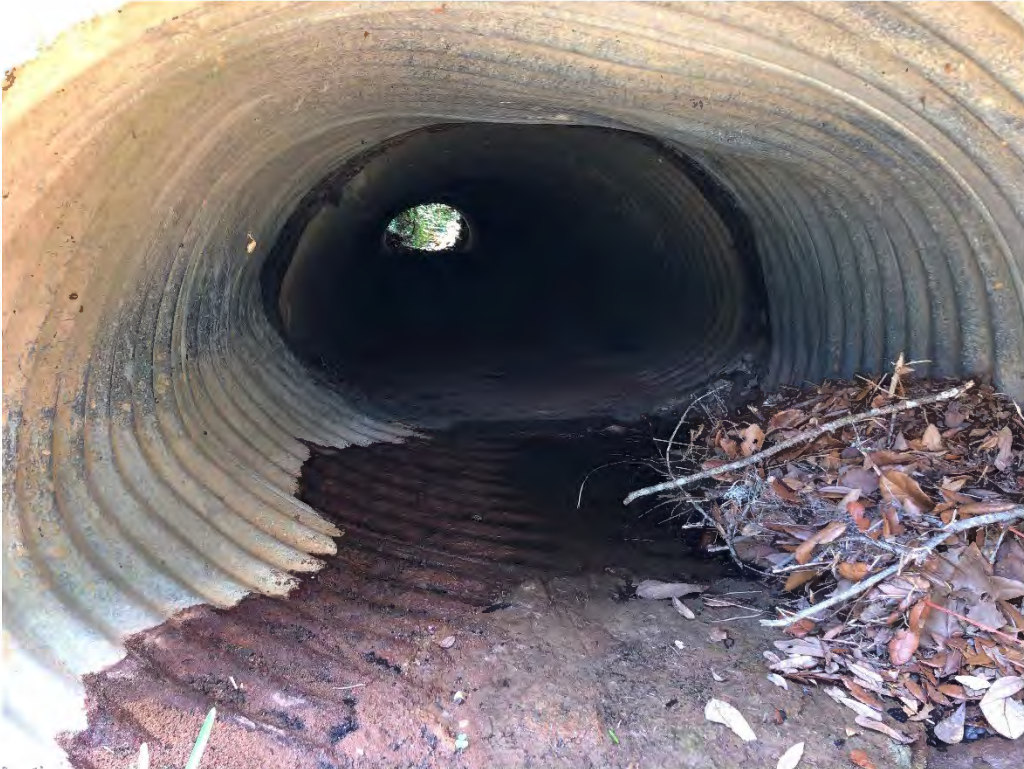
Figure 9110:
Photo taken facing West toward a crushed corrugated metal P-CH-28 along Oak St.

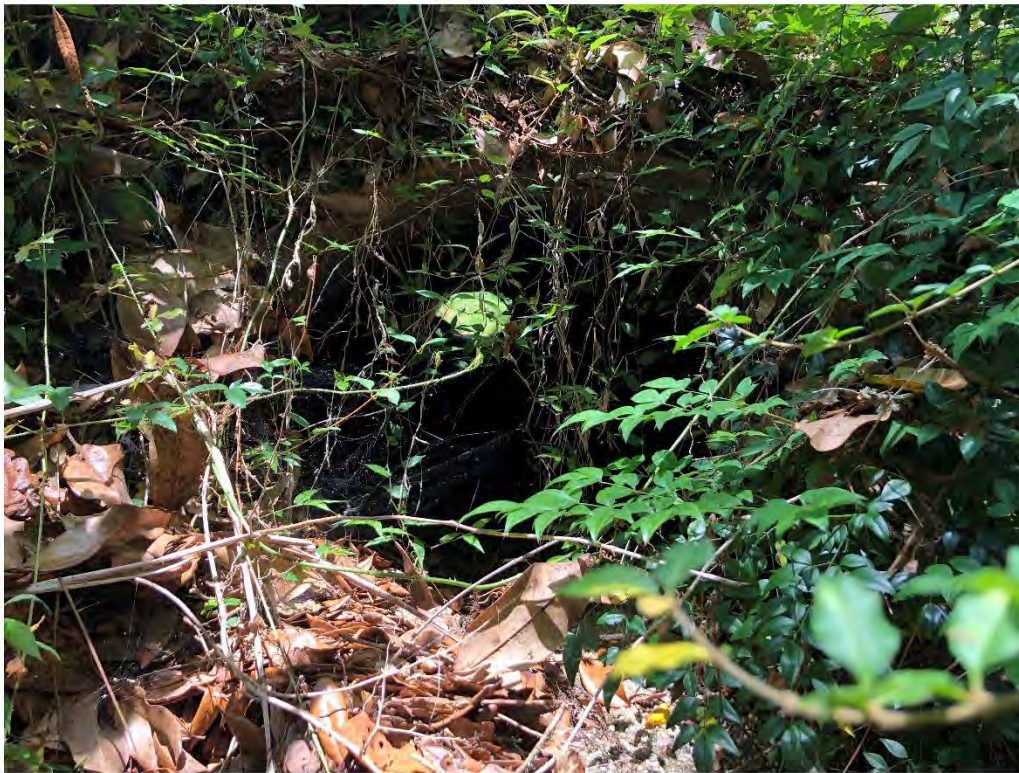
Figure 9117:

Photo taken facing North toward an overgrown P-CO-28 along Oak St.

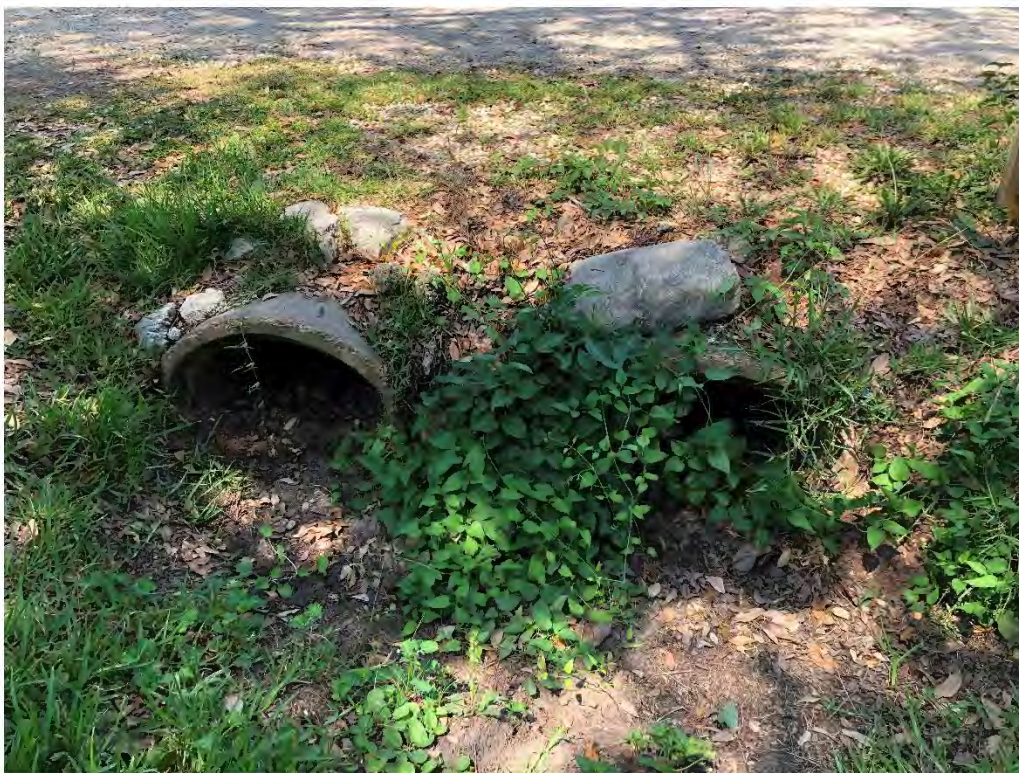
Figure 9606:
Photo taken facing West toward a silted MN-CO-21 across a driveway.

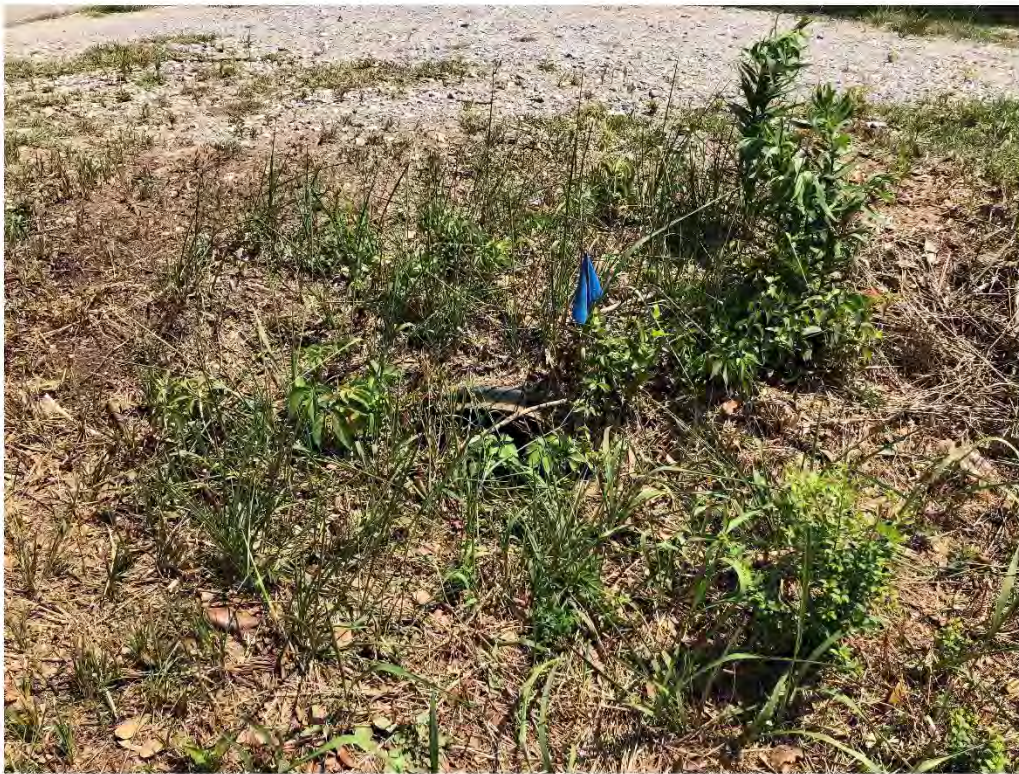
Figure 9622:
Photo taken facing North toward a very silted OAK-CO-5 across Jessamine St.

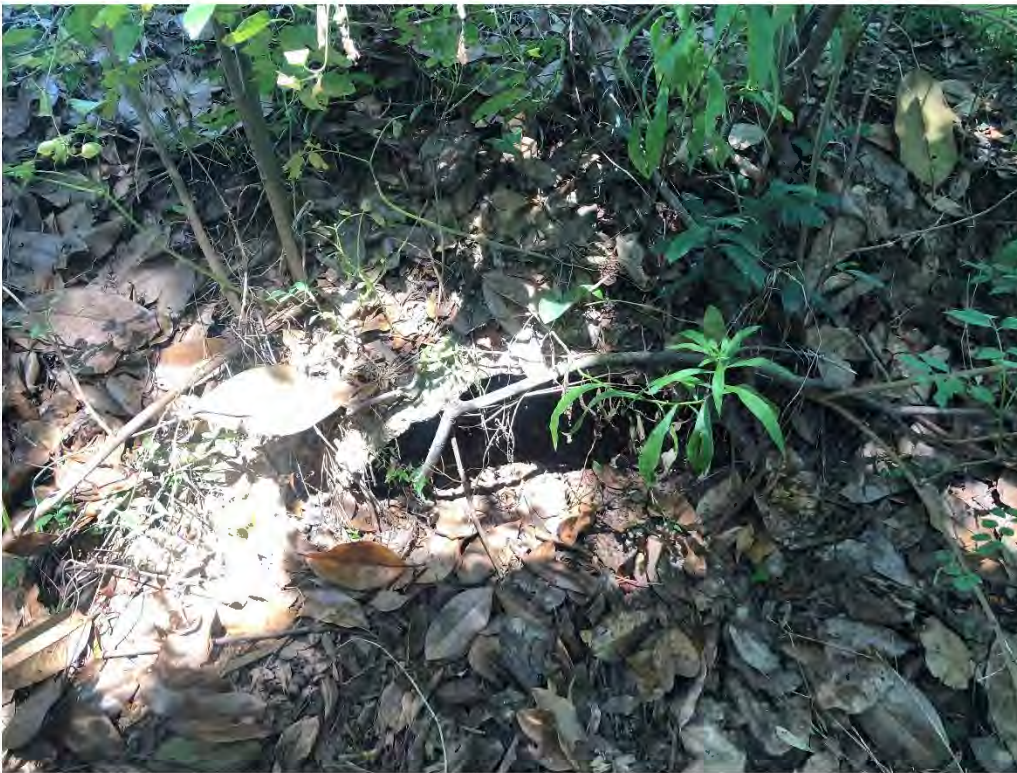
Figure 9632:

Photo taken facing West toward a very silted OAK-CO-8 that crosses Jessamine St.

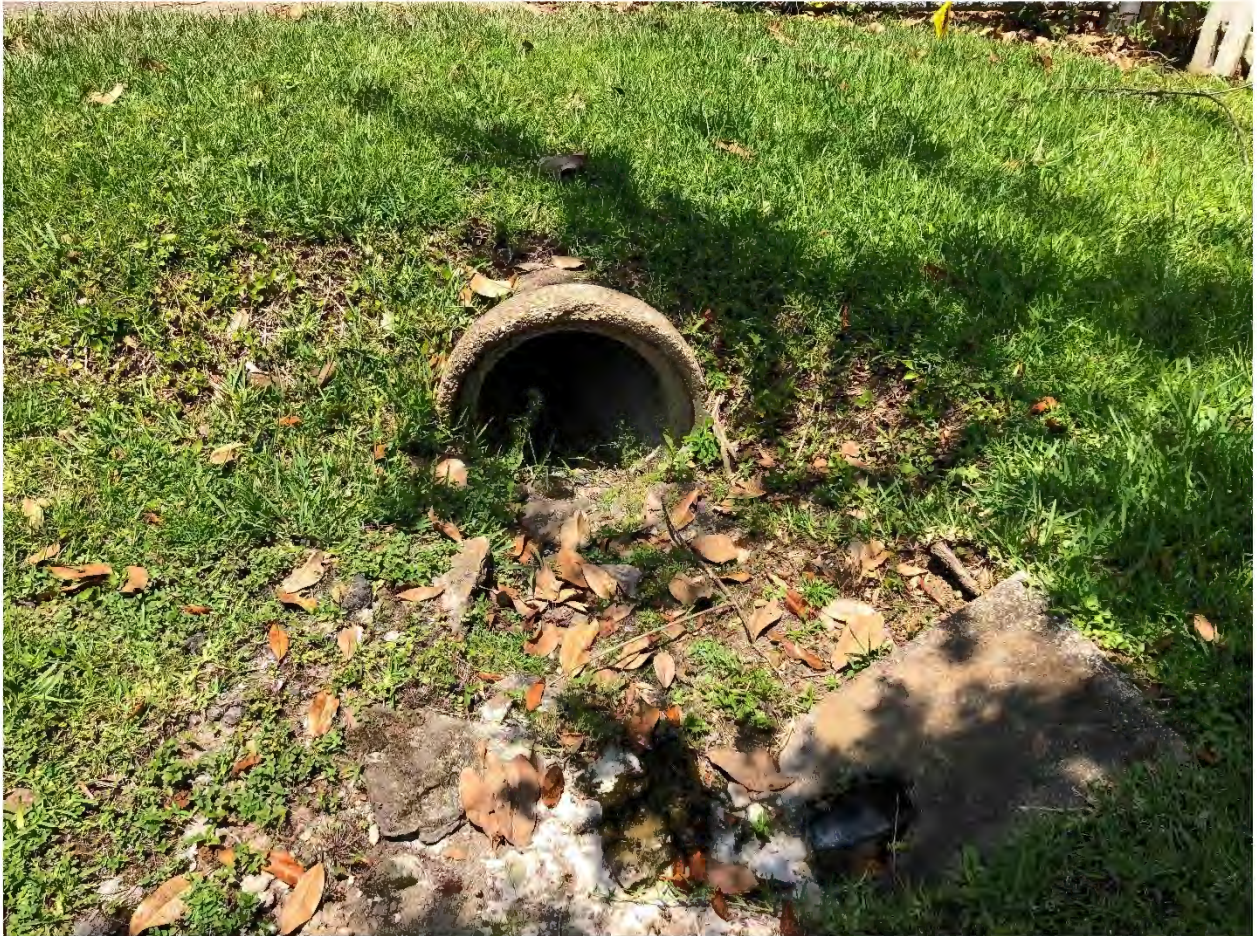
Figure 9673:

Photo taken of a silted OAK-CO-26 at the intersection of Oak St and a residential driveway.
