Town of Magnolia Springs Comprehensive Drainage Masterplan

Town of Magnolia Springs
Magnolia Springs, Baldwin County, Alabama

VOLKERT

March 2023

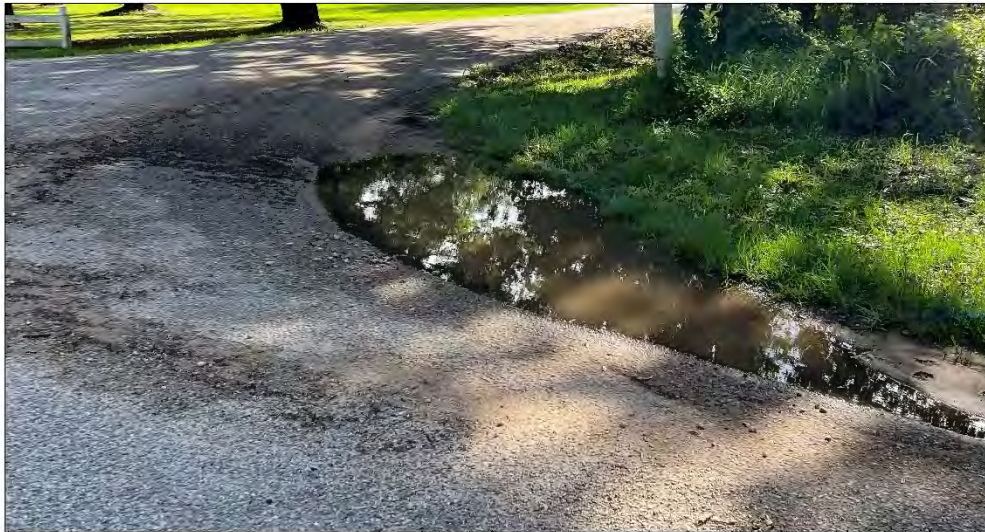
Figure 5. General view of standing water.

Category 2 improvements are items that should be completed in the near future but are not an immediate concern. These improvements include pipe replacements, pipe end treatments and ditch regrading to provide adequate flow capacity and minimize erosion and siltation. Figures 3-5 below show examples of areas where category 2 improvements are recommended.

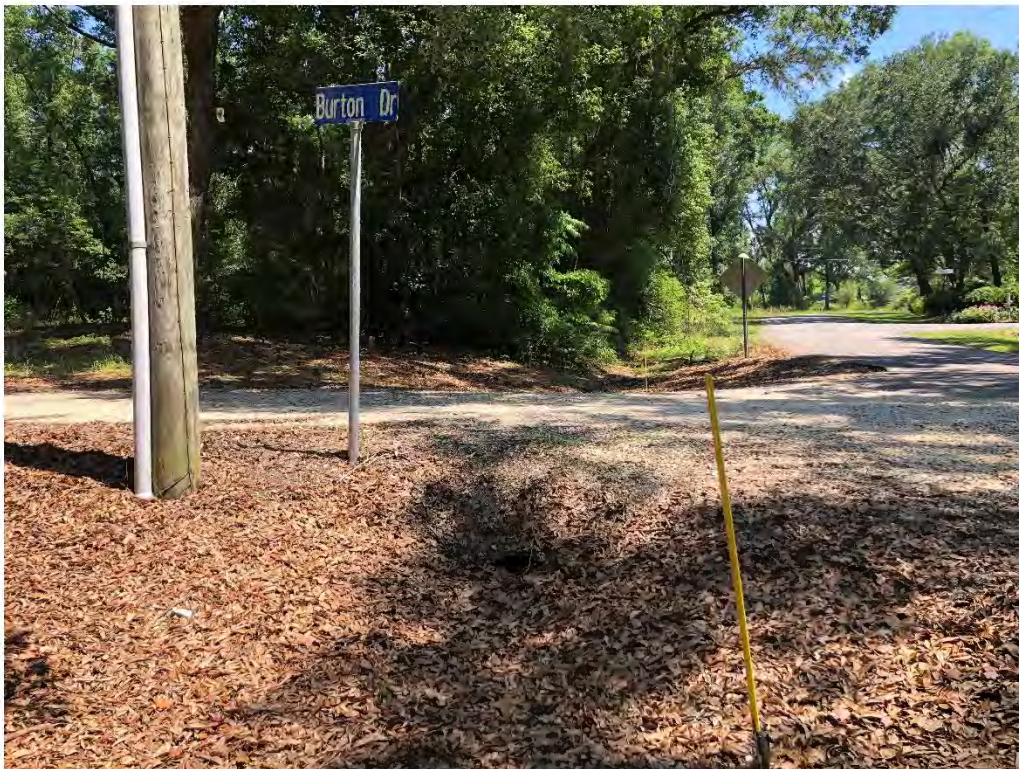
Figure 9038:
Photo taken facing North toward a silted W-CO-2 at the intersection of Woodland Ave and a driveway.

It is recommended to provide maintenance of silted in pipes and ditches, as noted in the photo pages provided in Appendix C. In addition to general maintenance of existing infrastructure, the proposed drainage improvements were consolidated into projects based on category and location. The projects were then ranked based on priority using a MCDA Matrix. All proposed improvements and correlating projects are provided in detail in Appendix H and the proposed projects are summarized below.

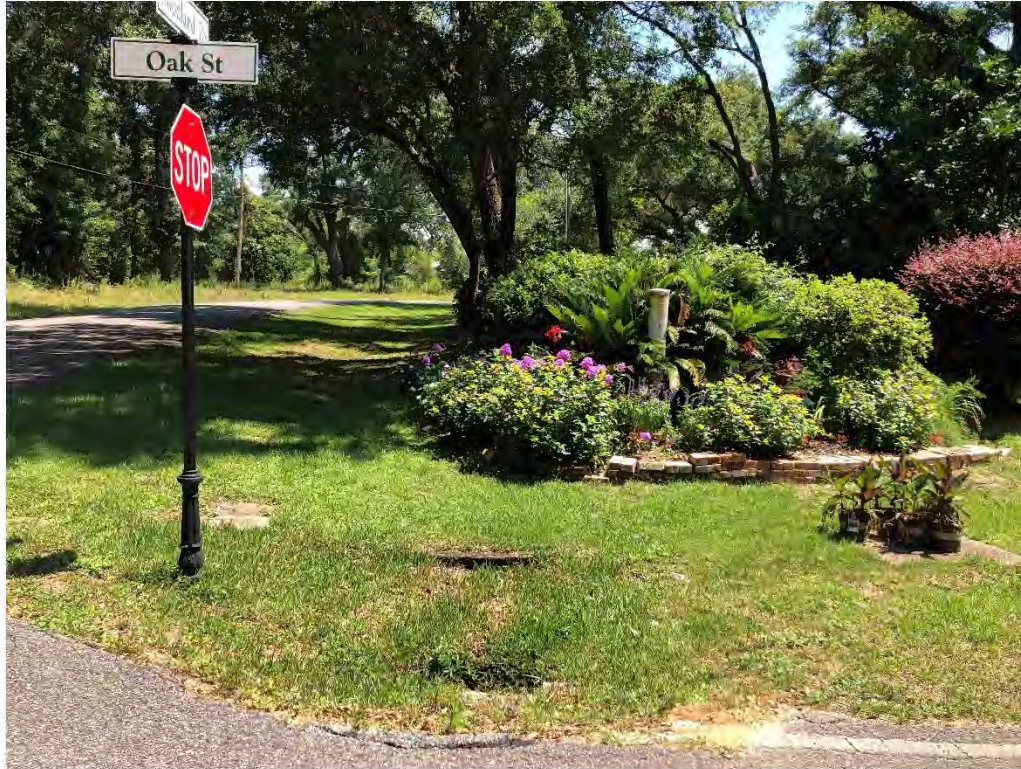
Figure 9047:
Photo taken facing North toward a grassed W-CH-1 at the intersection of Woodland Ave and Oak St.

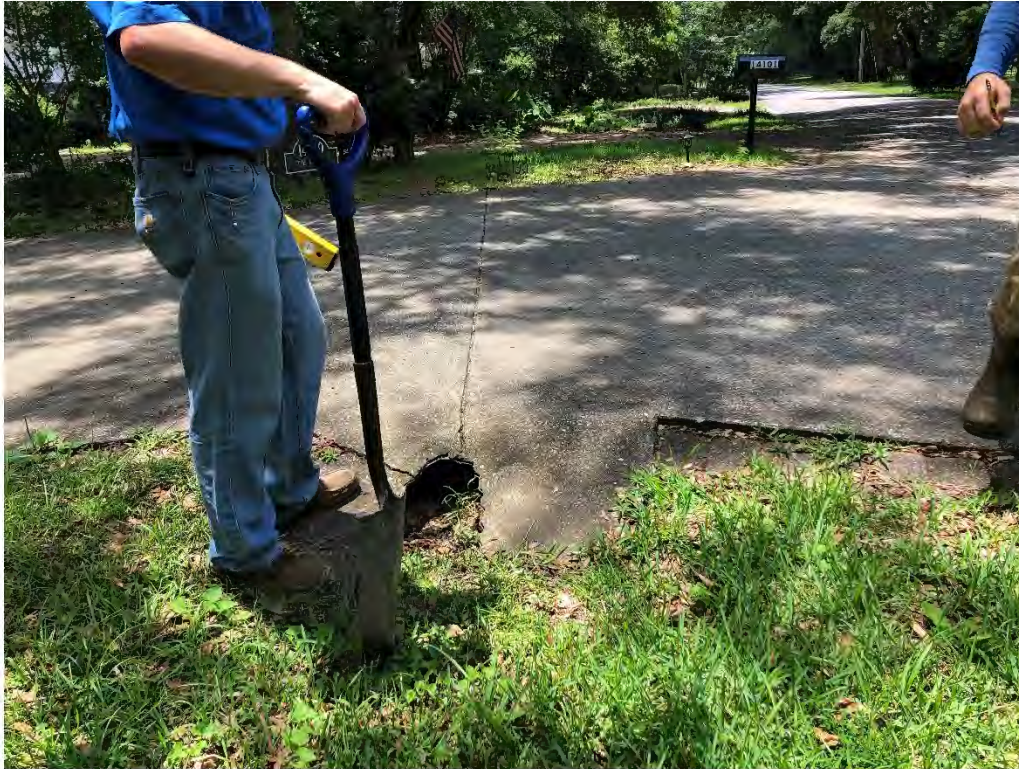
Figure 9074:
Photo taken of a small, silted pipe along Oak St.

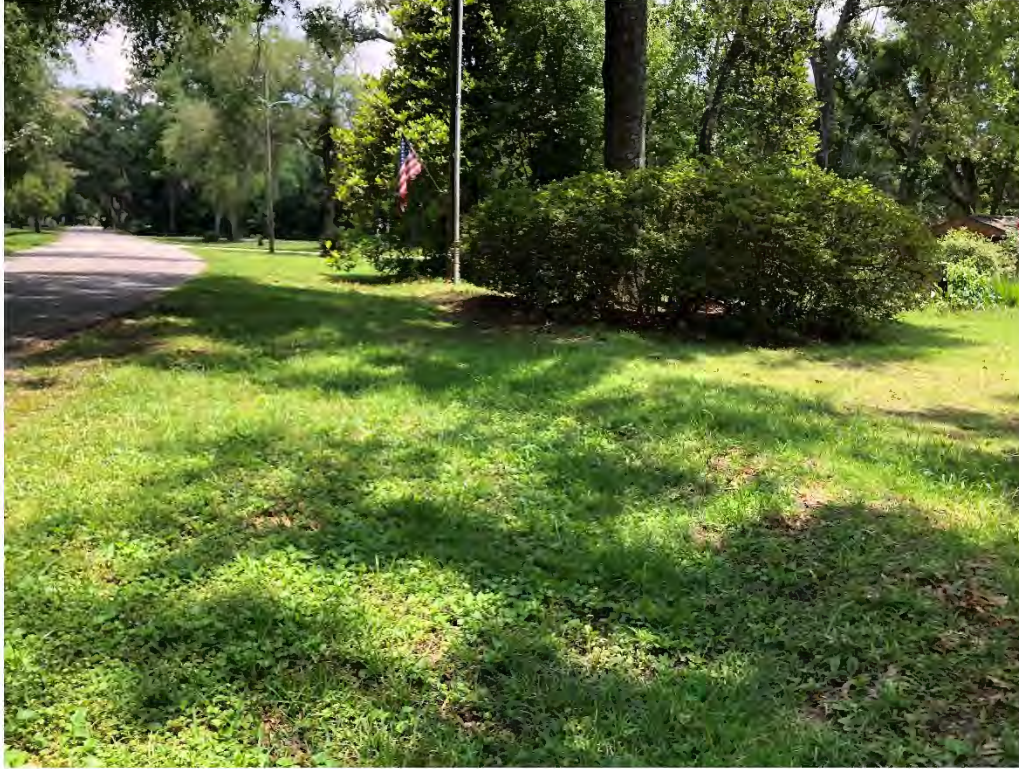
Figure 9076:
Photo taken facing East toward P-CH-36 along Oak St.

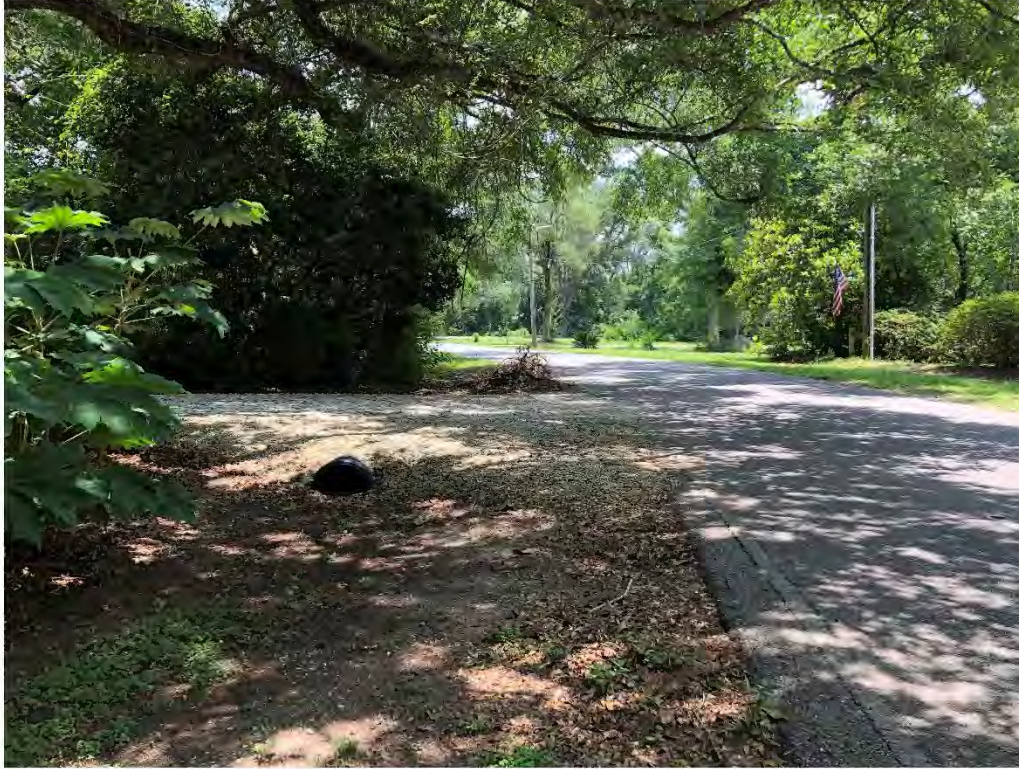
Figure 9078:
Photo taken facing East toward a silted P-CO-25 along Oak St.

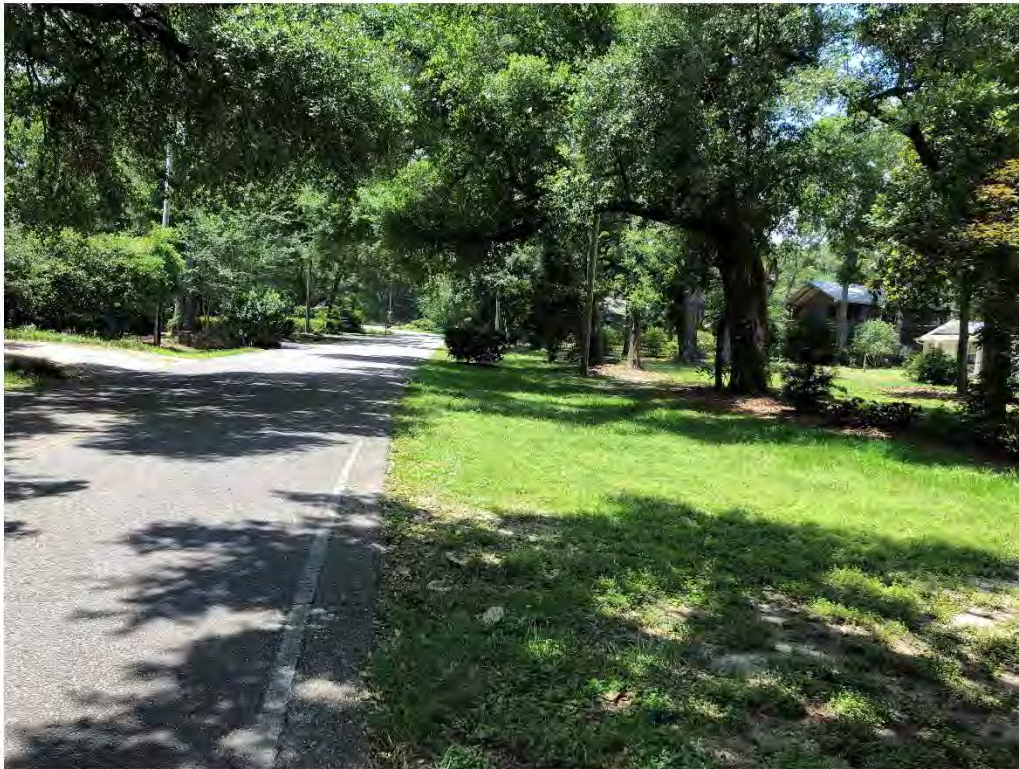
Figure 9079:
Photo taken facing West toward a ditch along the northern side of Oak St.

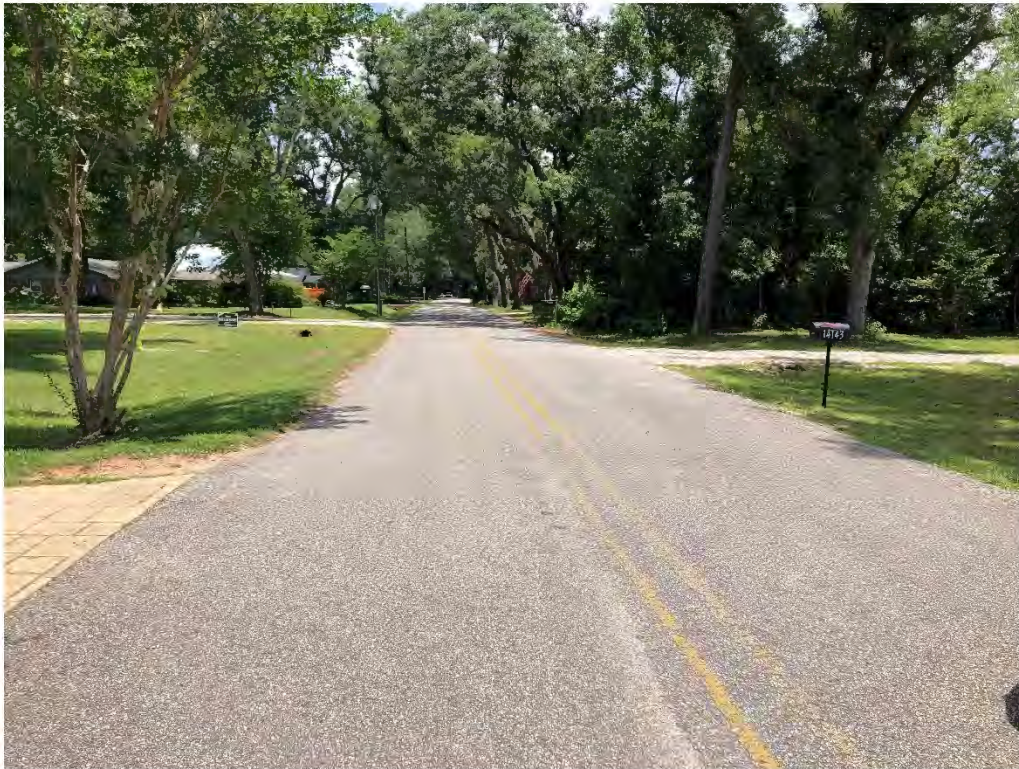
Figure 9085:
Photo taken facing East toward a grassed P-CH-28 along Oak St.

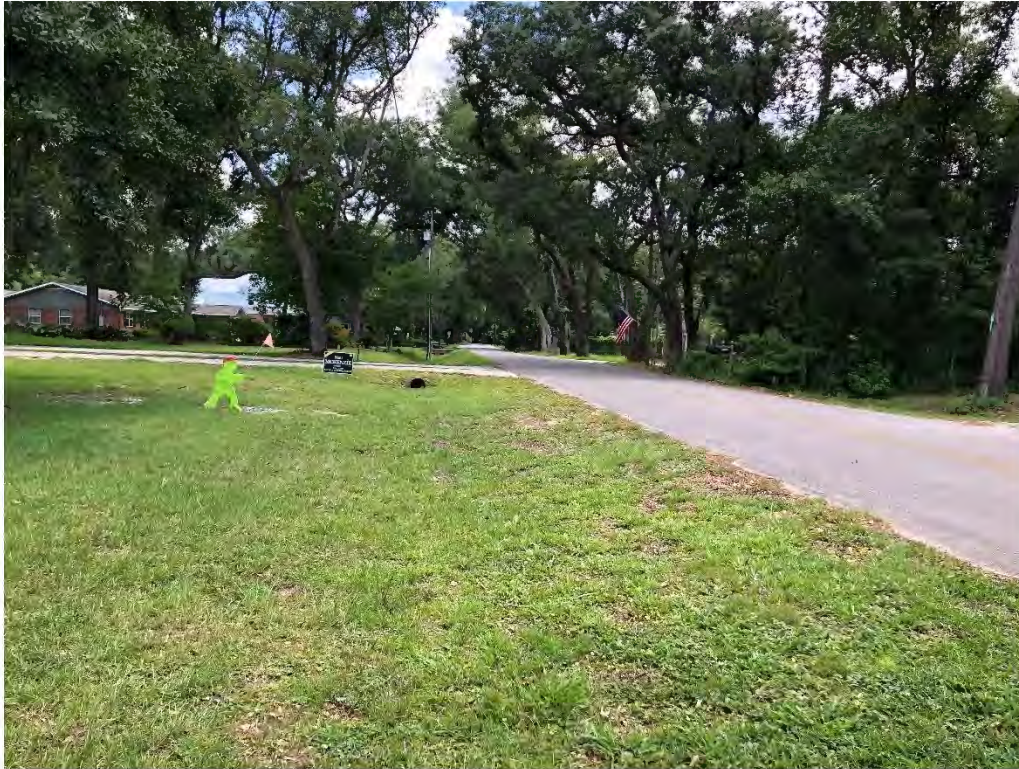
Figure 9090:
Photo taken facing East toward a grassed P-CH-28 along Oak St.

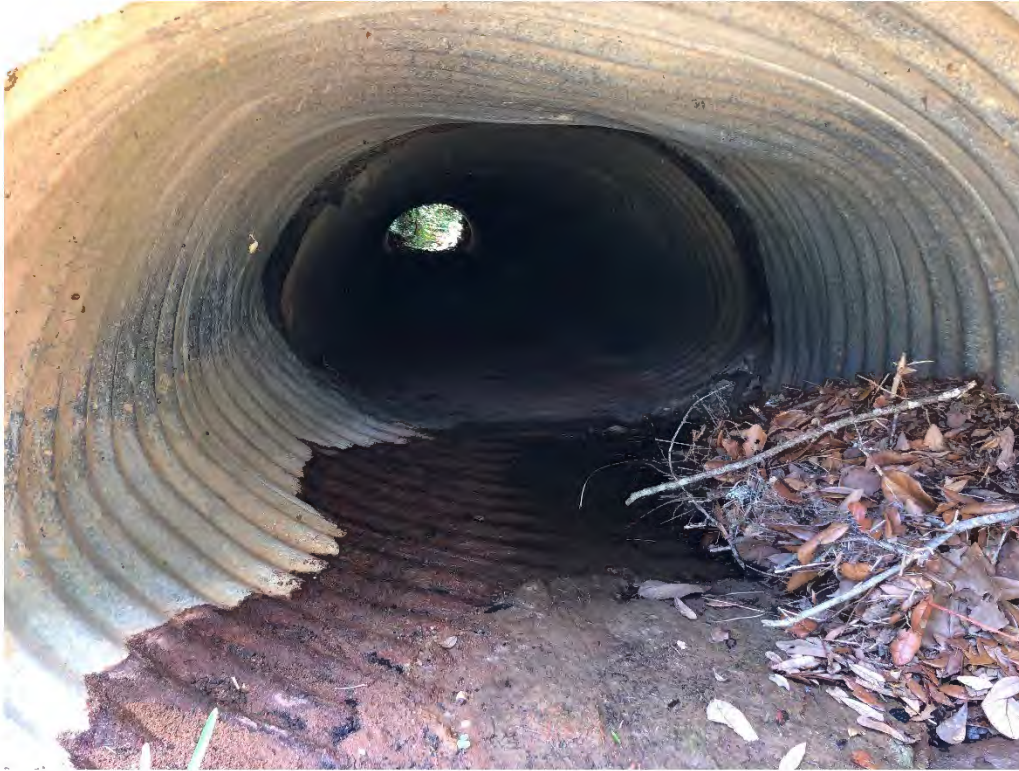
Figure 9110:
Photo taken facing West toward a crushed corrugated metal P-CH-28 along Oak St.

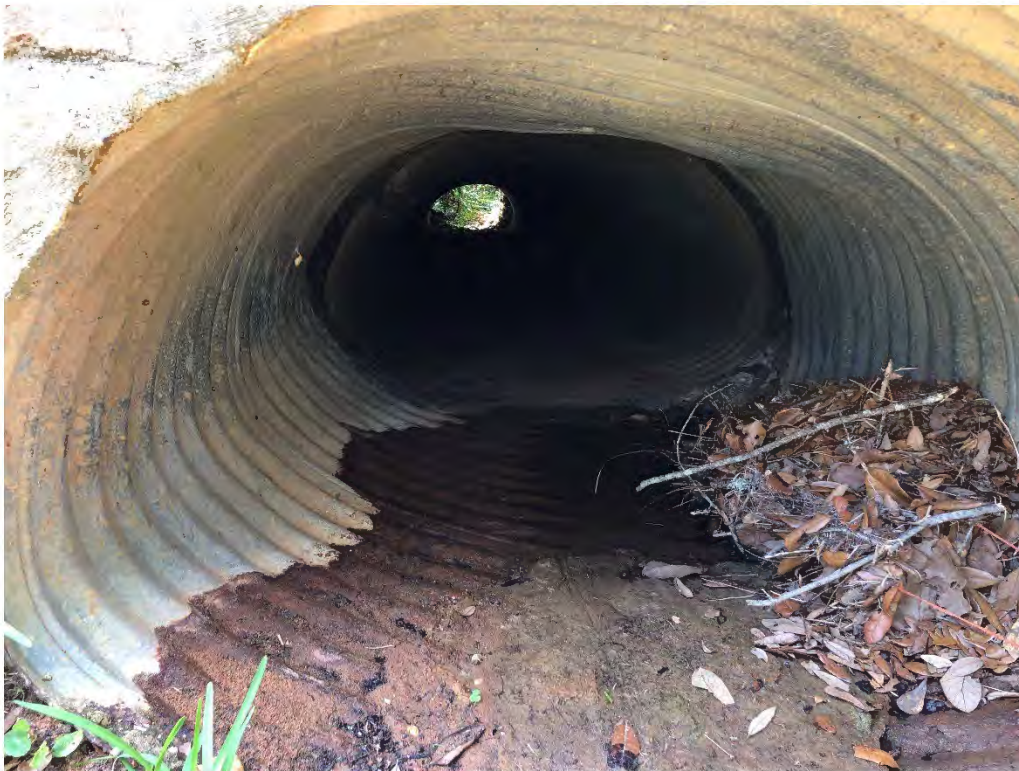
Figure 9111:
Photo taken facing West toward a crushed corrugated metal P-CH-28 along Oak St.

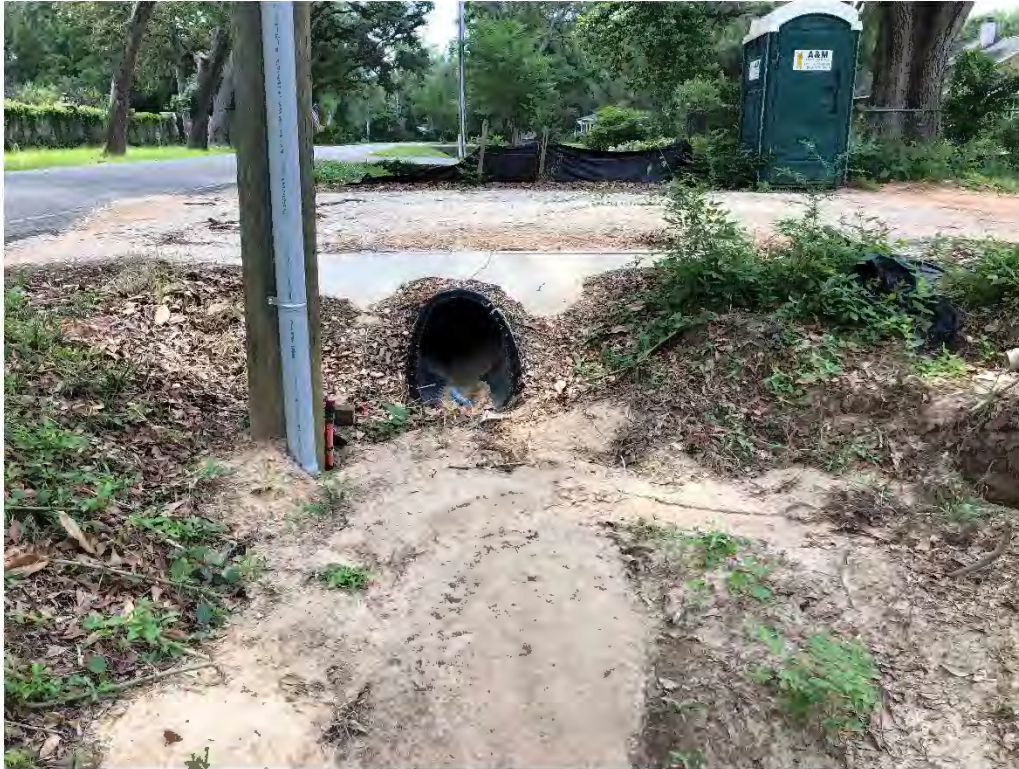
Figure 9125:
Photo taken facing East toward a slightly silted P-CO-23 along Oak St.

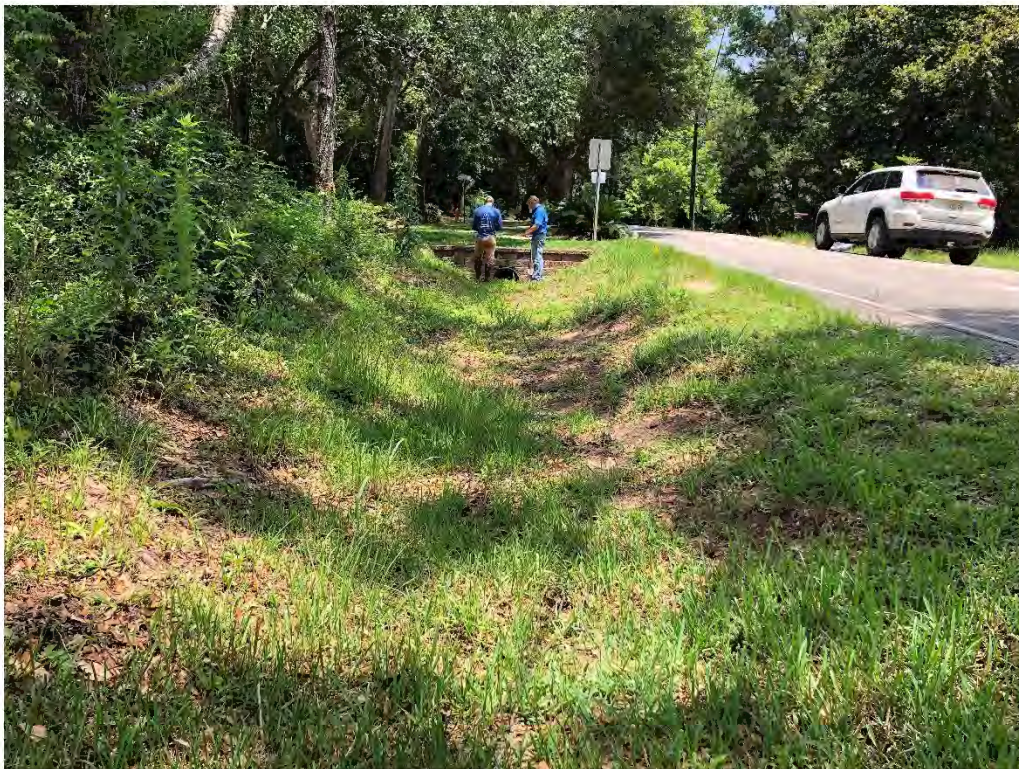
Figure 9126:
Photo taken facing West toward a silted P-CO-23 along Oak St.

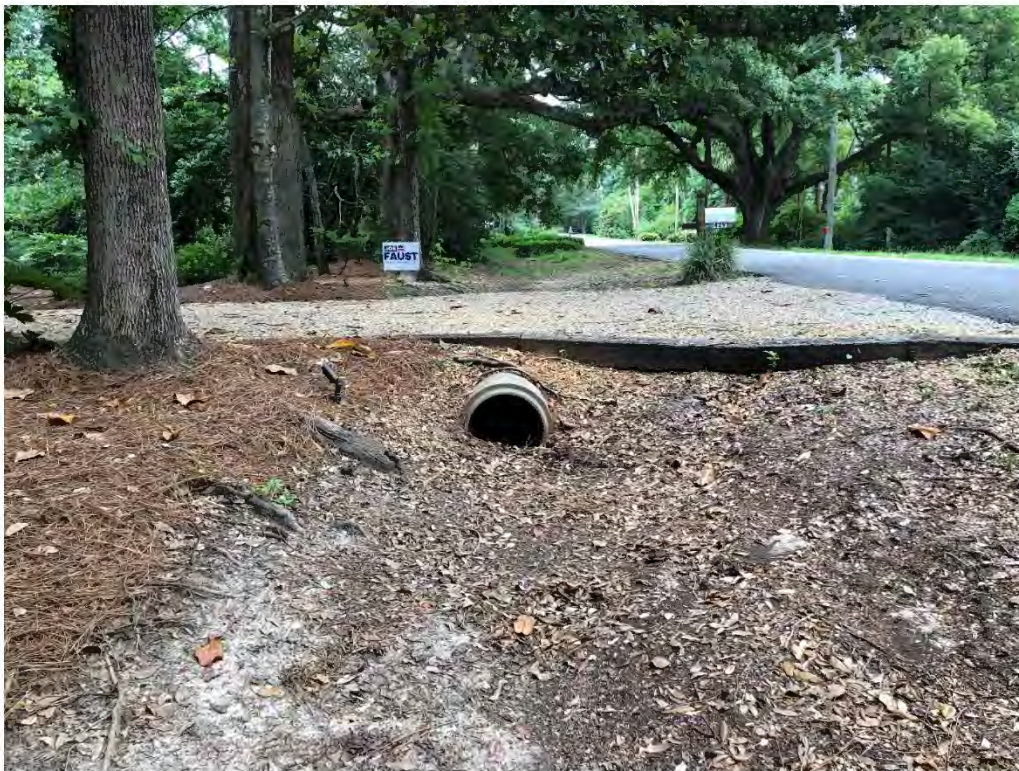
Figure 9144:
Photo taken facing East toward a silted P-CO-20 along Oak St.

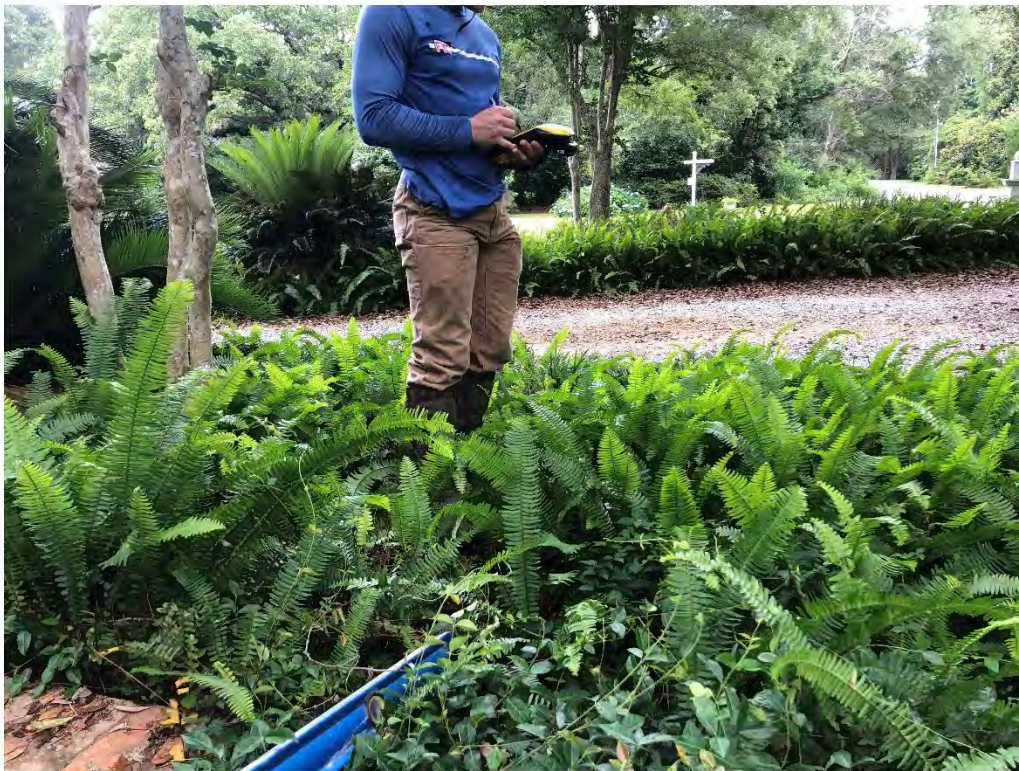
Figure 9148:
Photo taken facing East toward an overgrown P-CO-19 along Oak St.

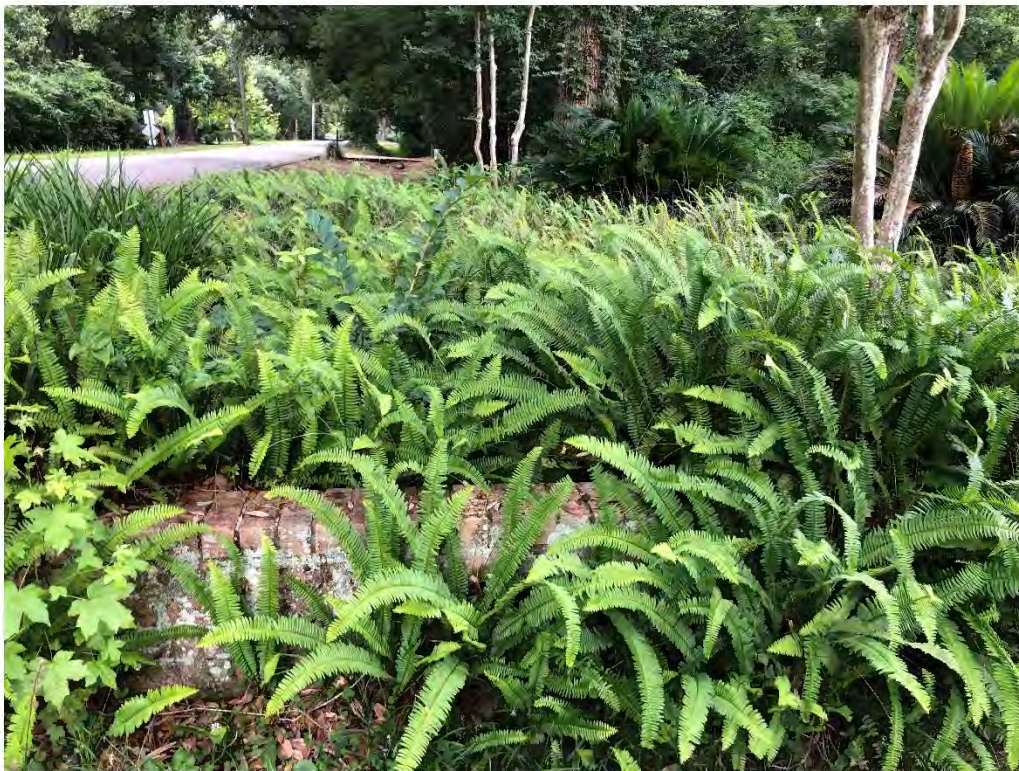
Figure 9150:
Photo taken facing West toward an overgrown P-CO-21 along Oak St.

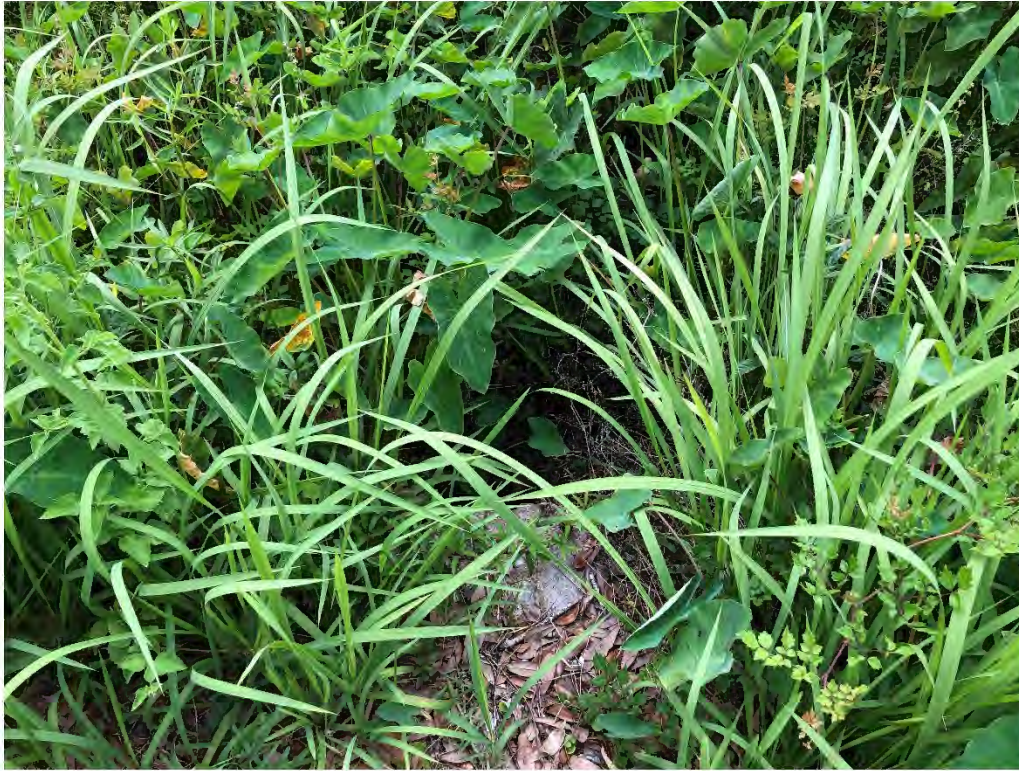
Figure 9157:
Photo taken facing North toward an overgrown BB-CO-15 along Island Ave.

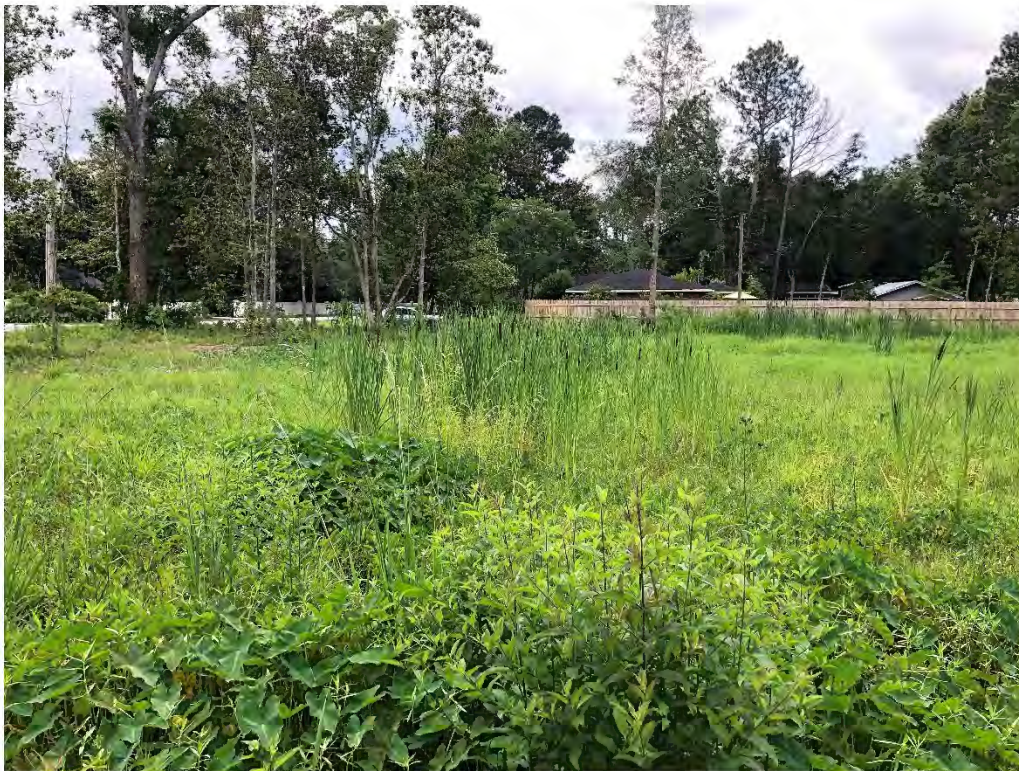
Figure 9158:
Photo taken facing North toward an overgrown BB-CO-15 along Island Ave.

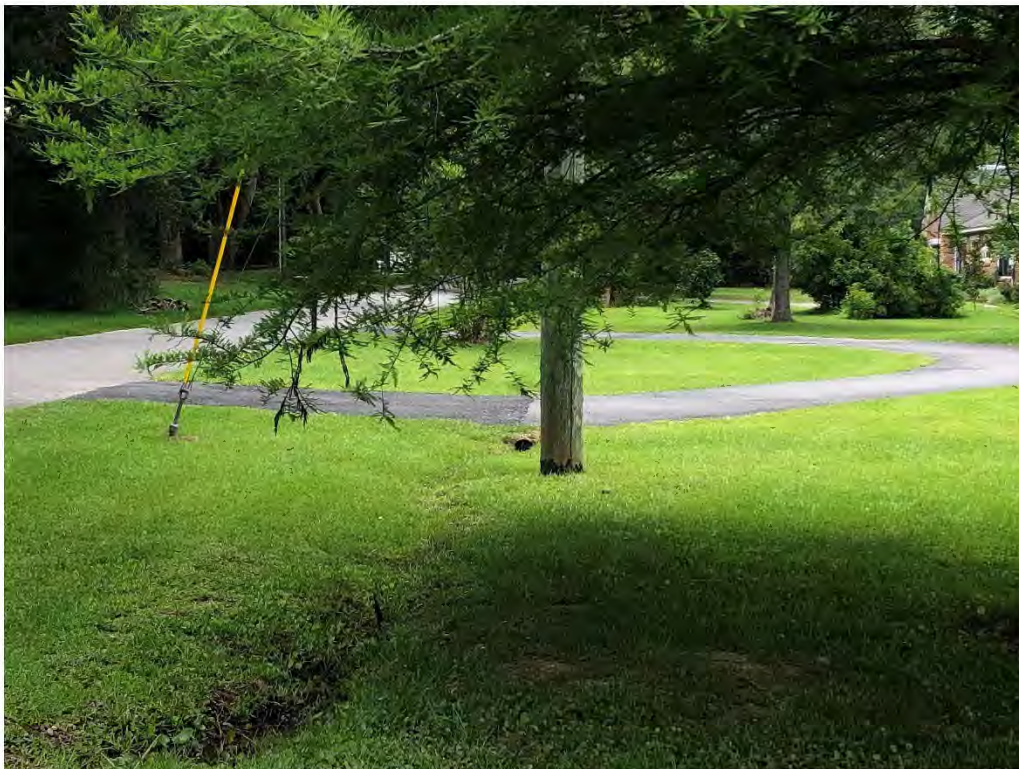
Figure 9160:
Photo taken facing NE toward a grassed BB-CH-14 along Island Ave.

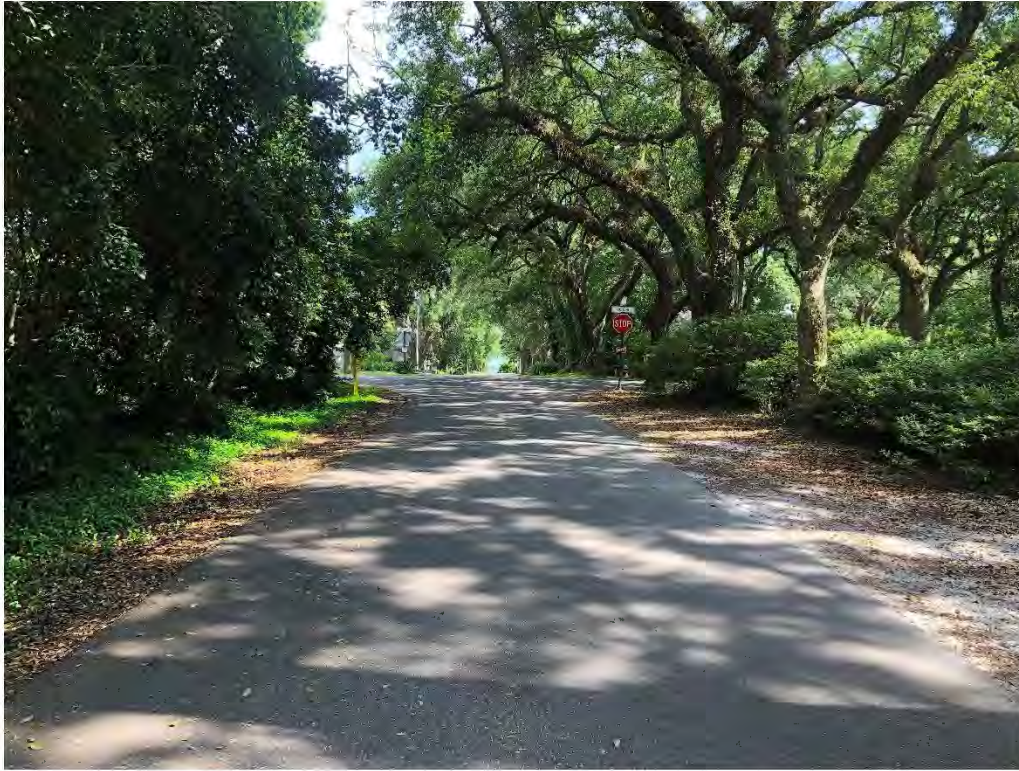
Figure 9226:
Photo taken facing South toward J-CO-2 at the intersection of Oak St and Jessamine St.

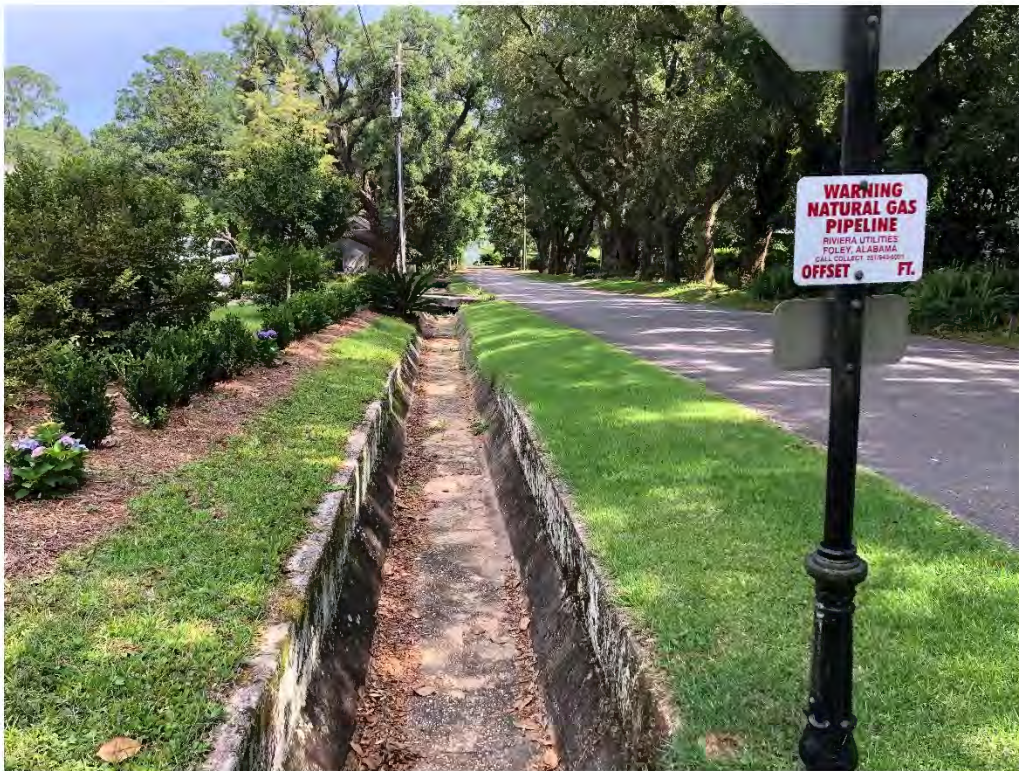
Figure 9231:
Photo taken facing South toward CH-200 along Jessamine St.

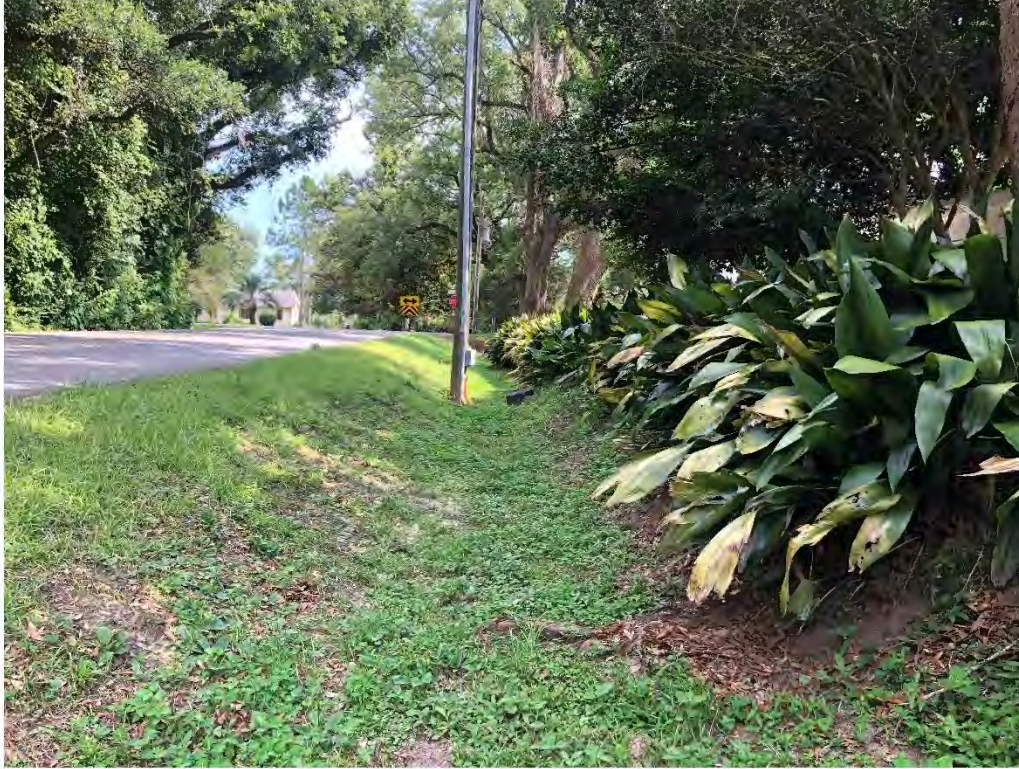
Figure 9232:
Photo taken facing South toward P-CH-20 at the intersection of Oak St and Pecan Grove St.

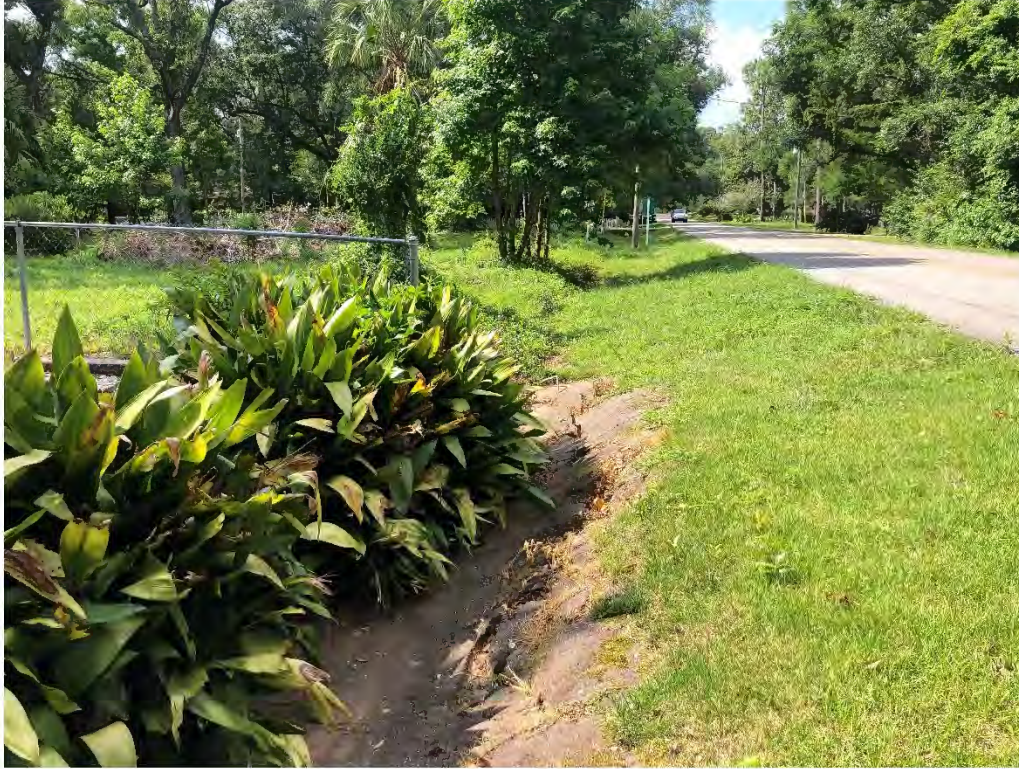
Figure 9236:
Photo taken facing North toward P-CH-19 along Pecan Grove St.

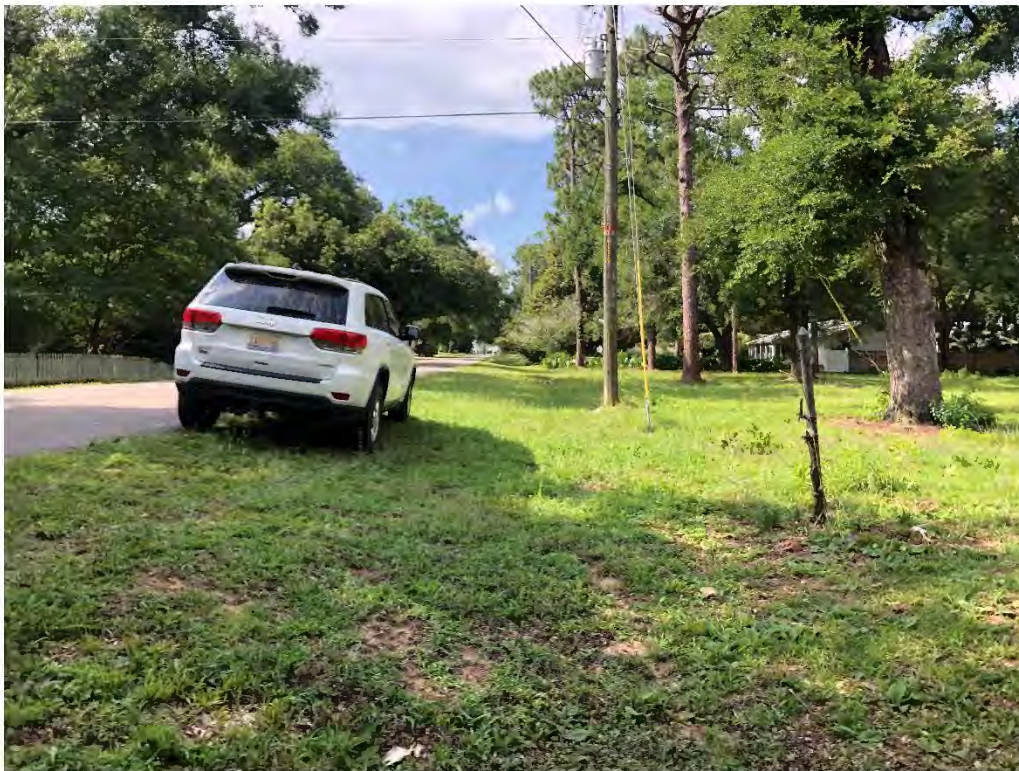
Figure 9239:
Photo taken facing North toward a silted P-CH-17 along Pecan Grove St.

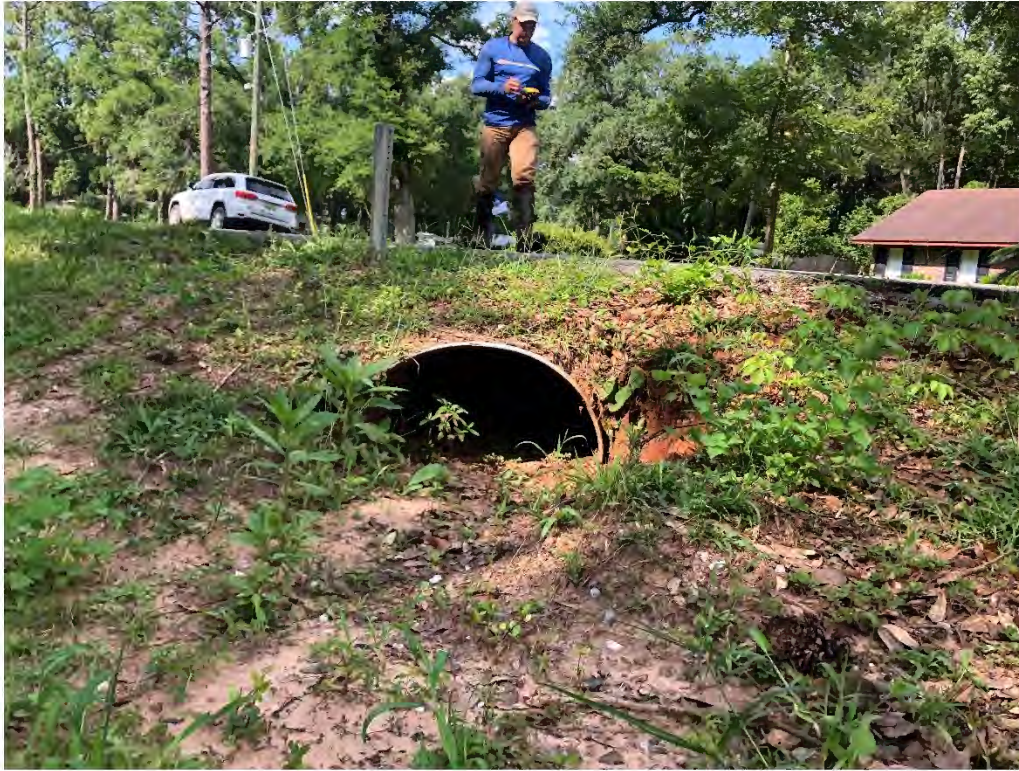
Figure 9243:
Photo taken facing SW toward a silted P-CO-17 along Pecan Grove St.

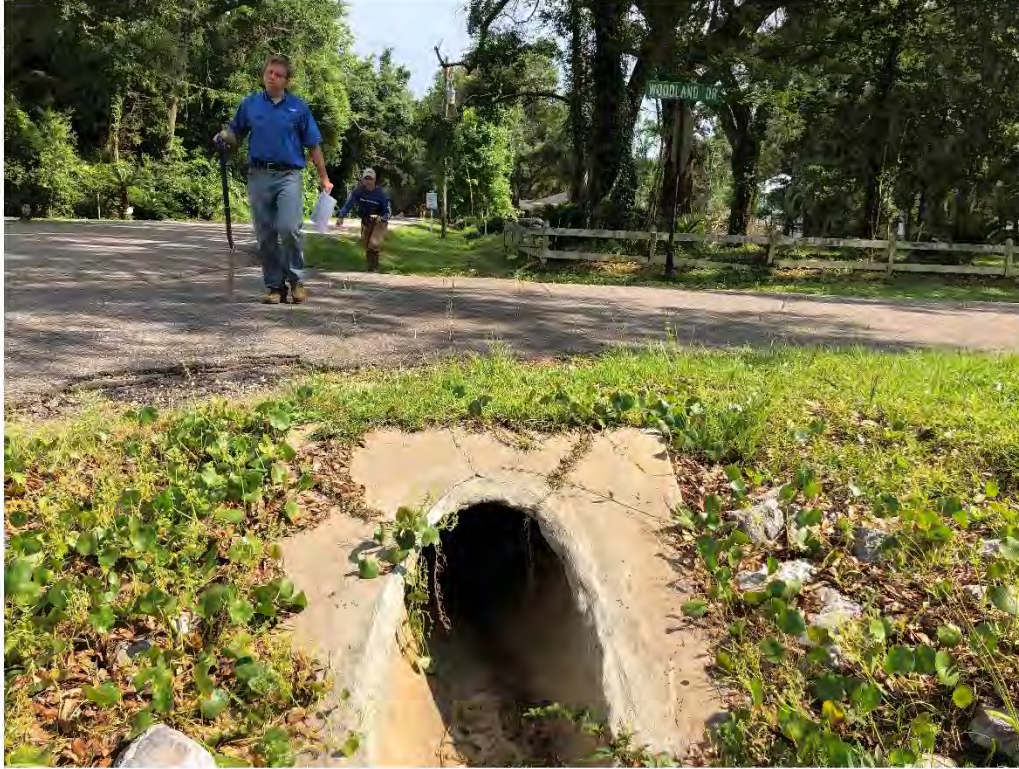
Figure 9248:
Photo taken facing South toward P-CH-18 at the intersection of Pecan Grove St and Woodland Ave.

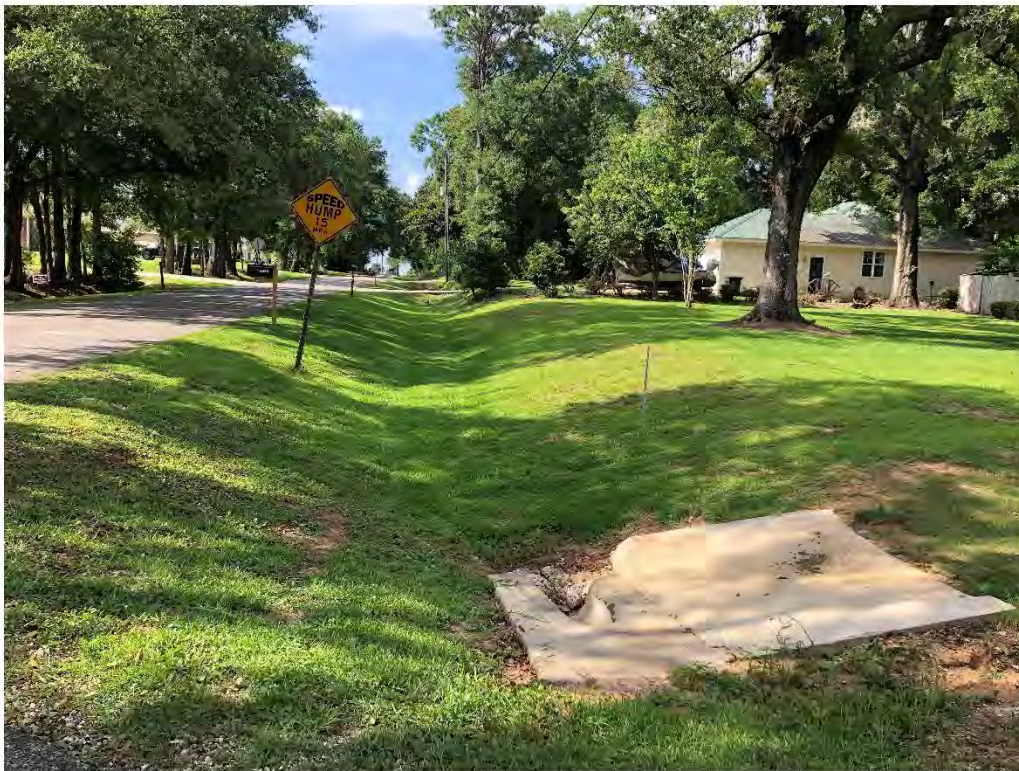
Figure 9258:
Photo taken facing North toward P-CH-14 along Pecan Grove St.

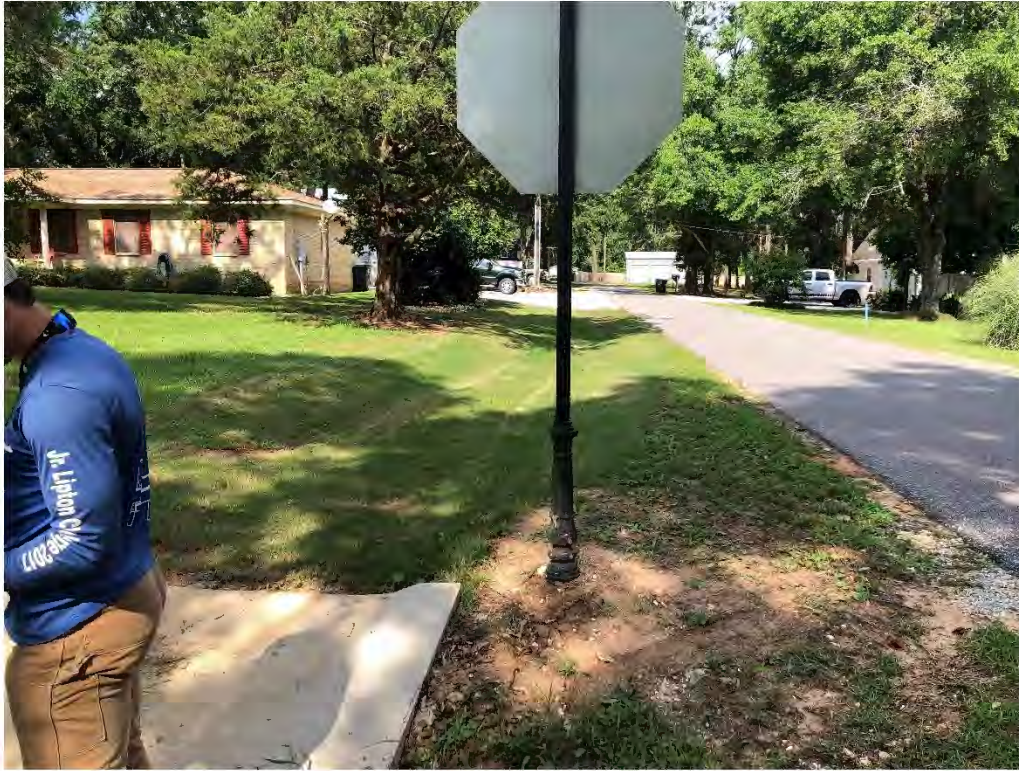
Figure 9259:
Photo taken facing North toward P-CH-16 along Pecan Grove St.
