Town of Magnolia Springs Comprehensive Drainage Masterplan

Town of Magnolia Springs
Magnolia Springs, Baldwin County, Alabama

VOLKERT

March 2023

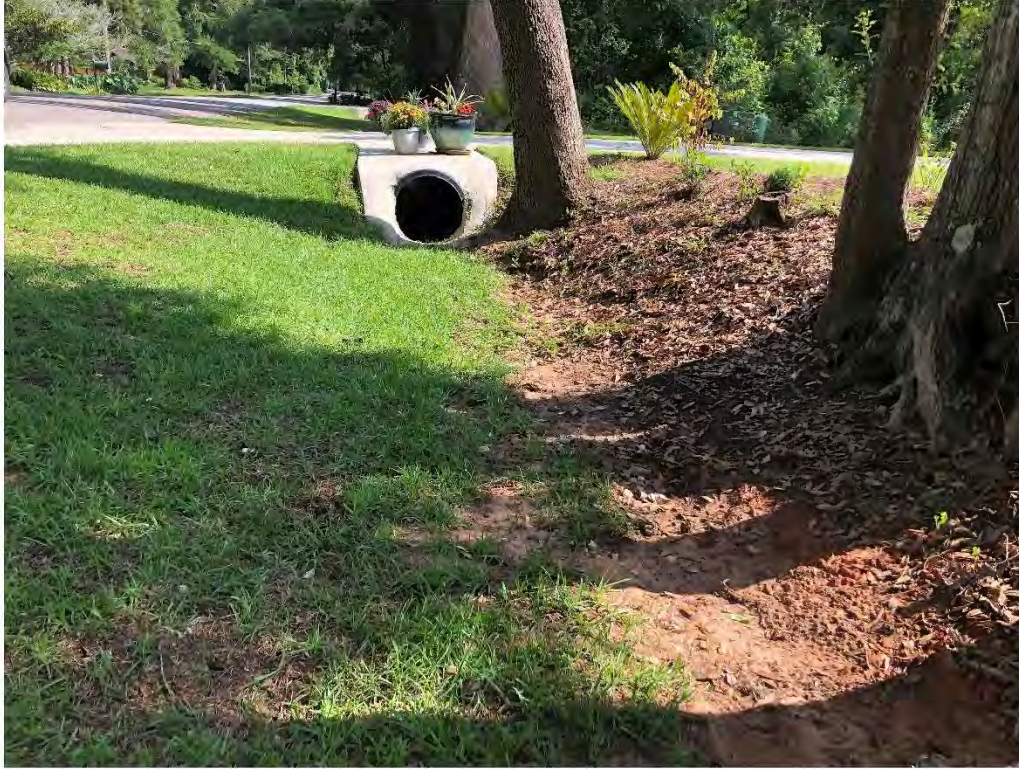
Figure 9262:
Photo taken facing South toward P-CO-13 at the intersection of Pecan Grove St and a residential driveway.

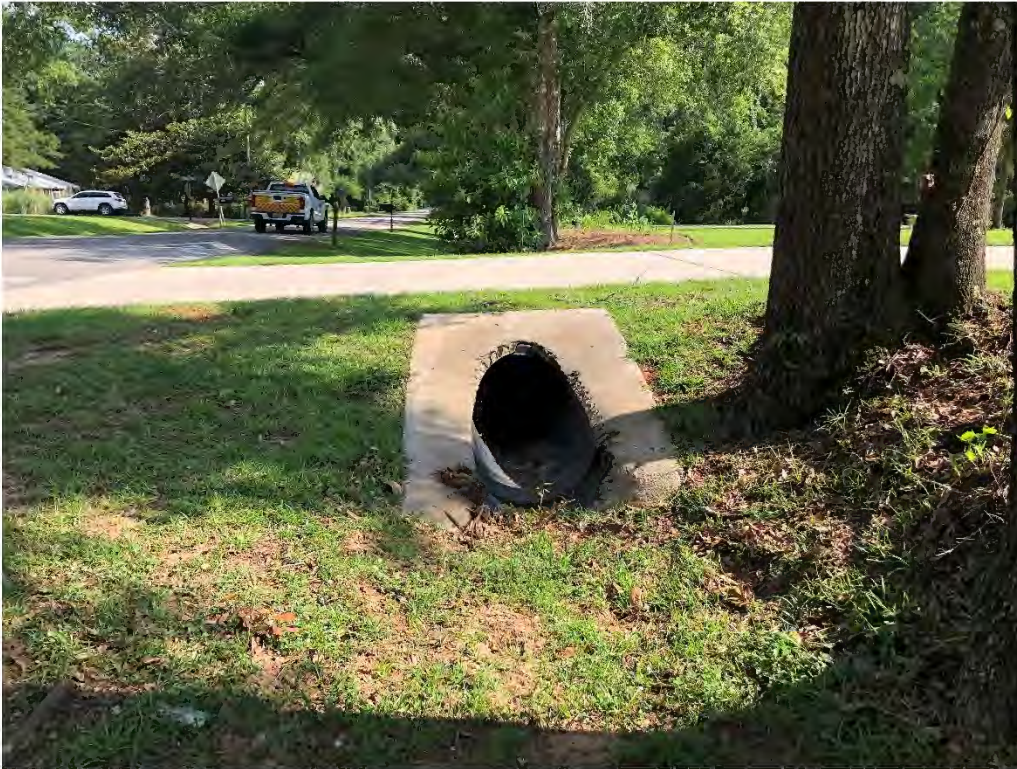
Figure 9267:
Photo taken facing South toward P-CO-11 at the intersection of Pecan Grove St and a residential driveway.

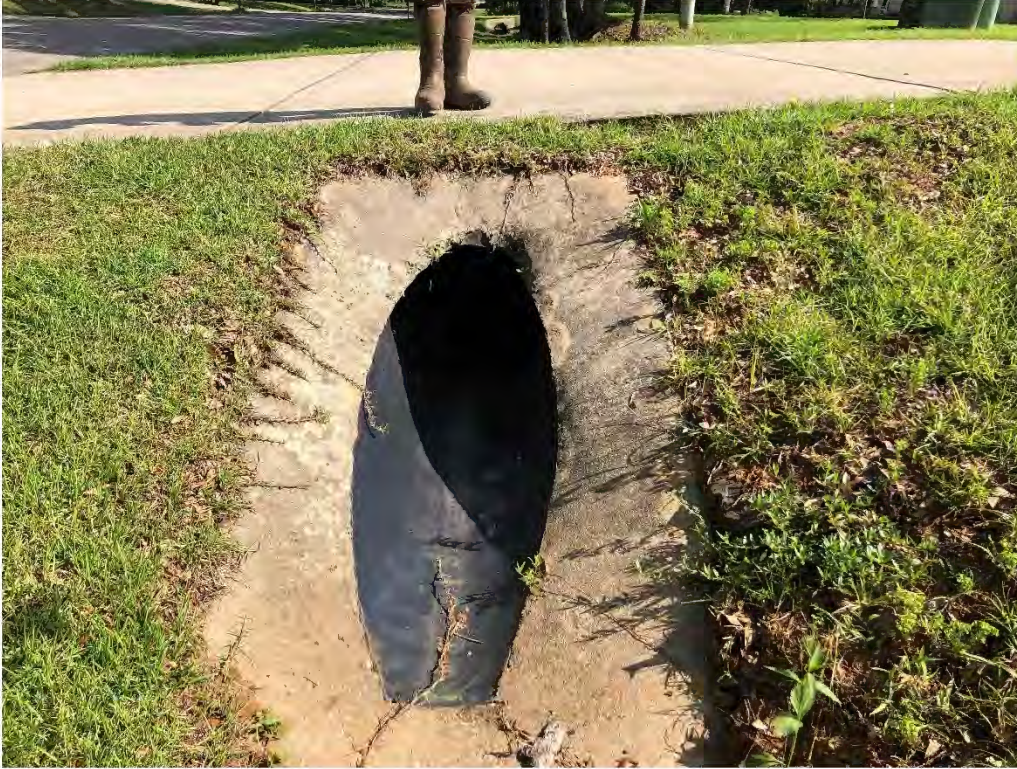
Figure 9271:
Photo taken facing North toward P-CO-13 at the intersection of Pecan Grove St and a residential driveway.

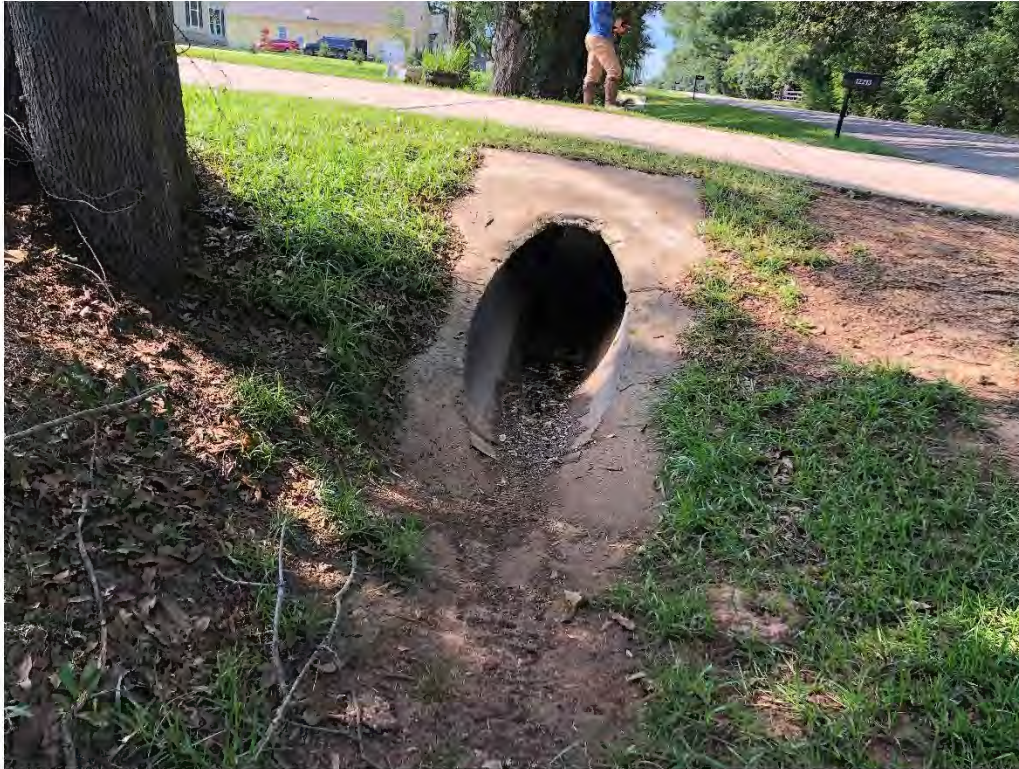
Figure 9277:
Photo taken facing North toward P-CO-5 at the intersection of Pecan Grove St and a residential driveway.

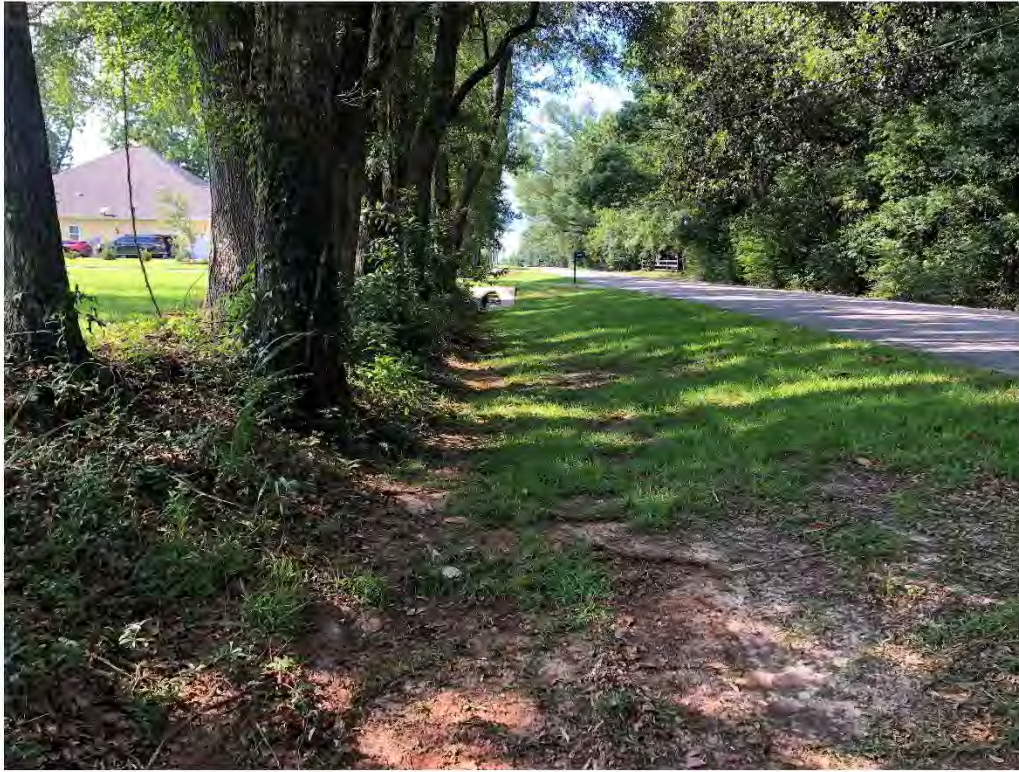
Figure 9279:
Photo taken facing North toward P-CH-6 along Pecan Grove St.

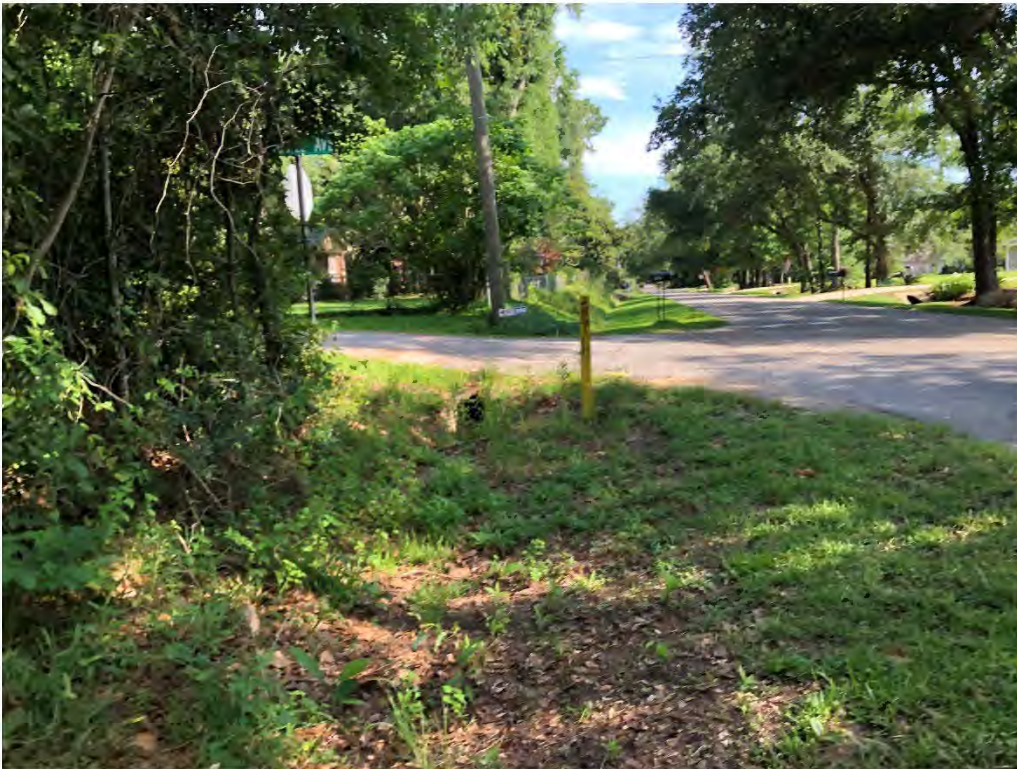
Figure 9281:
Photo taken facing South toward P-CH-5 along Pecan Grove St.

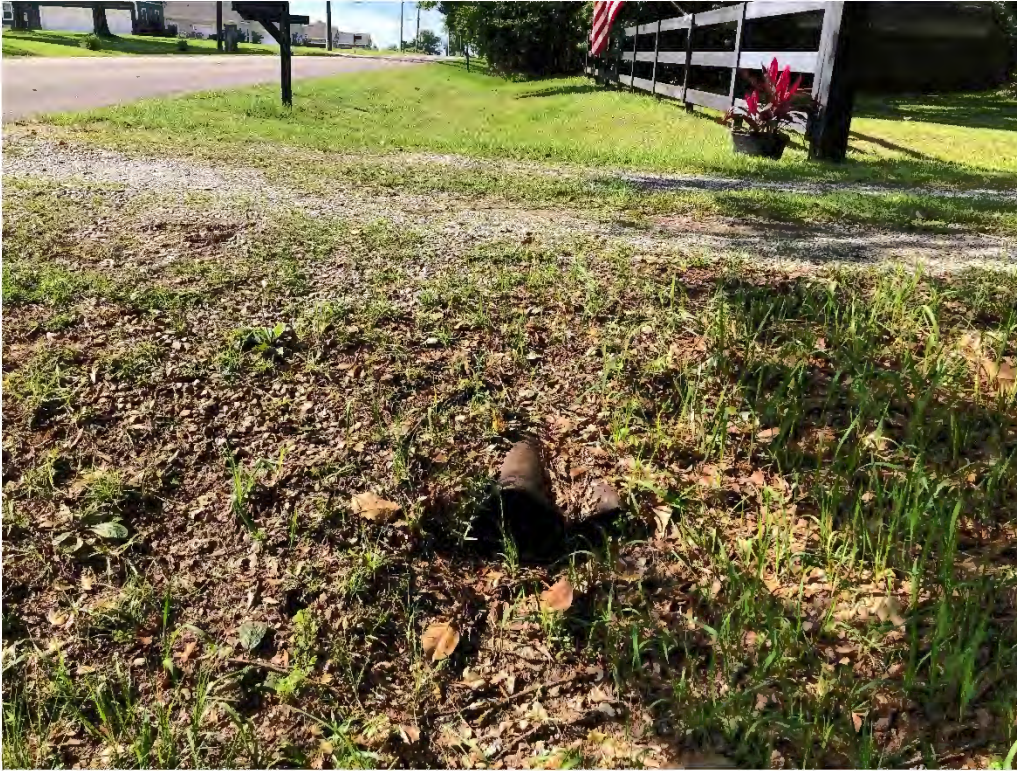
Figure 9288:
Photo taken facing North toward P-CO-3 at the intersection of Pecan Grove St and a residential driveway.

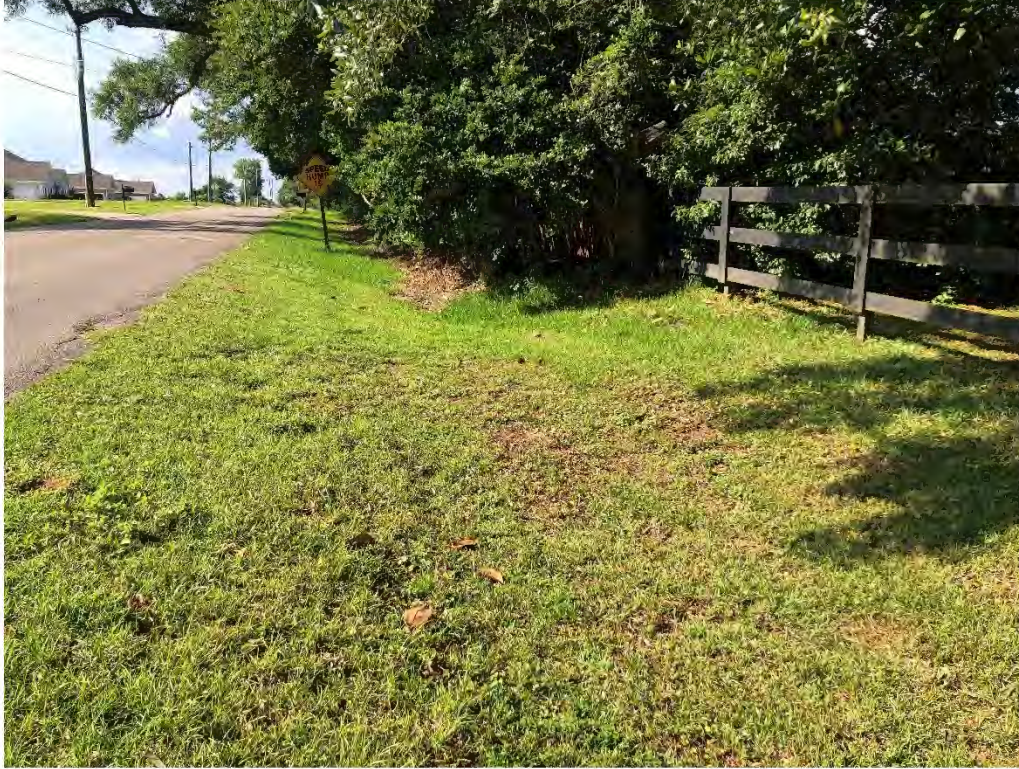
Figure 9291:
Photo taken facing North toward P-CH-4 along Pecan Grove St.

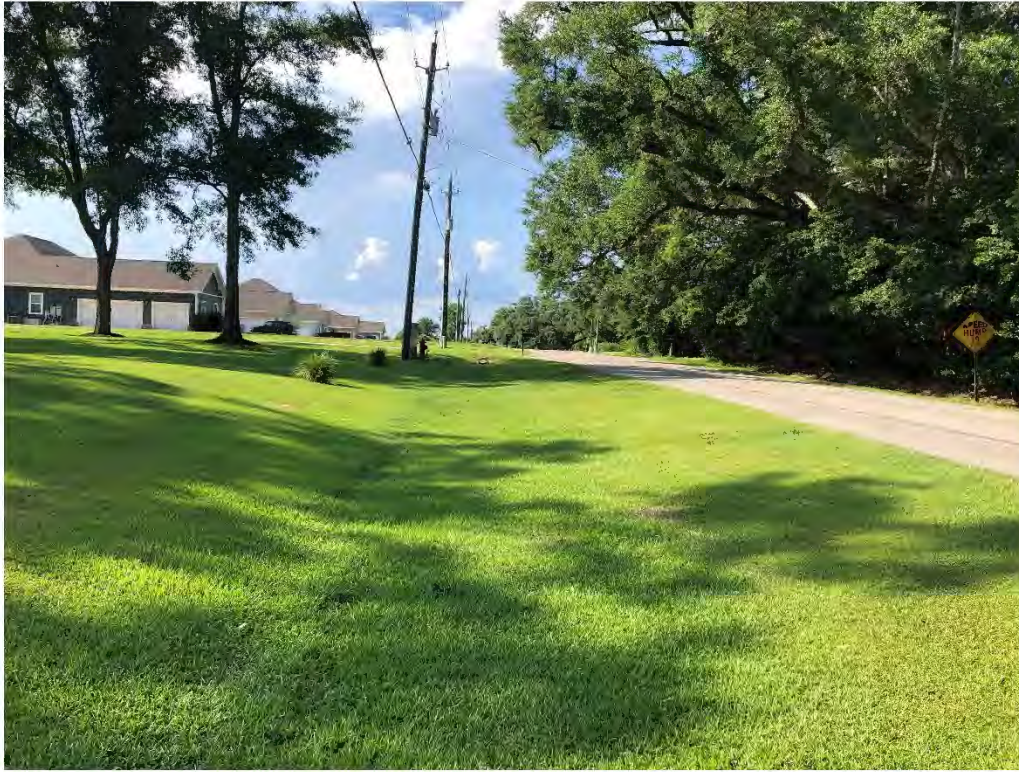
Figure 9293:
Photo taken facing North toward P-CH-3 along Pecan Grove St.

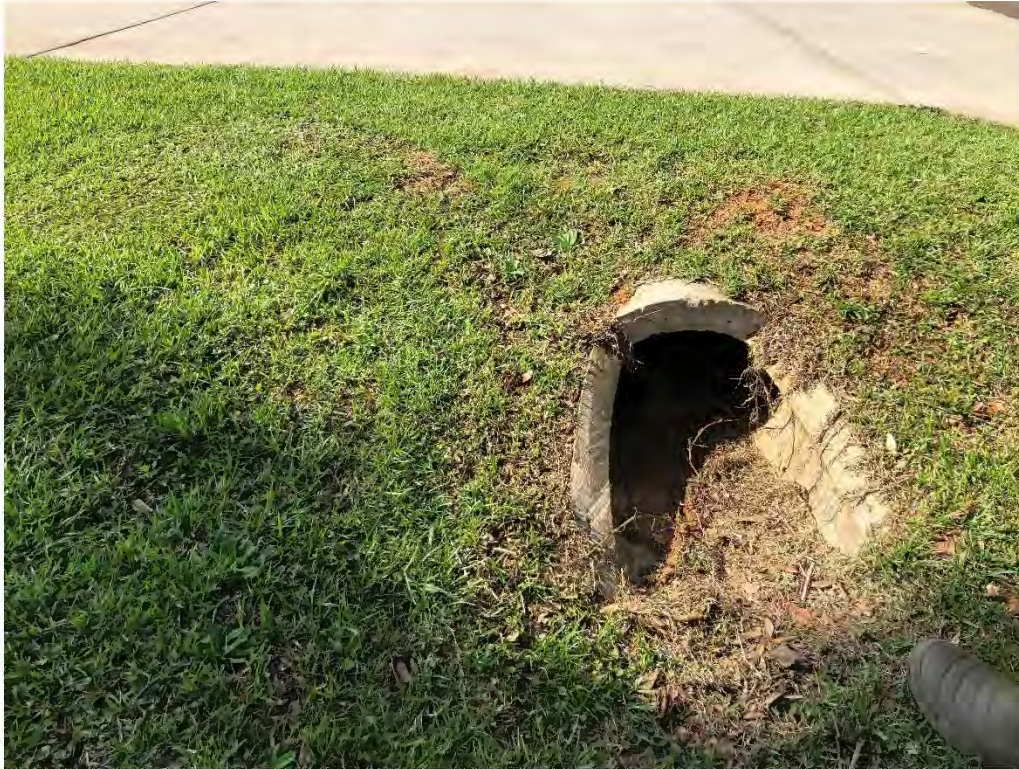
Figure 9294:
Photo taken facing North toward P-CO-2 at the intersection of Pecan Grove St and a residential driveway.

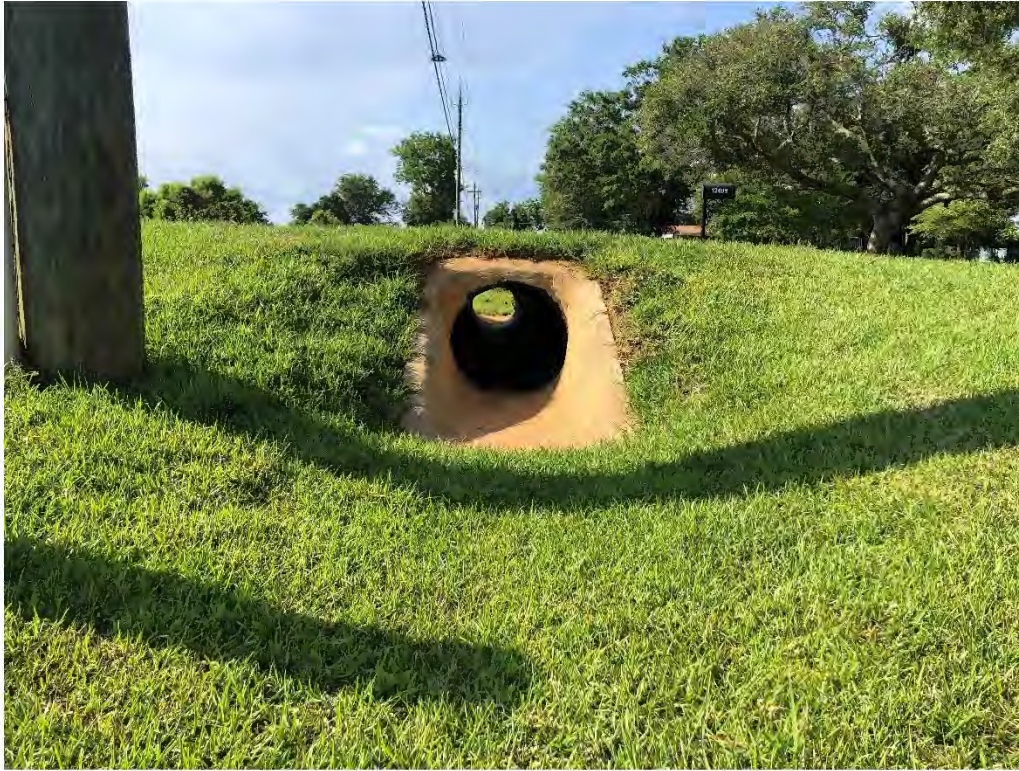
Figure 9309:
Photo taken facing North toward OAK-CO-17 at the intersection of Pecan Grove St and a residential driveway.

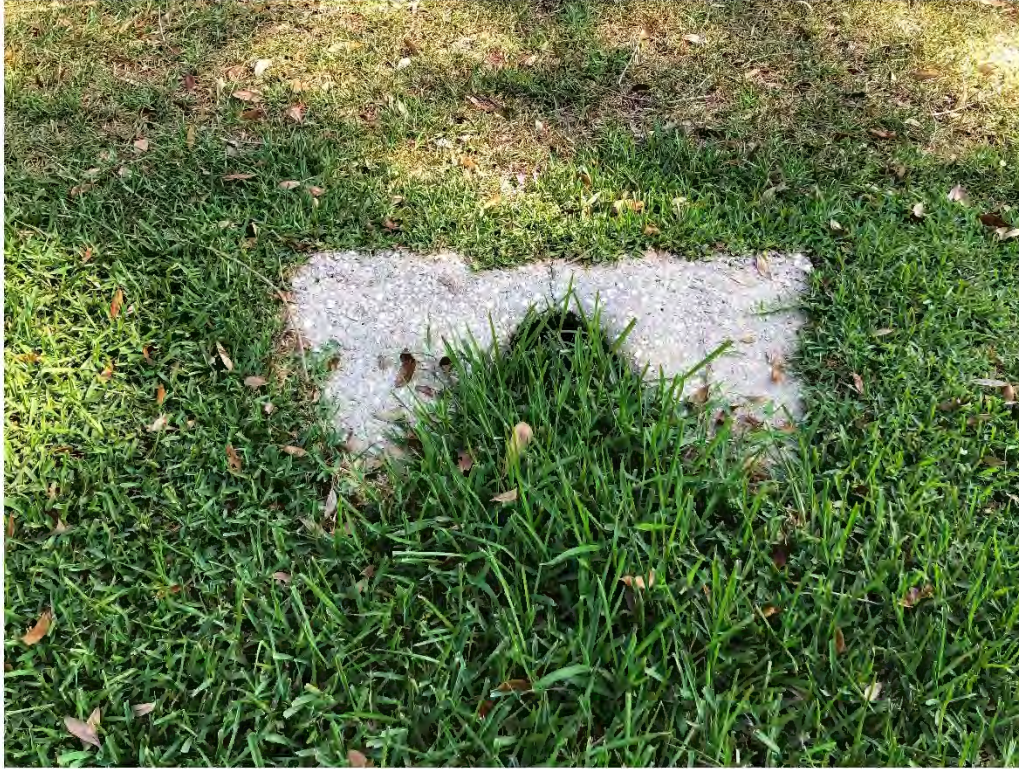
Figure 9489:
Photo taken facing North toward VG-CO-2 at the intersection of Village Green Drive and a residential driveway.

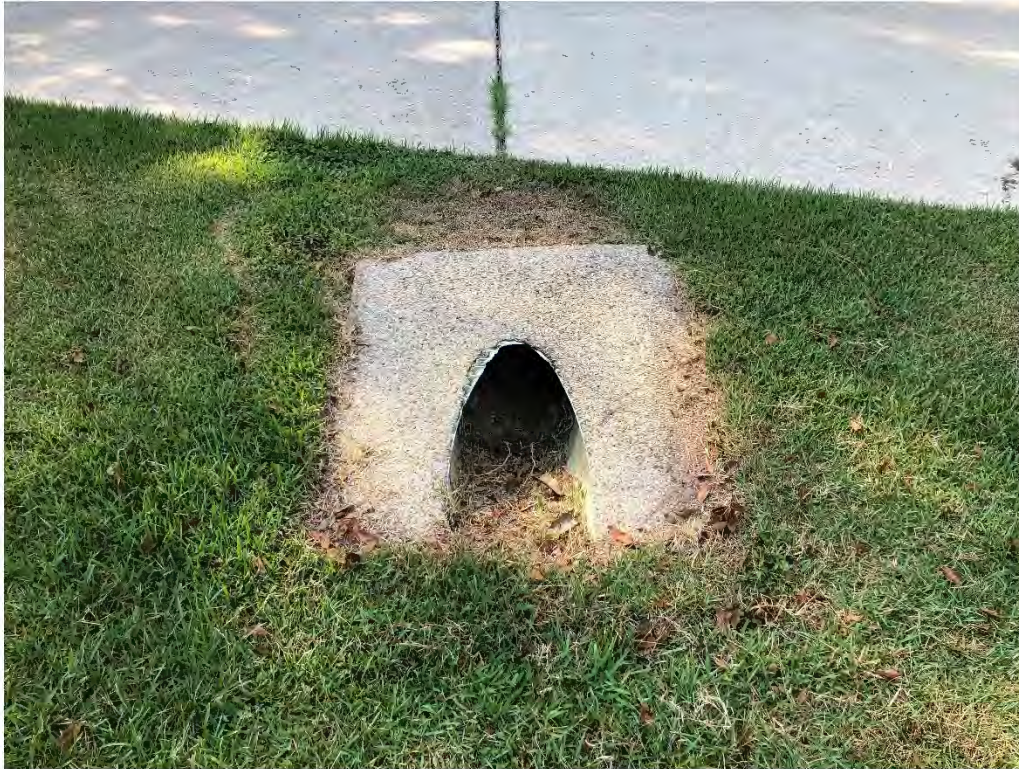
Figure 9492:
Photo taken facing SE toward VG-CO-3 at the intersection of Village Green Drive and a residential driveway.

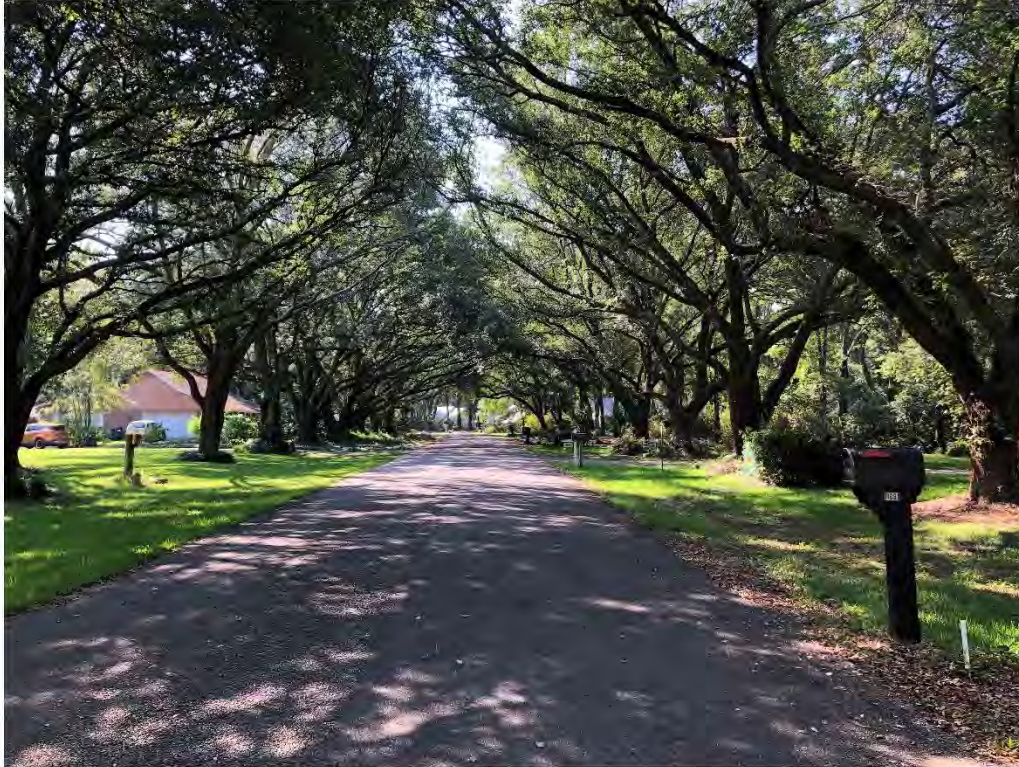
Figure 9501:
Photo taken facing East along Village Green Drive.

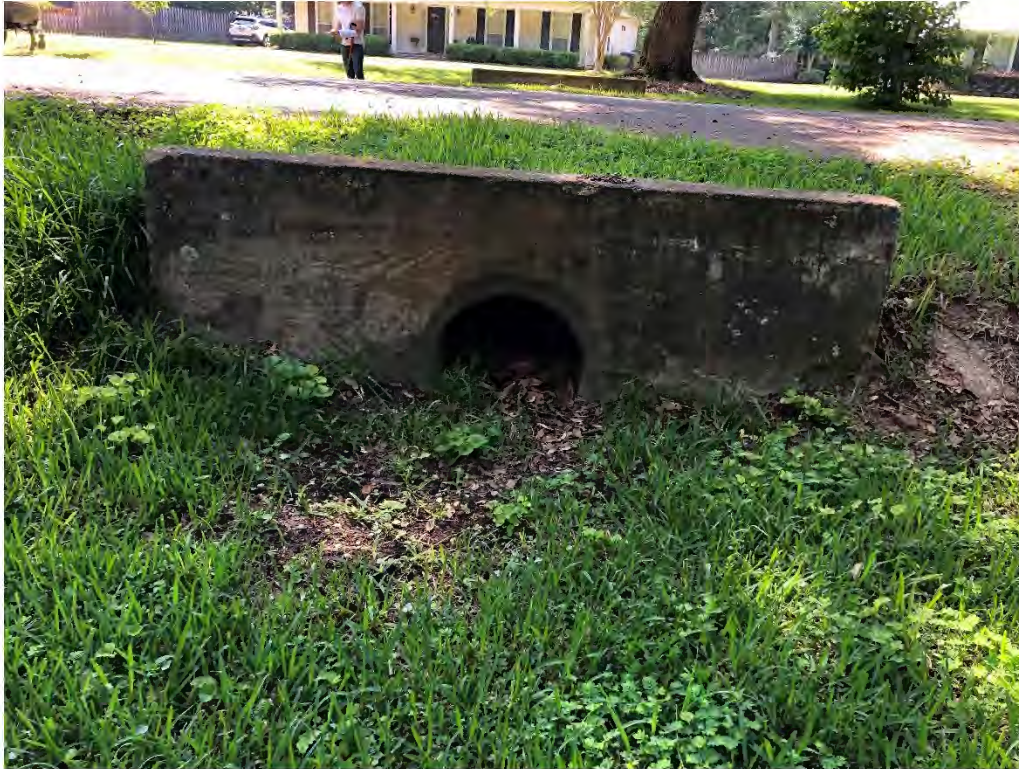
Figure 9508:
Photo taken facing East toward VG-CO-7 that crosses Village Green Drive.

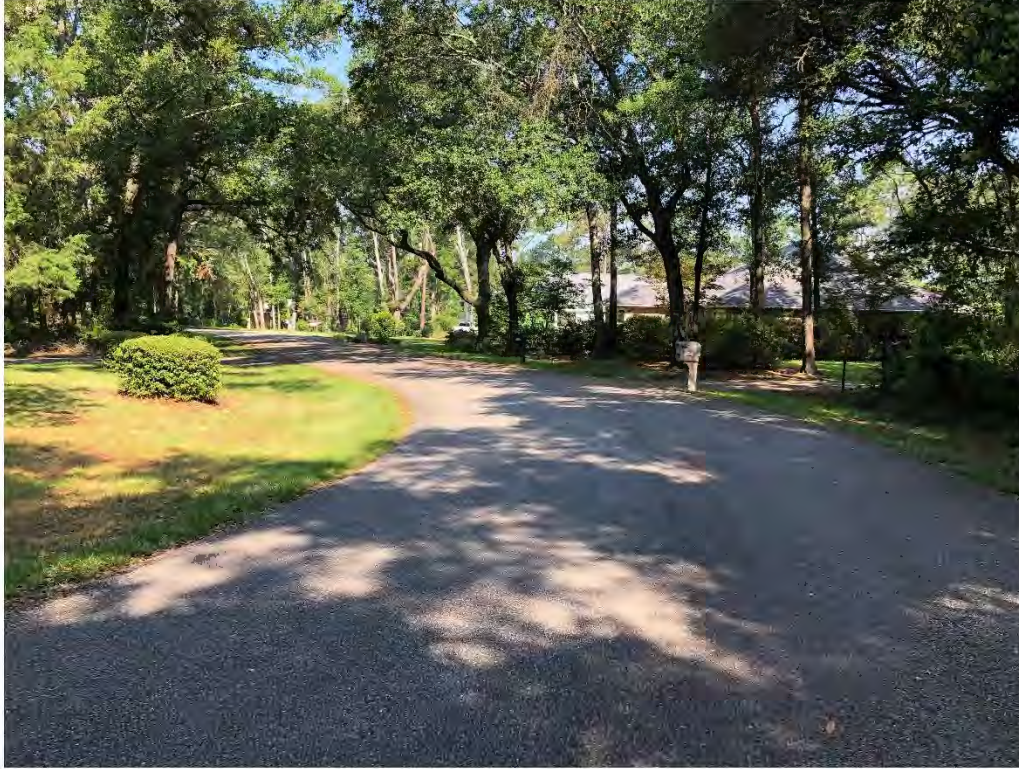
Figure 9515:
Photo taken facing NW of a ditch along Village Green Drive.

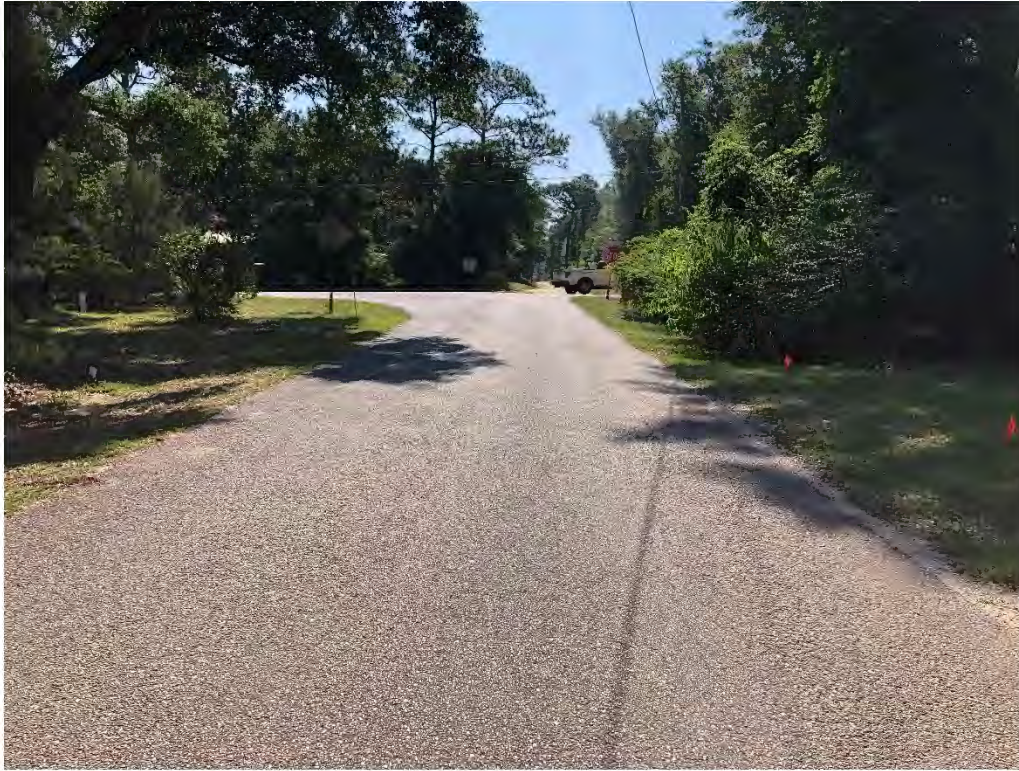
Figure 9519:
Photo taken facing East toward a ditch at the intersection of HWY 49 and Cotton Stocking Lane.

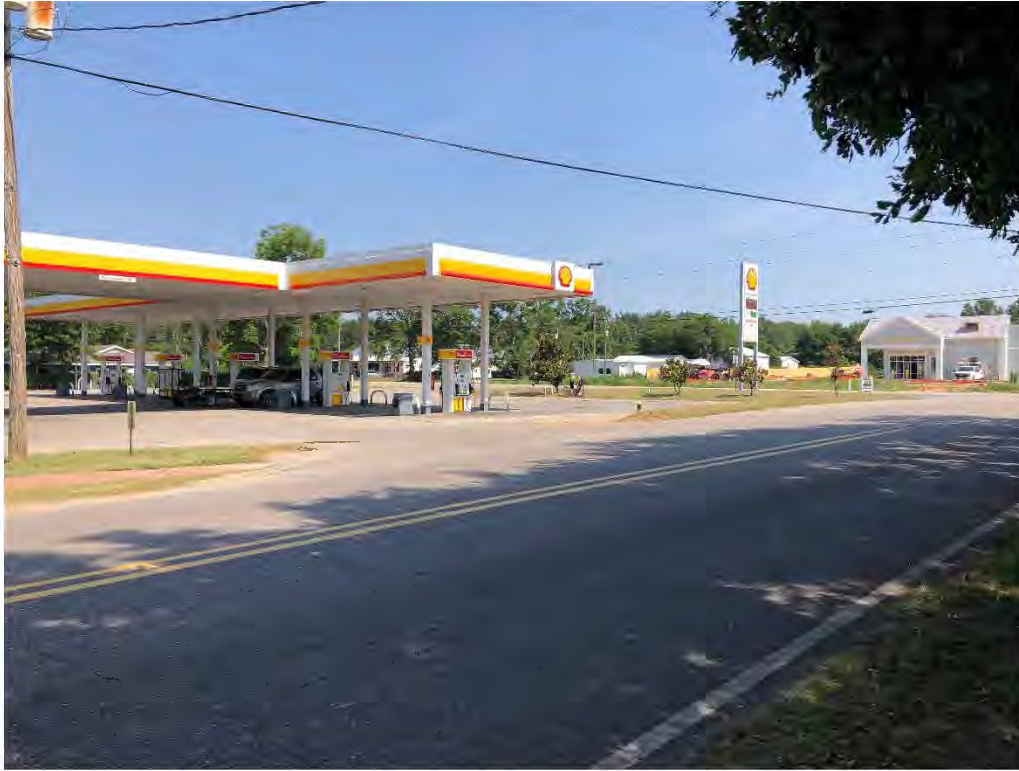
Figure 9529:

Photo taken facing North toward MN-CH-1 at the intersection of Magnolia Springs HWY and driveway.

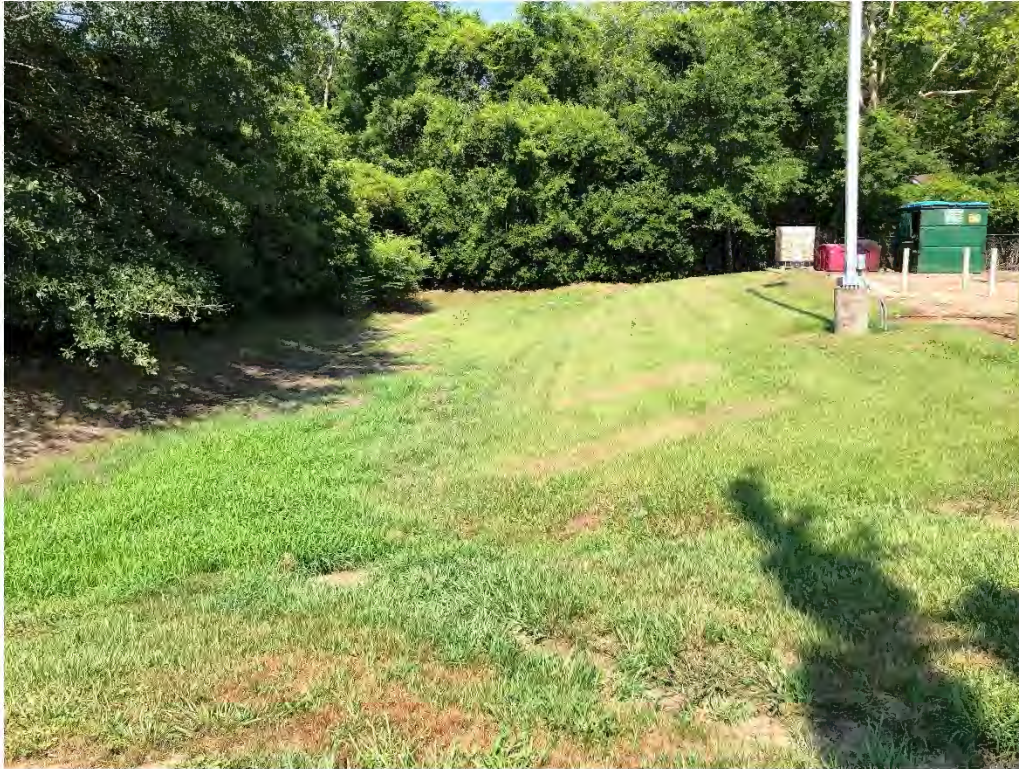
Figure 9531:
Photo taken facing South toward MN-CH-2 along Magnolia Springs HWY.

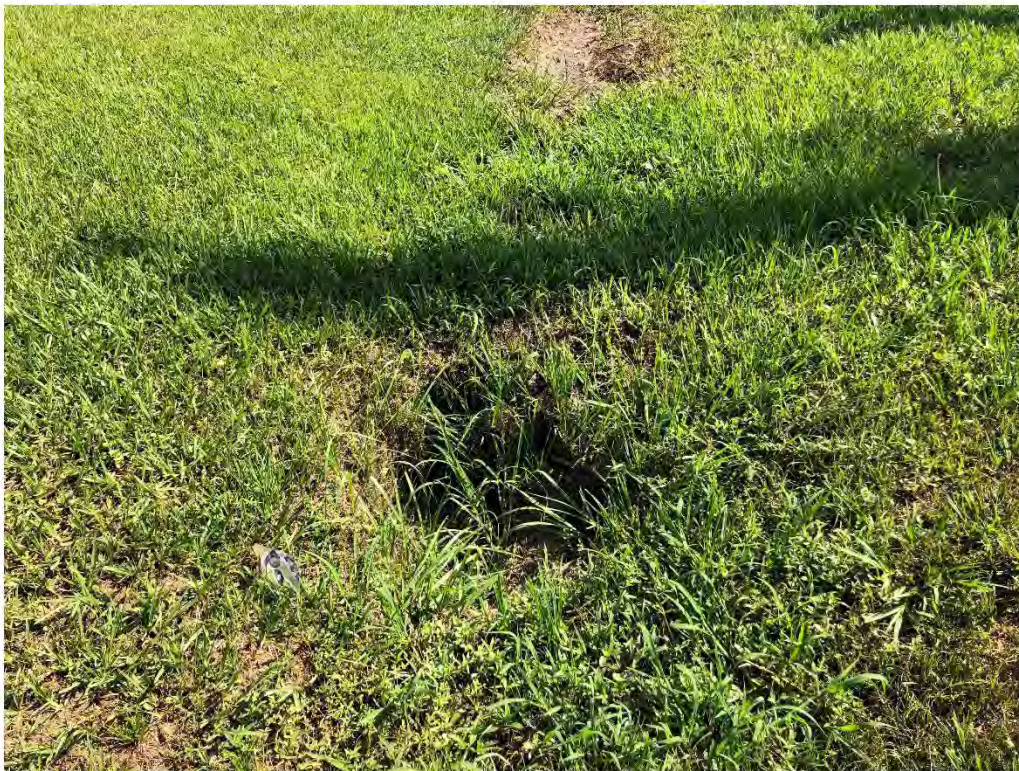
Figure 9532:
Photo taken facing West toward a ditch along Magnolia Springs HWY.

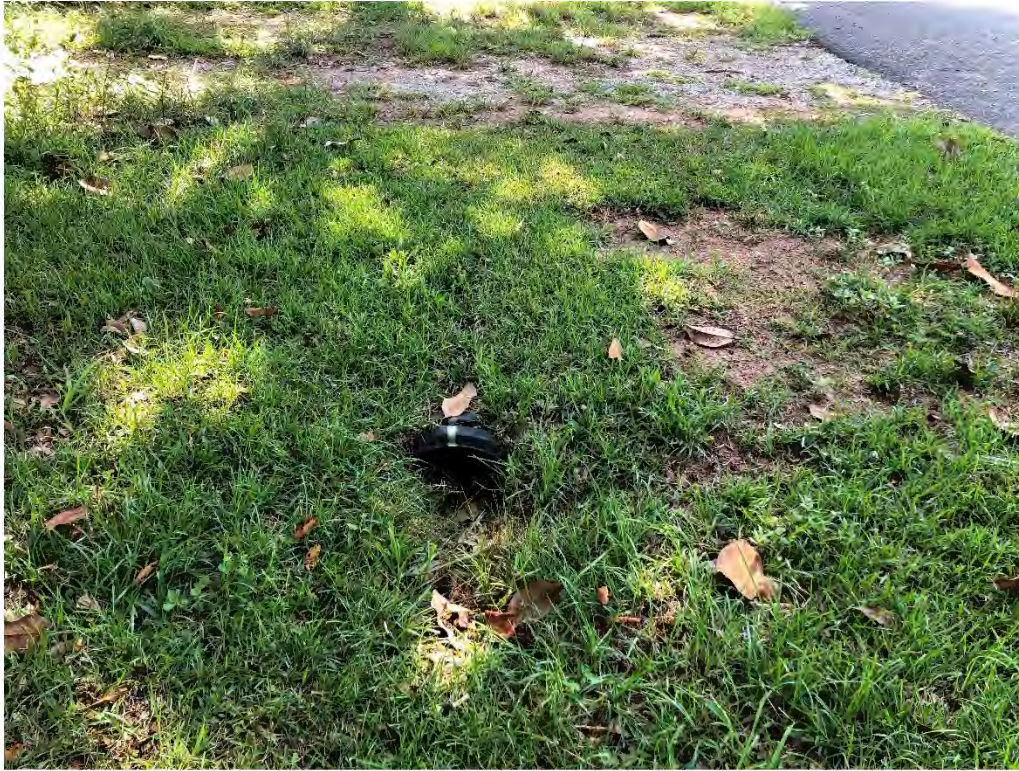
Figure 9533:
Photo taken facing West toward a ditch along Magnolia Springs HWY.

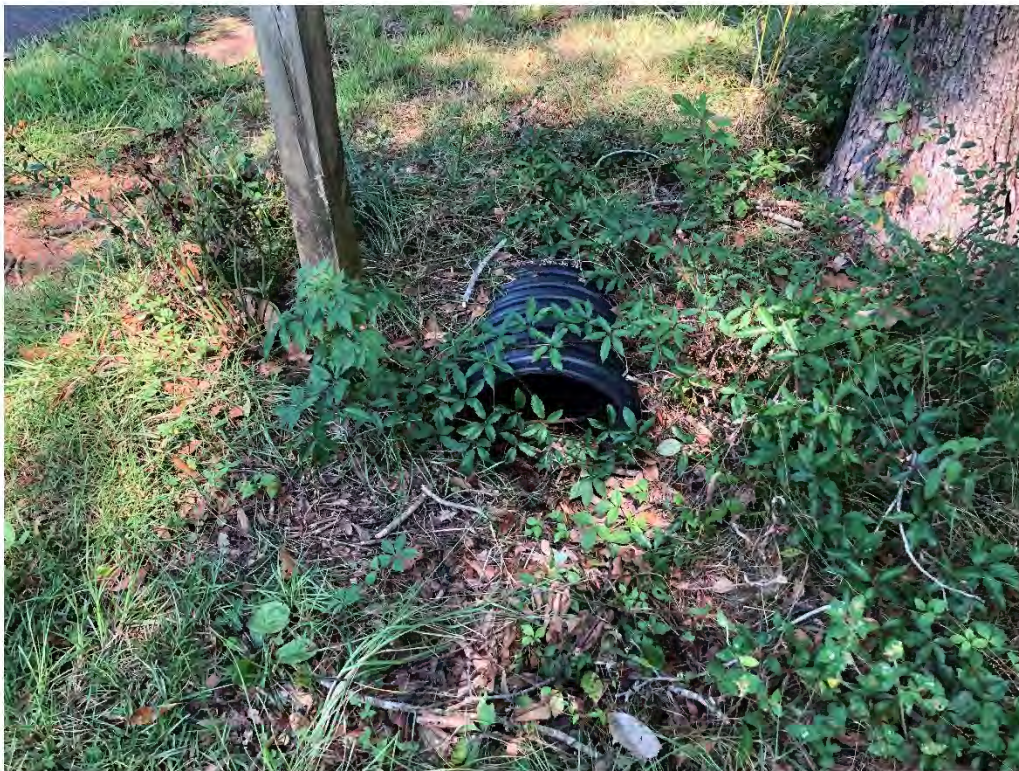
Figure 9534:
Photo taken facing East toward OAK-CO-29 at the intersection of Camelia Ave and a driveway.

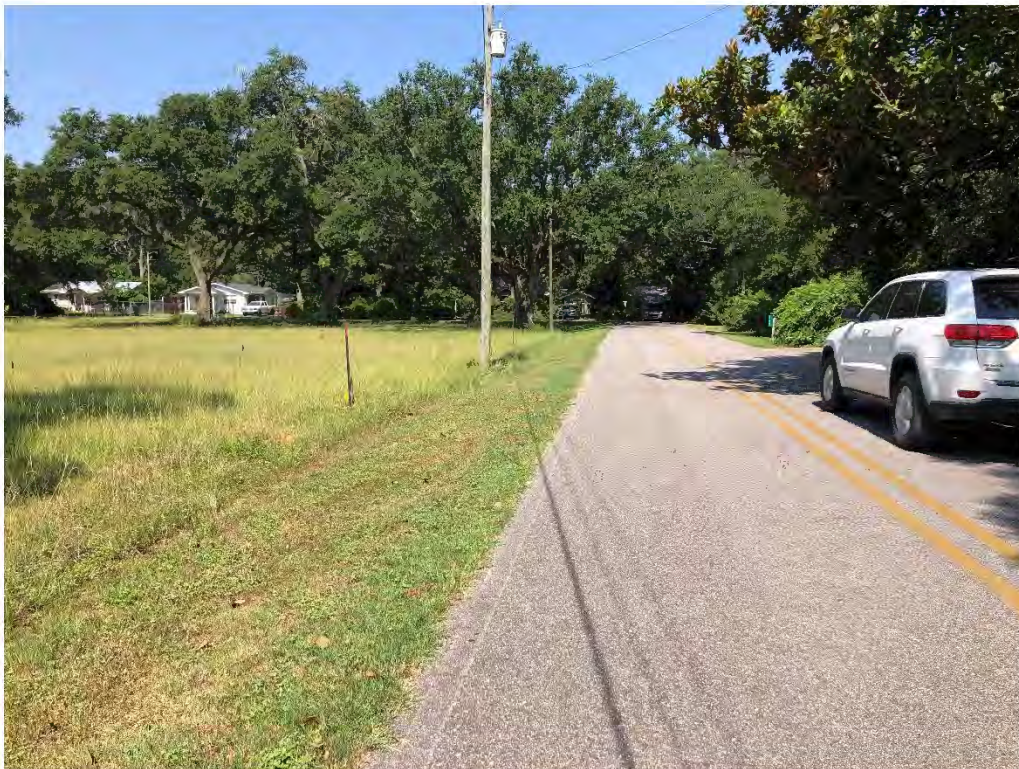
Figure 9536:
Photo taken facing East toward OAK-CH-6 along Camelia Ave.

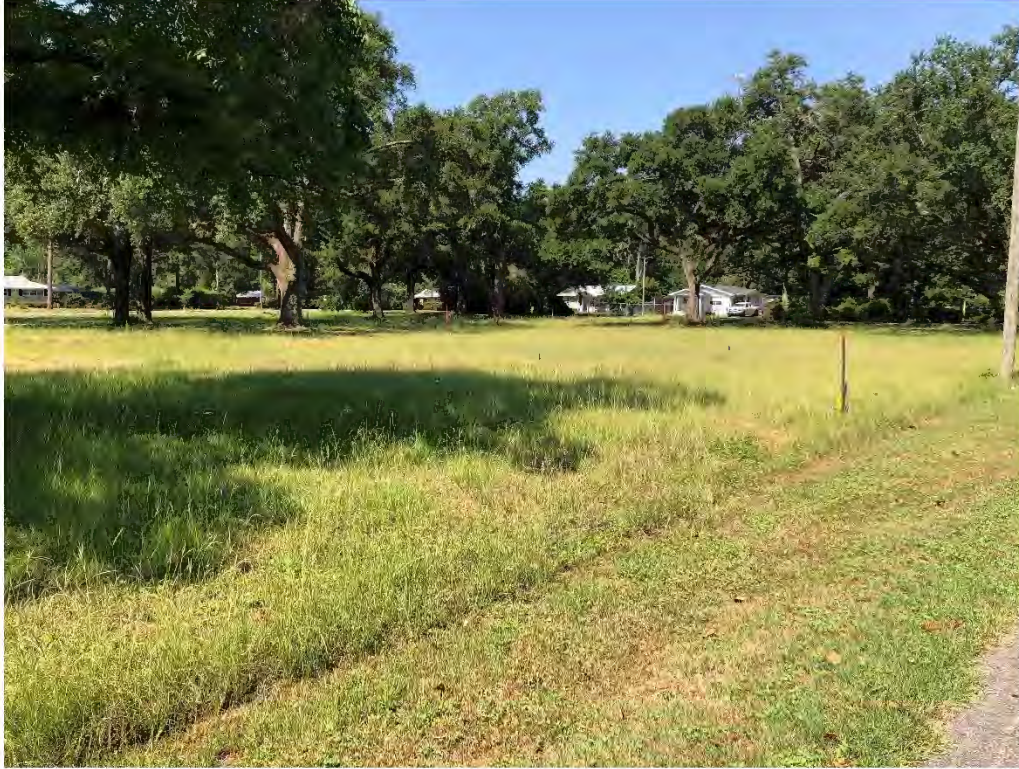
Figure 9537:
Photo taken facing West toward the ditch along the southern side of Camelia Ave.

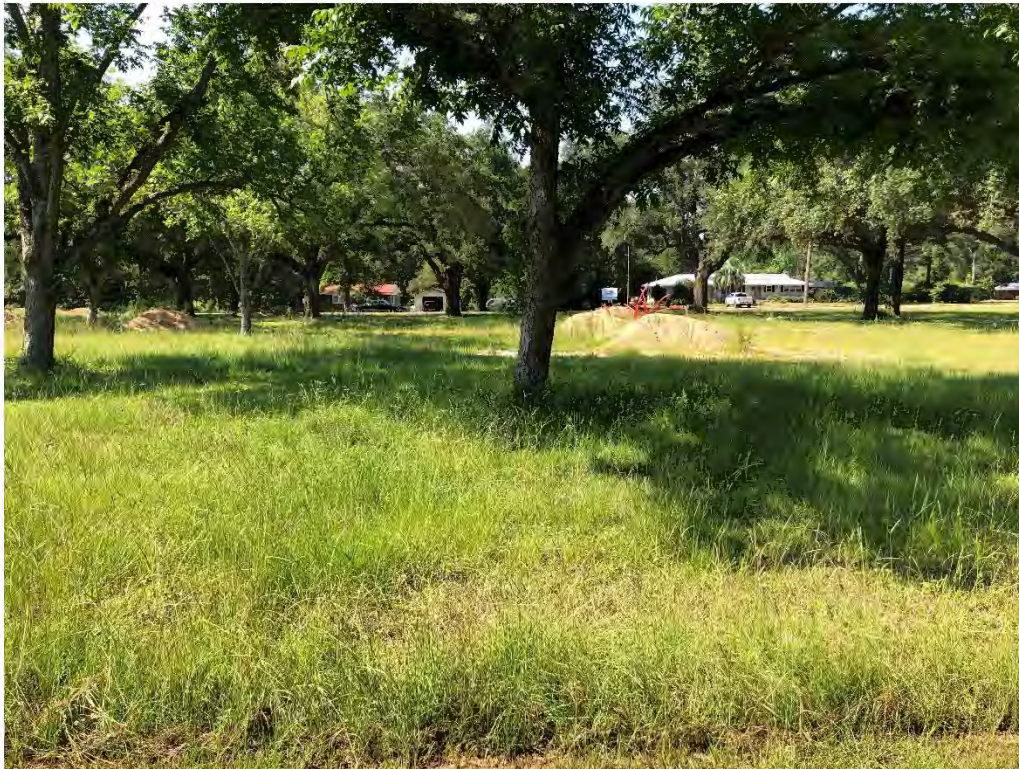
Figure 9538:
Photo taken facing South toward the ditch along the southern side of Camelia Ave.

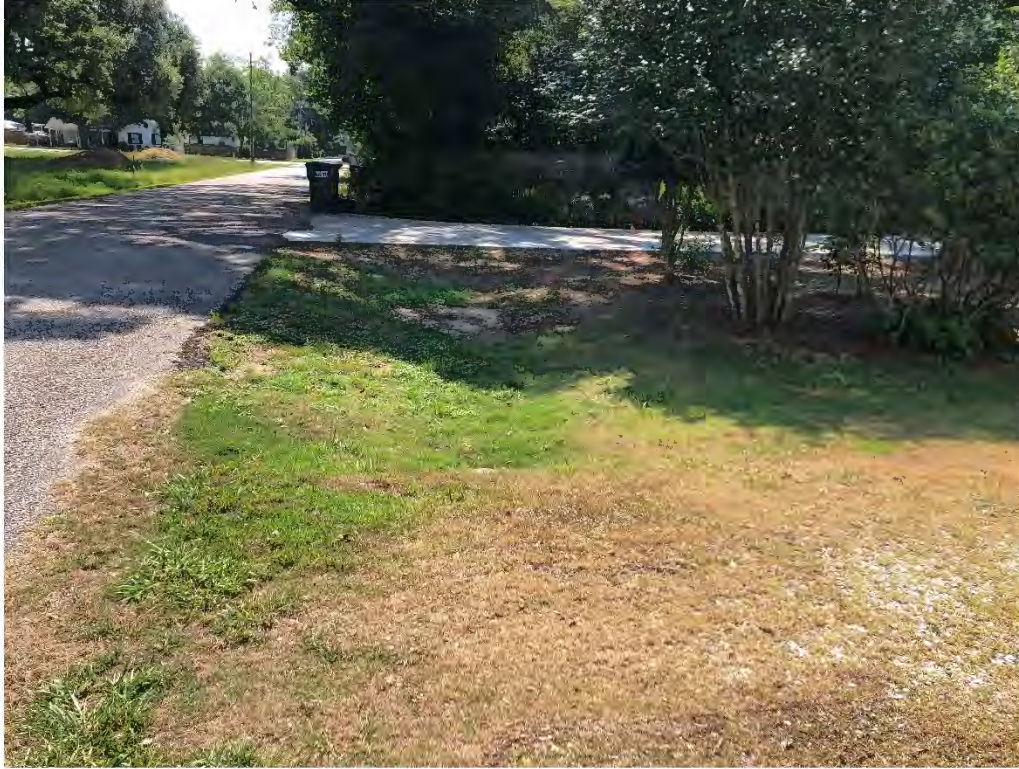
Figure 9543:
Photo taken facing West toward a ditch at the intersection of Camelia Ave and a driveway.

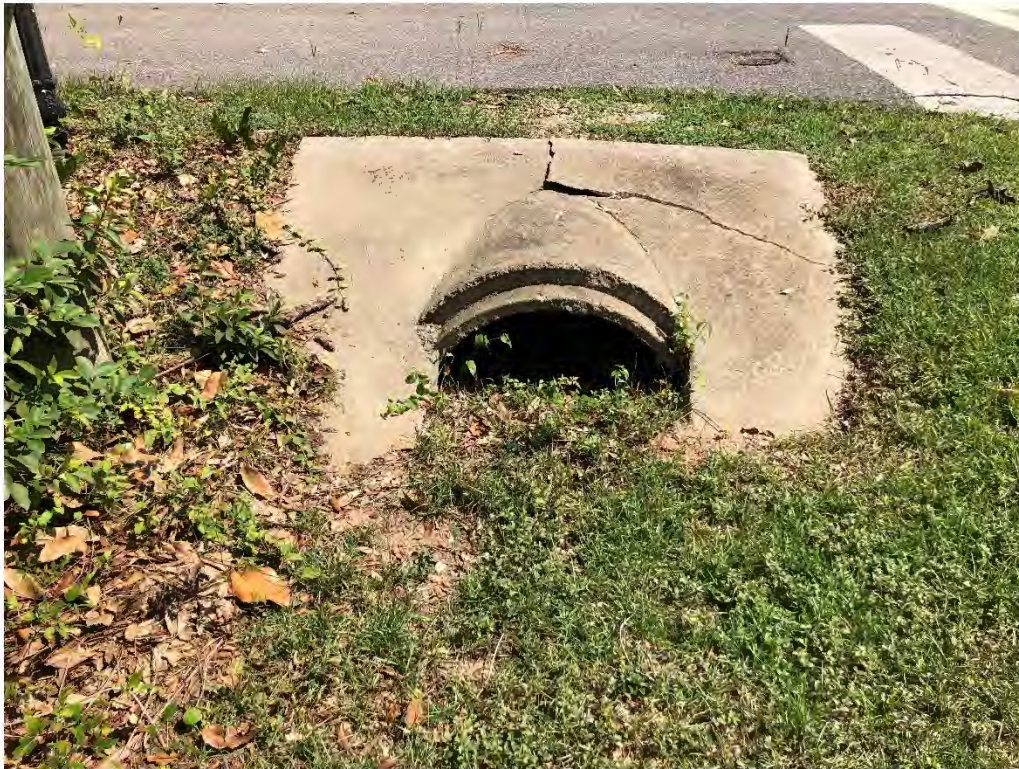
Figure 9546:
Photo taken facing SE toward OAK-CO-31 at the intersection of HWY 49 and School Street.

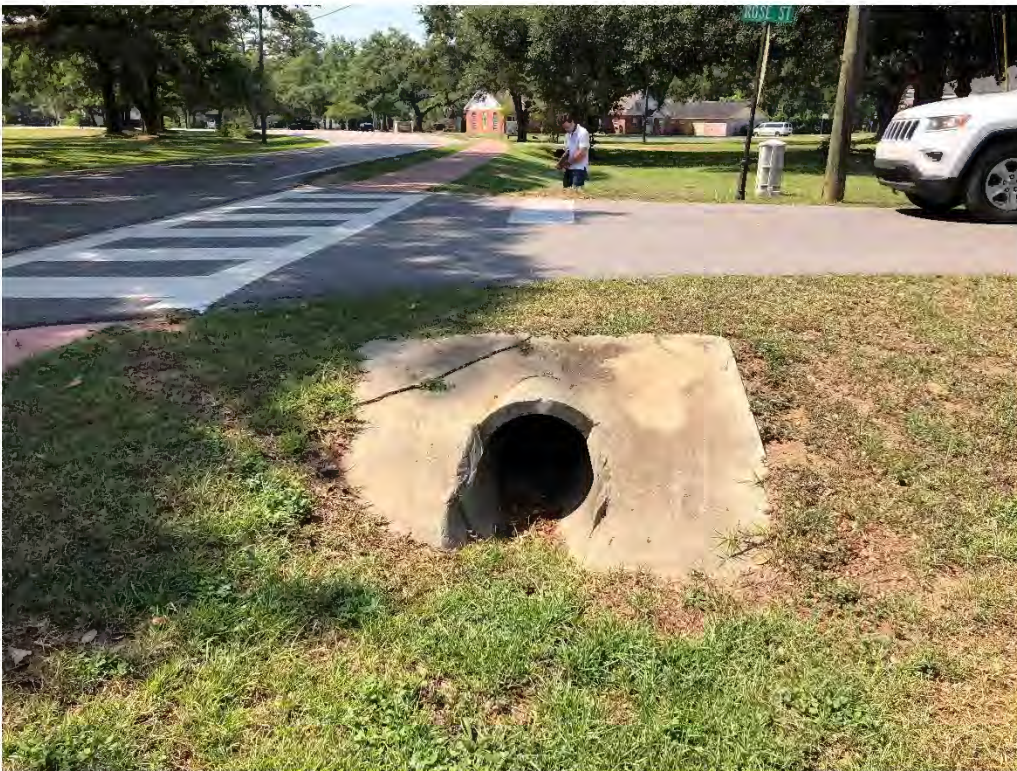
Figure 9548:
Photo taken facing South toward OAK-CH-30 at the intersection of HWY 49 and School Street.
