Town of Magnolia Springs Comprehensive Drainage Masterplan

Town of Magnolia Springs
Magnolia Springs, Baldwin County, Alabama

VOLKERT

March 2023

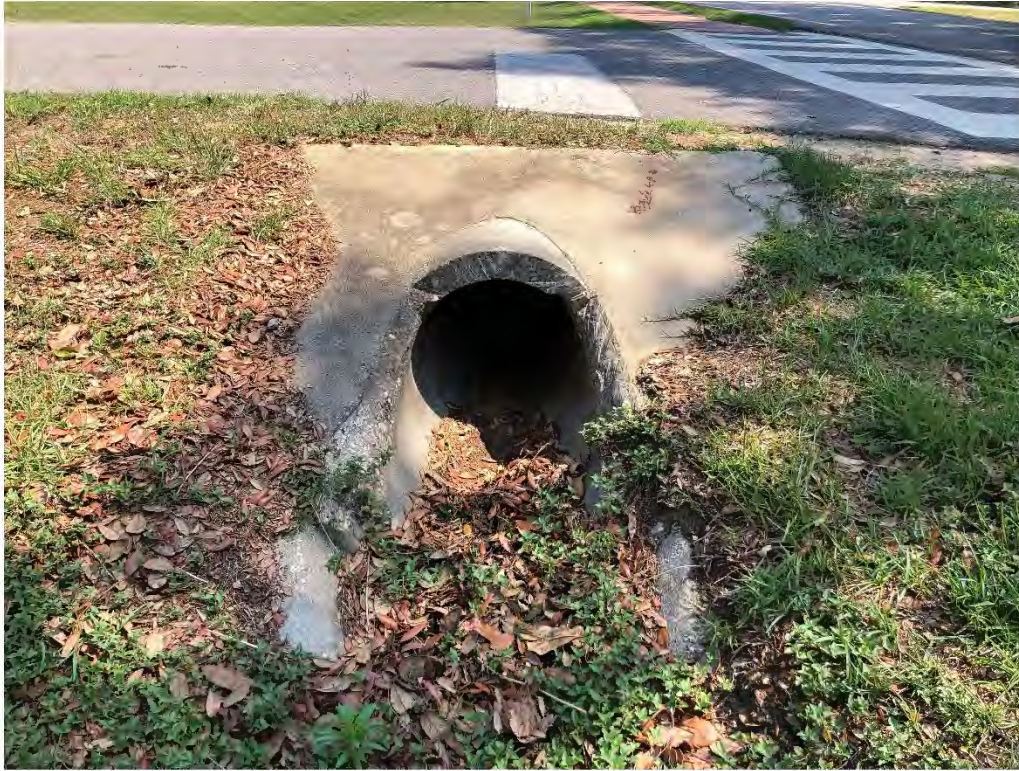
Figure 9549:
Photo taken facing South toward OAK-CO-32 at the intersection of HWY 49 and Rose Street.

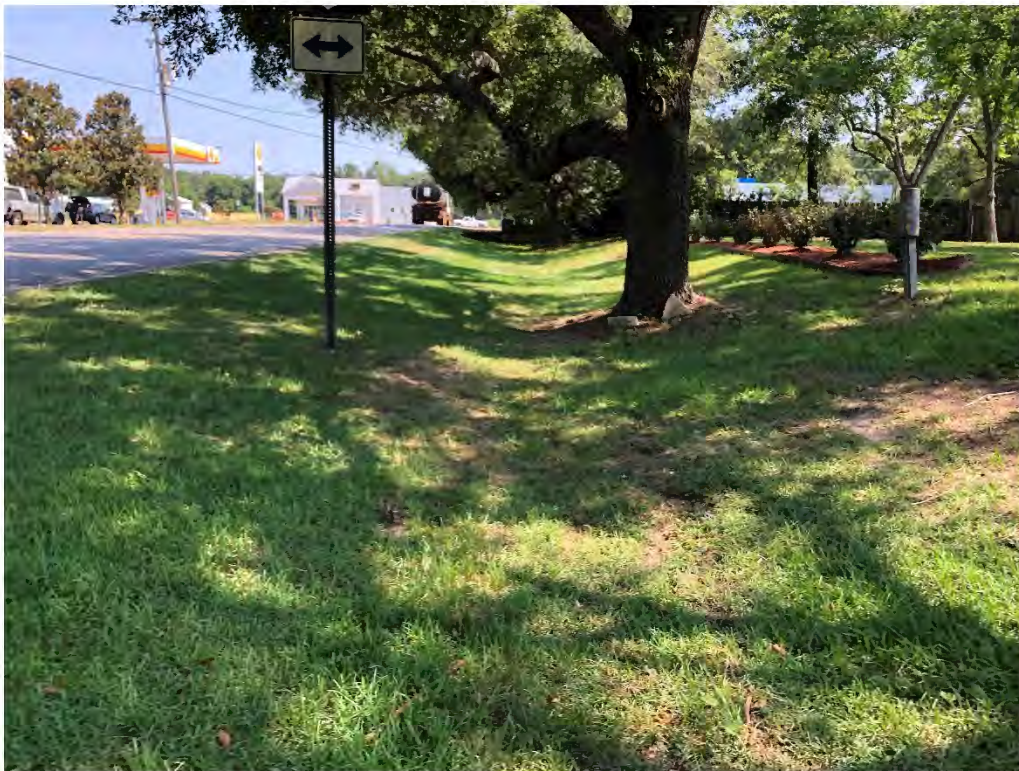
Figure 9550:
Photo taken facing North toward OAK-CO-32 at the intersection of HWY 49 and Rose Street.

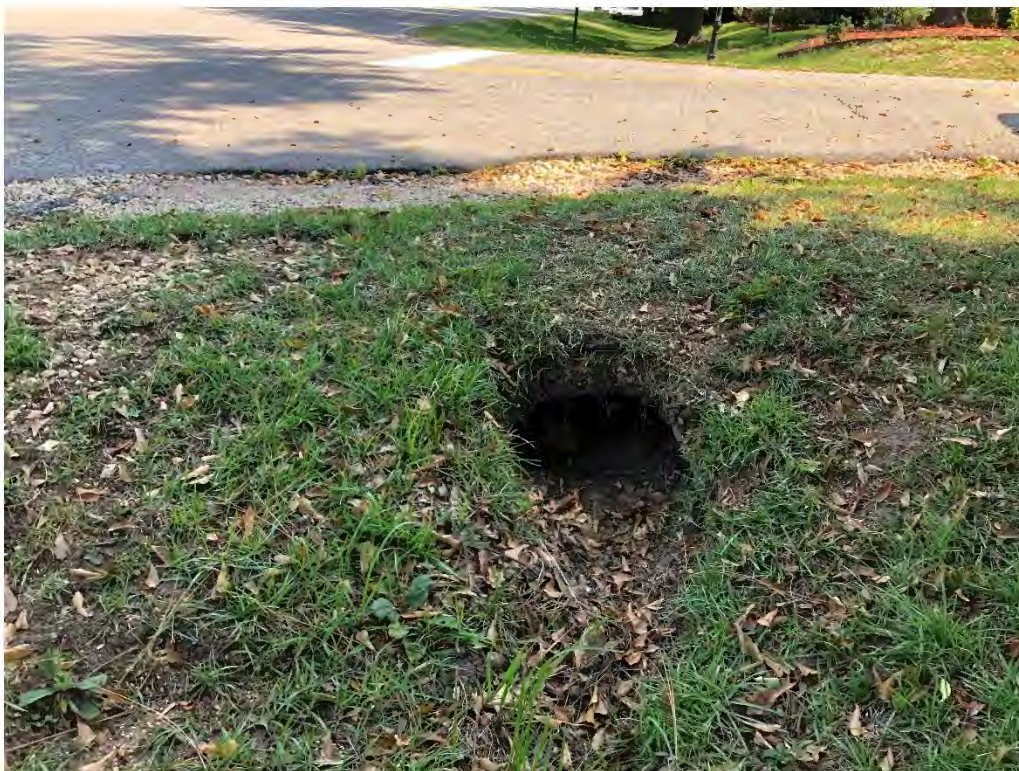
Figure 9552:
Photo taken facing South toward MN-CO-2 at the intersection of HWY 49 and Camelia Ave.

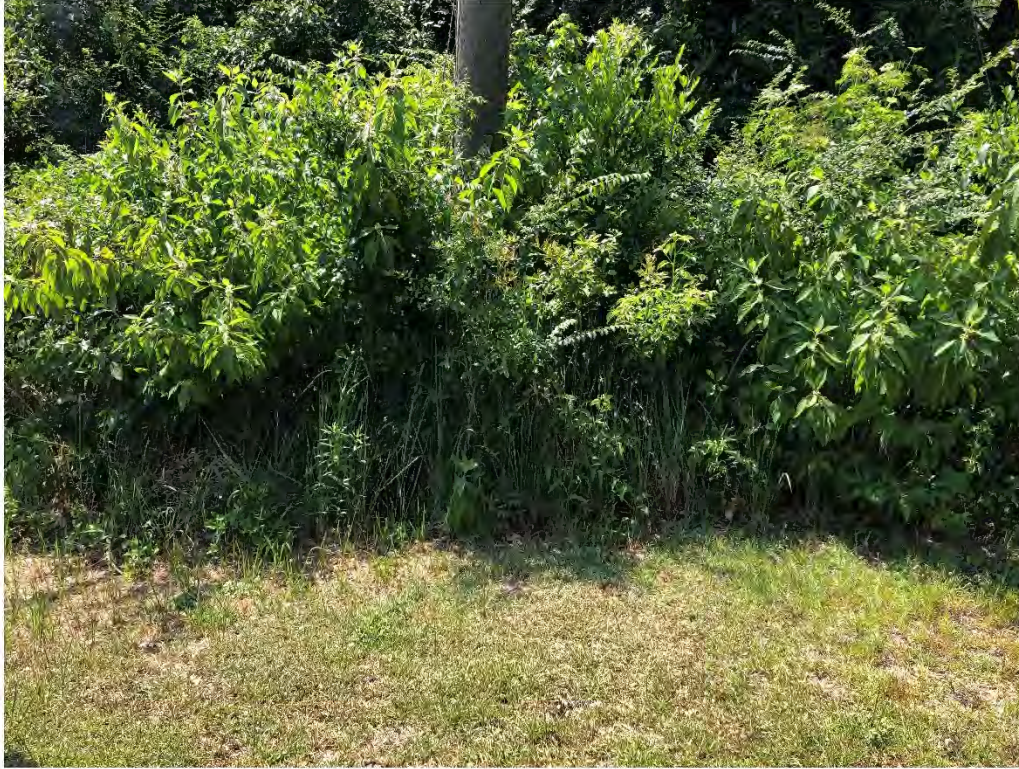
Figure 9558:
Photo taken facing North of G-CH-2 at the intersection of Old Marlow Road and Gates Ave.

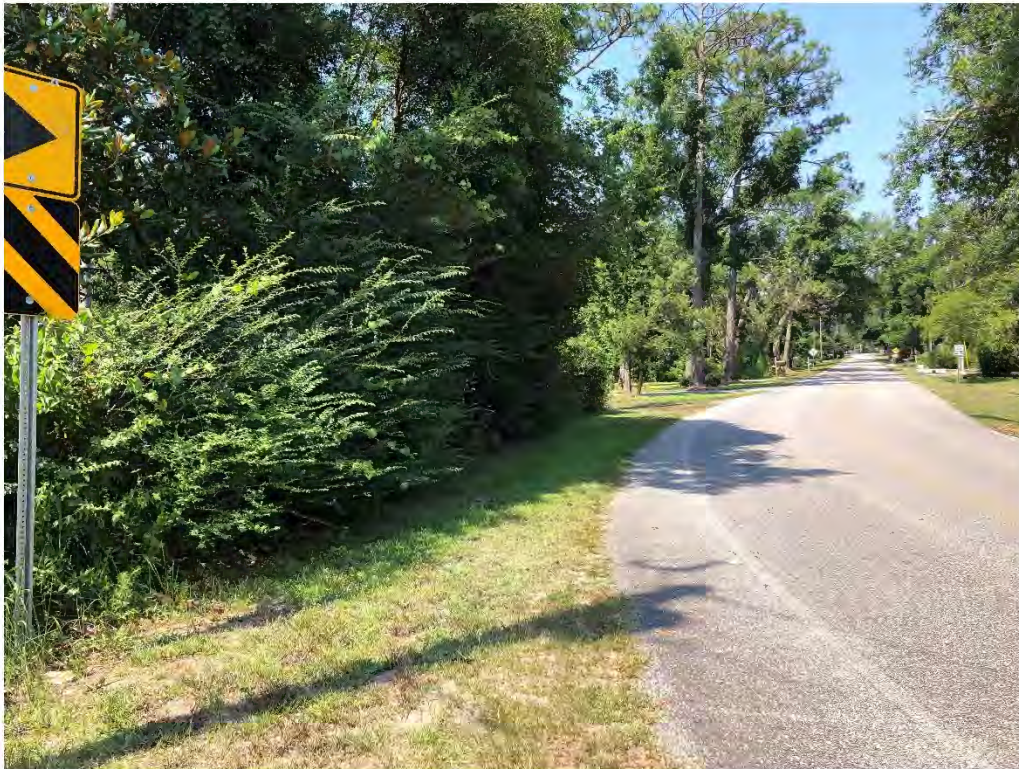
Figure 9559:
Photo taken of a ditch along Old Marlow Road.

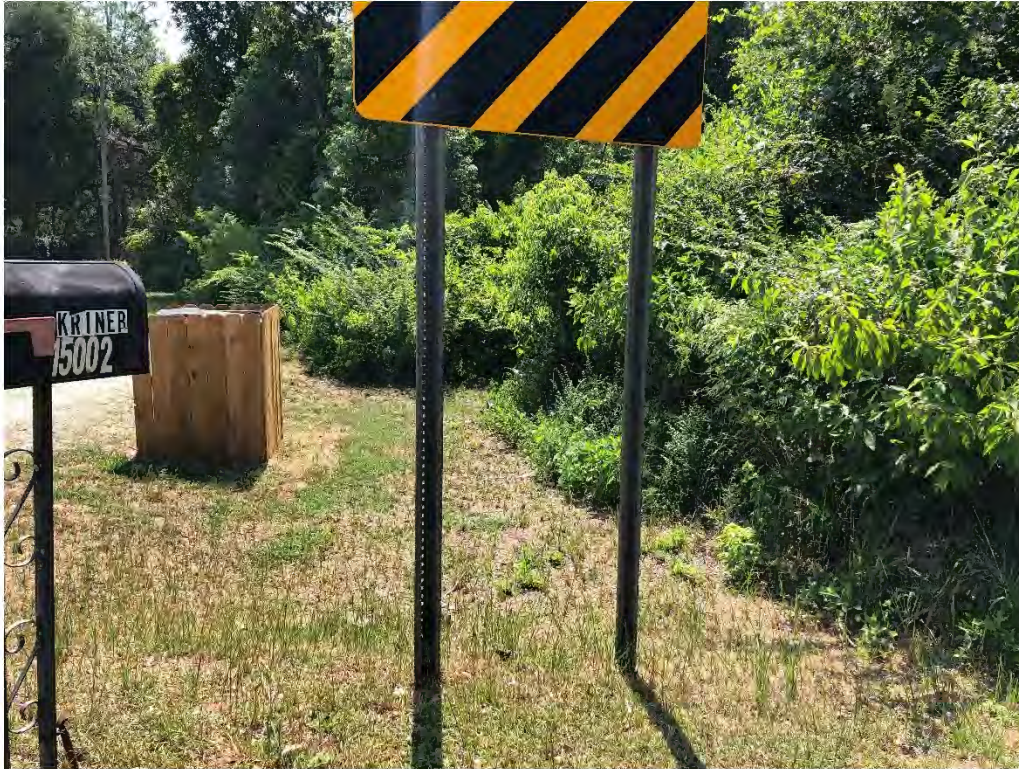
Figure 9560:
Photo taken facing SW of MN-CH-12 at the intersection of Old Marlow Road and Gates Ave.

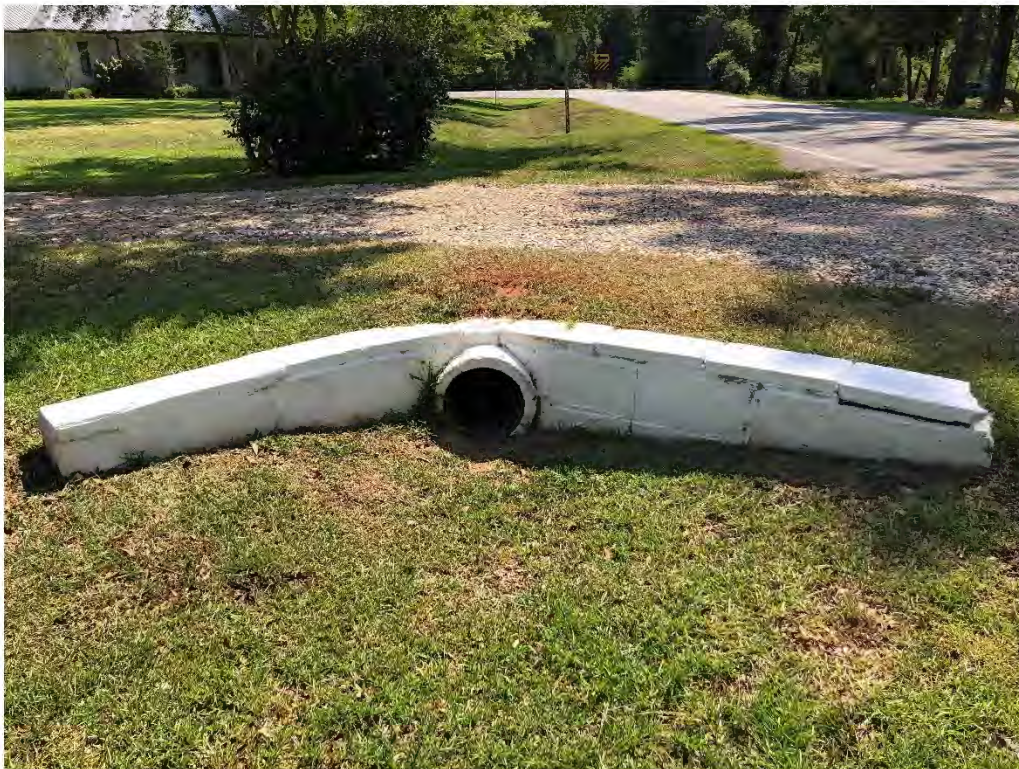
Figure 9561:
Photo taken facing NE of a ditch along Old Marlow Road.

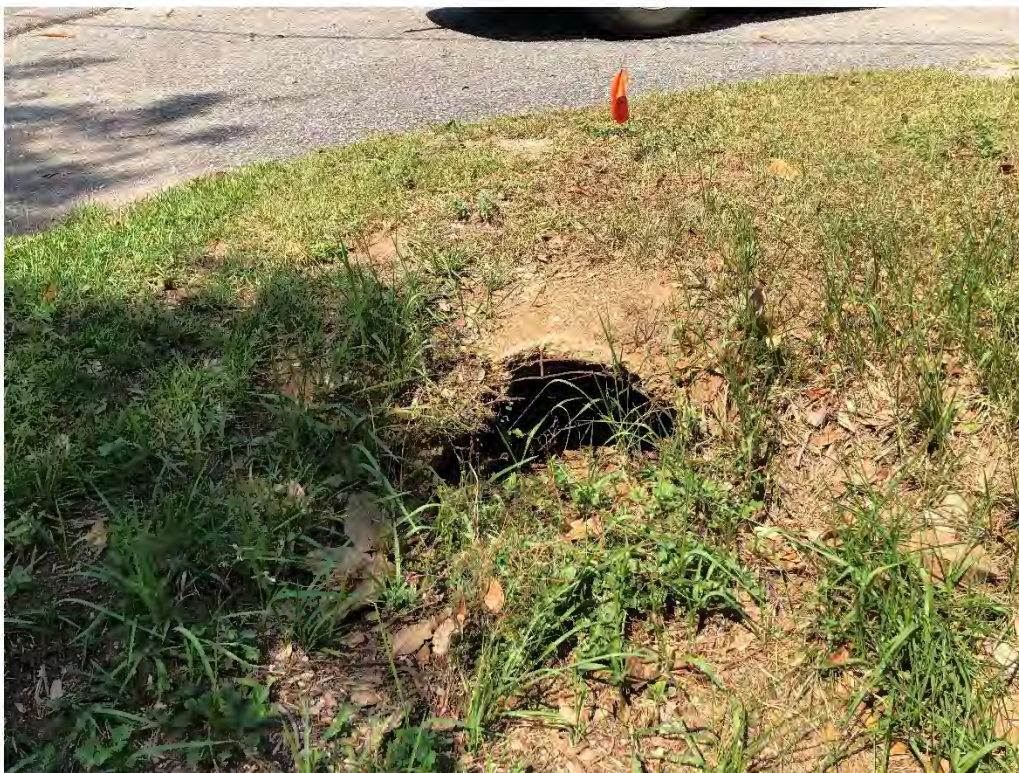
Figure 9573:
Photo taken facing West of MN-CO-14 at the intersection of Gates Ave and a driveway.

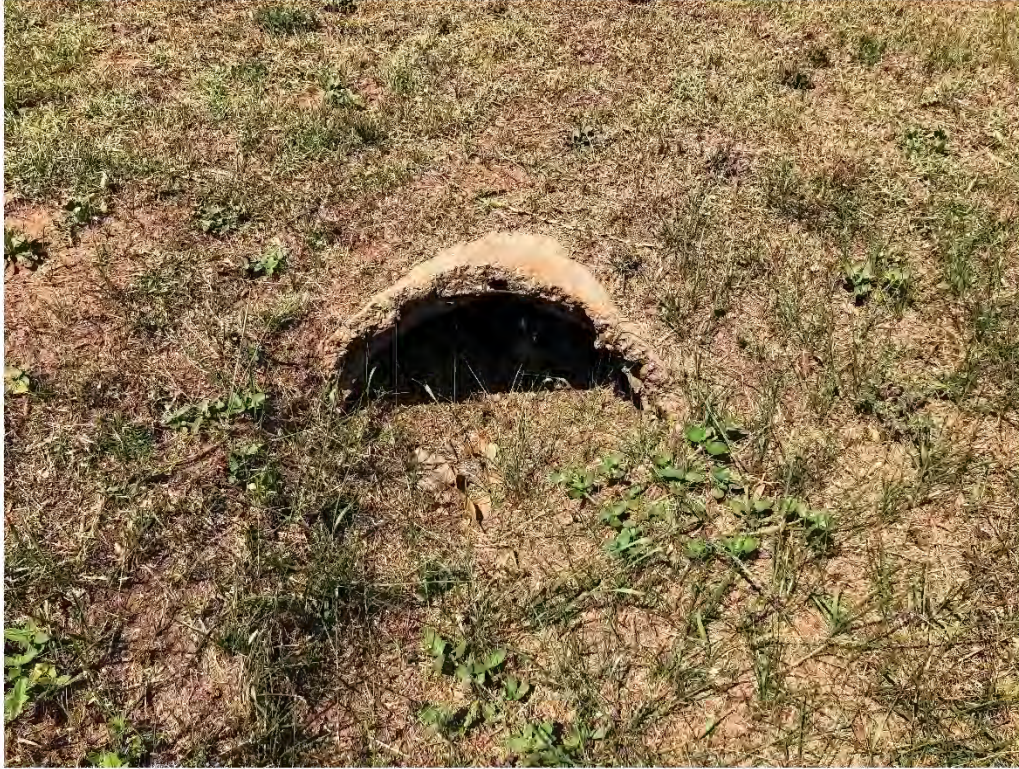
Figure 9576:
Photo taken facing East of MN-CO-15 at the intersection of Gates Ave and a driveway.

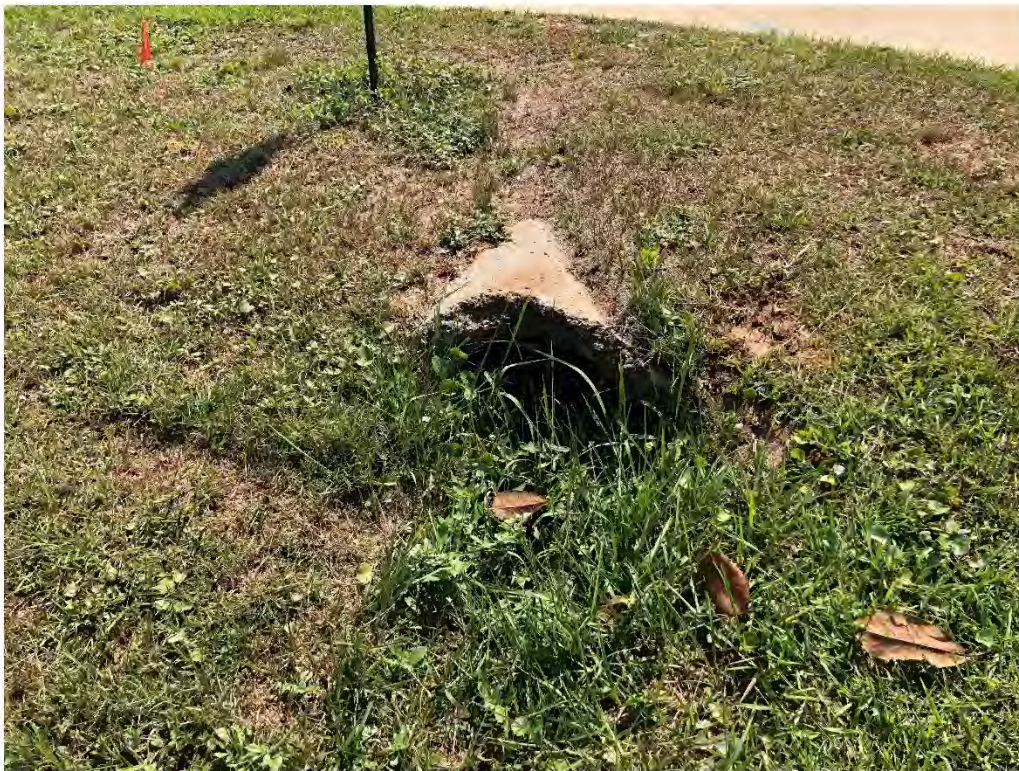
Figure 9577:
Photo taken facing West of MN-CO-15 at the intersection of Gates Ave and a driveway.

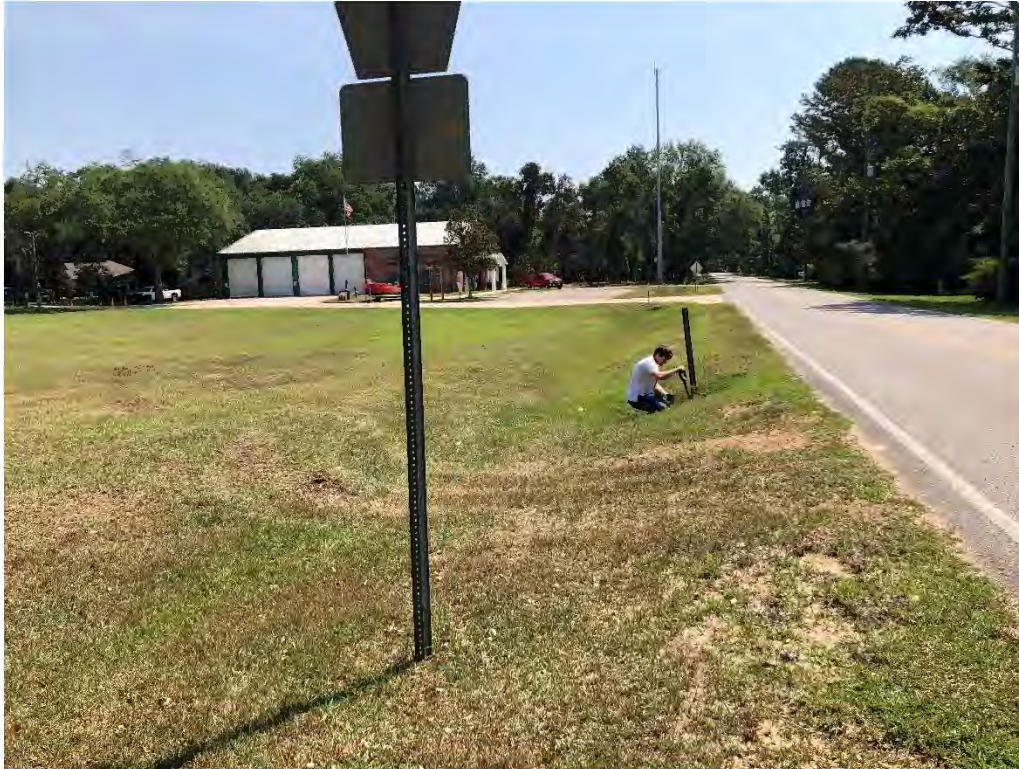
Figure 9585:
Photo taken facing East of MN-CH-18 along Gates Ave.

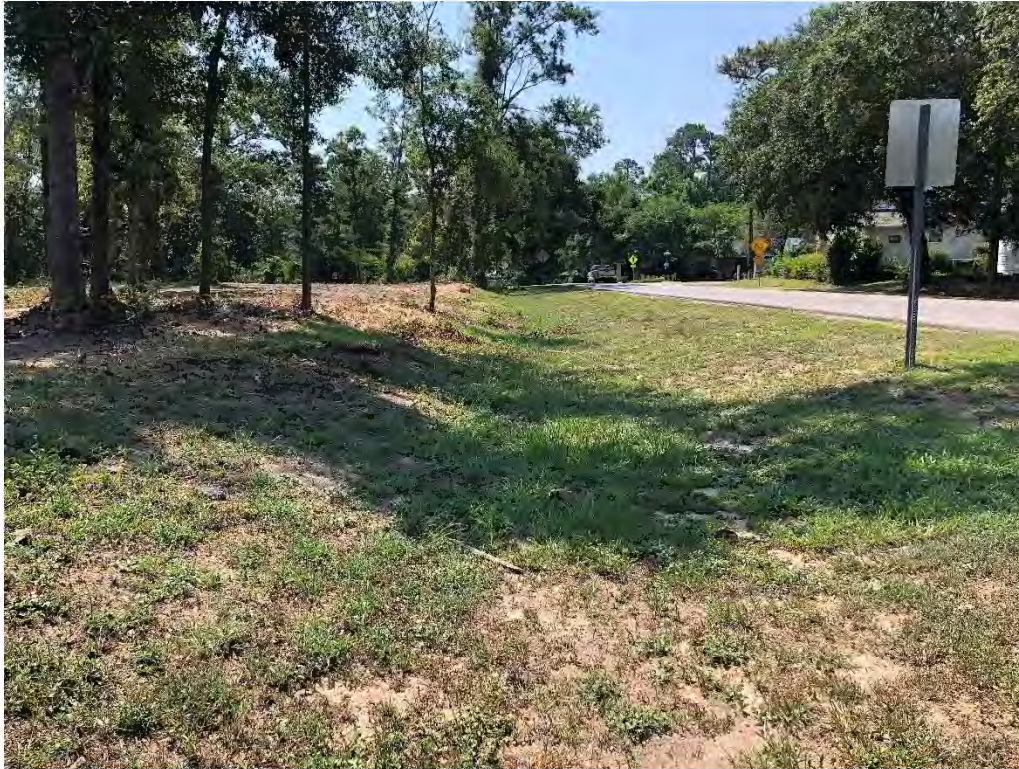
Figure 9593:
Photo taken facing South toward MN-CH-20 along HWY 49.

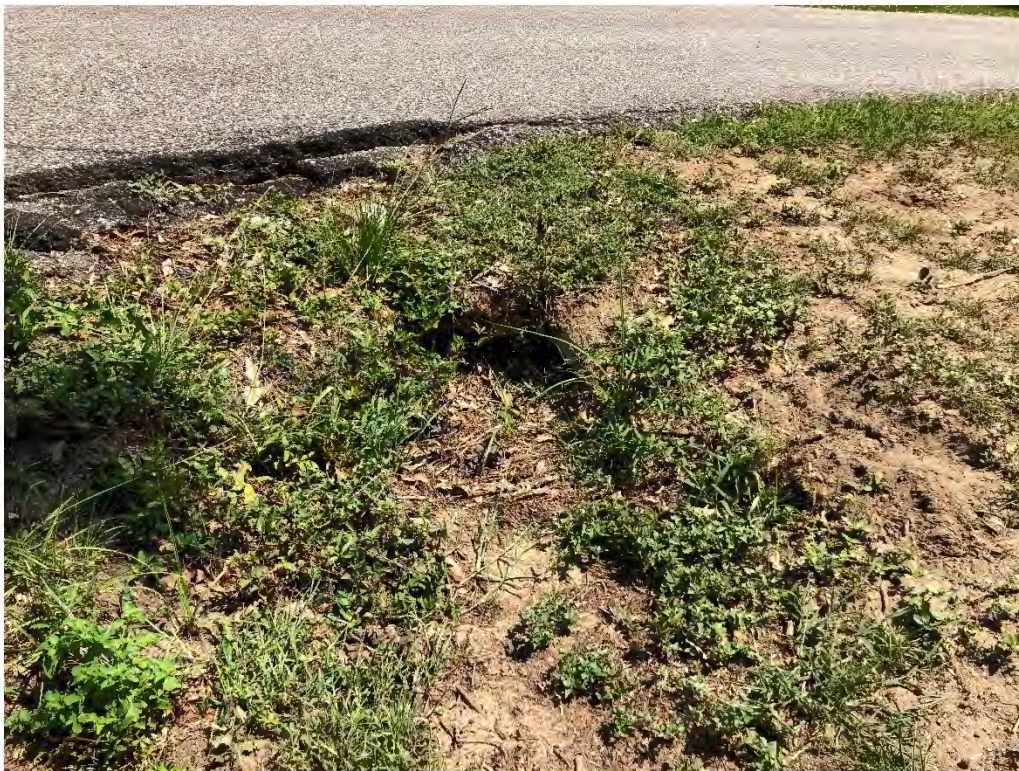
Figure 9594:
Photo taken facing North toward MN-CO-7 at the intersection of HWY 49 and School St.

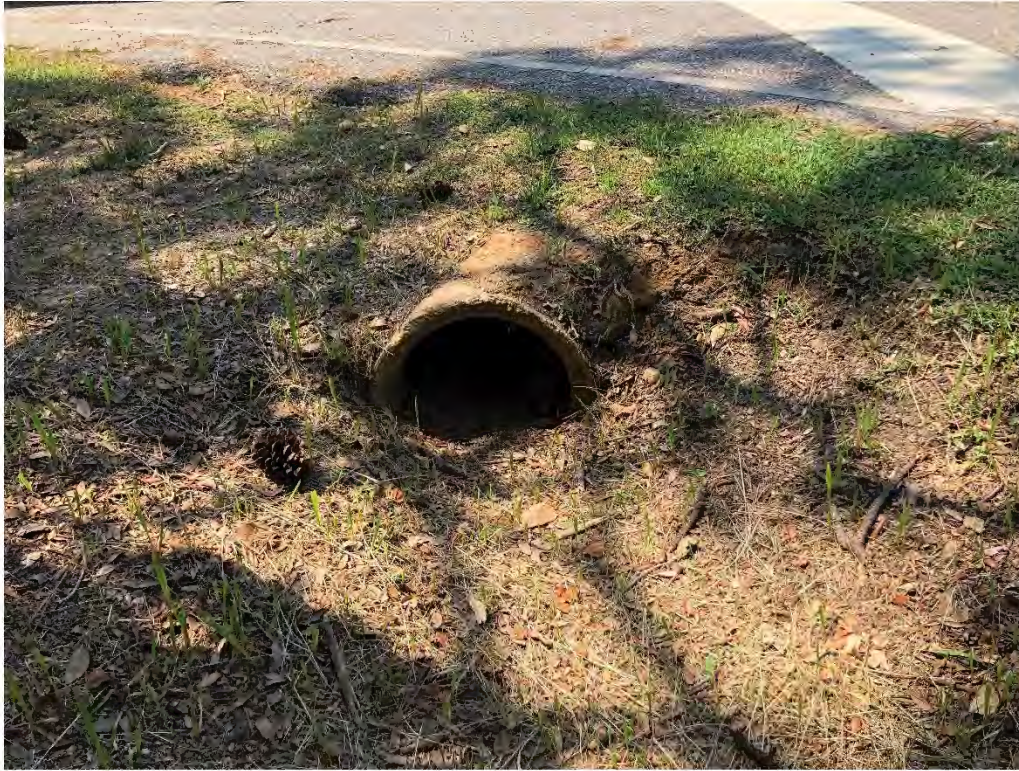
Figure 9595:
Photo taken facing South toward MN-CO-7 at the intersection of HWY 49 and School St.

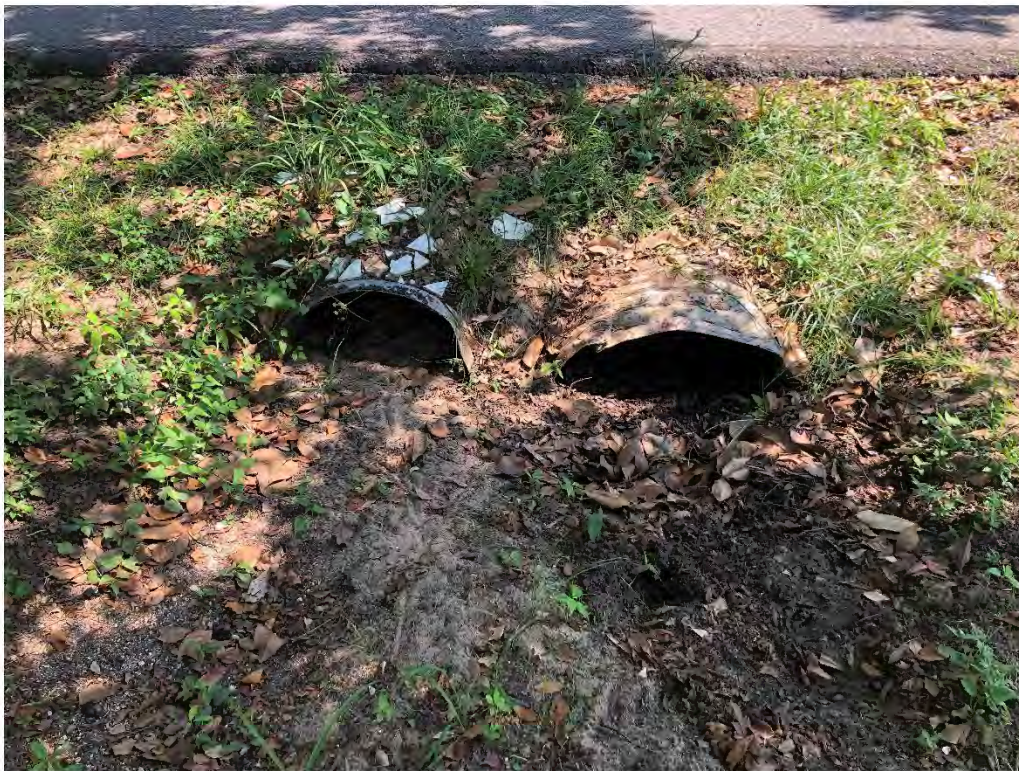
Figure 9598:
Photo taken of a silted pipe at the intersection of School Street and Magnolia Ave.

It is recommended to provide maintenance of silted in pipes and ditches, as noted in the photo pages provided in Appendix C. In addition to general maintenance of existing infrastructure, the proposed drainage improvements were consolidated into projects based on category and location. The projects were then ranked based on priority using a MCDA Matrix. All proposed improvements and correlating projects are provided in detail in Appendix H and the proposed projects are summarized below.

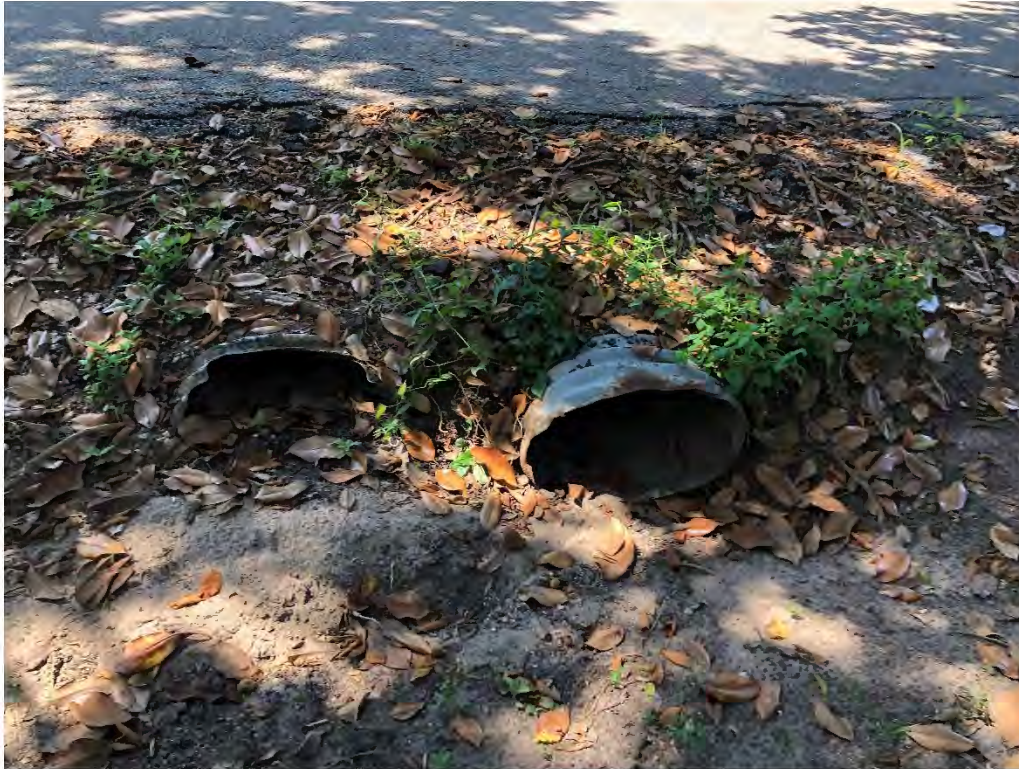
Figure 9599:
Photo taken of a silted pipe at the intersection of School Street and Magnolia Ave.

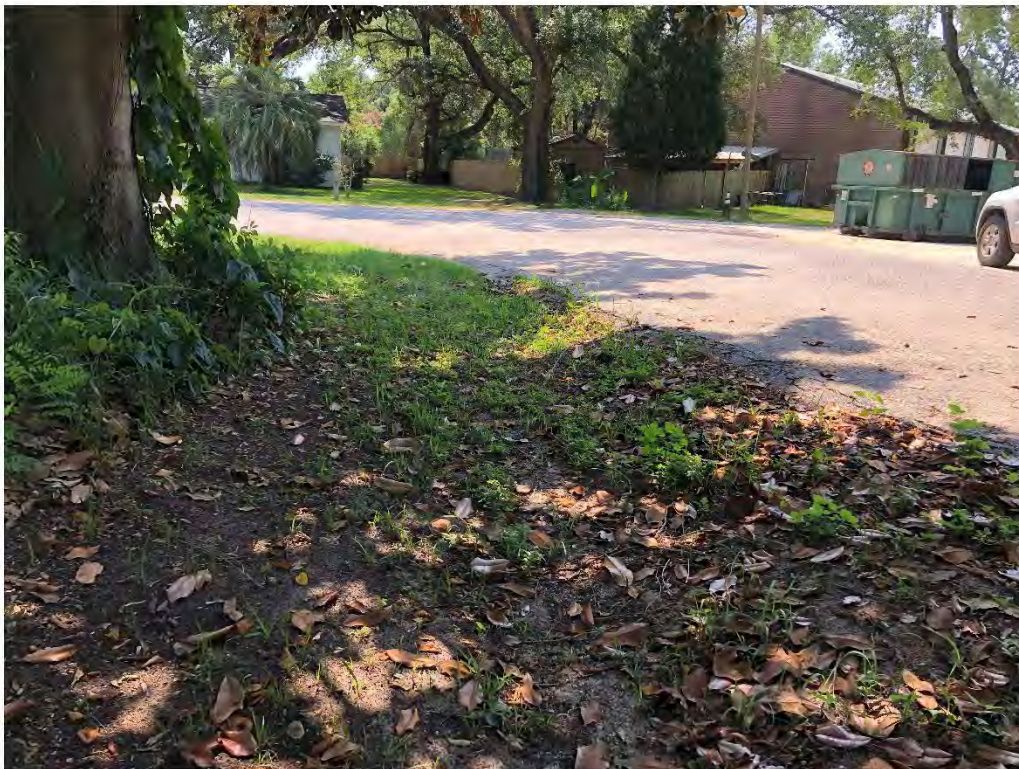
Figure 9600:
Photo taken facing East toward a ditch at the intersection of School Street and Magnolia Ave.

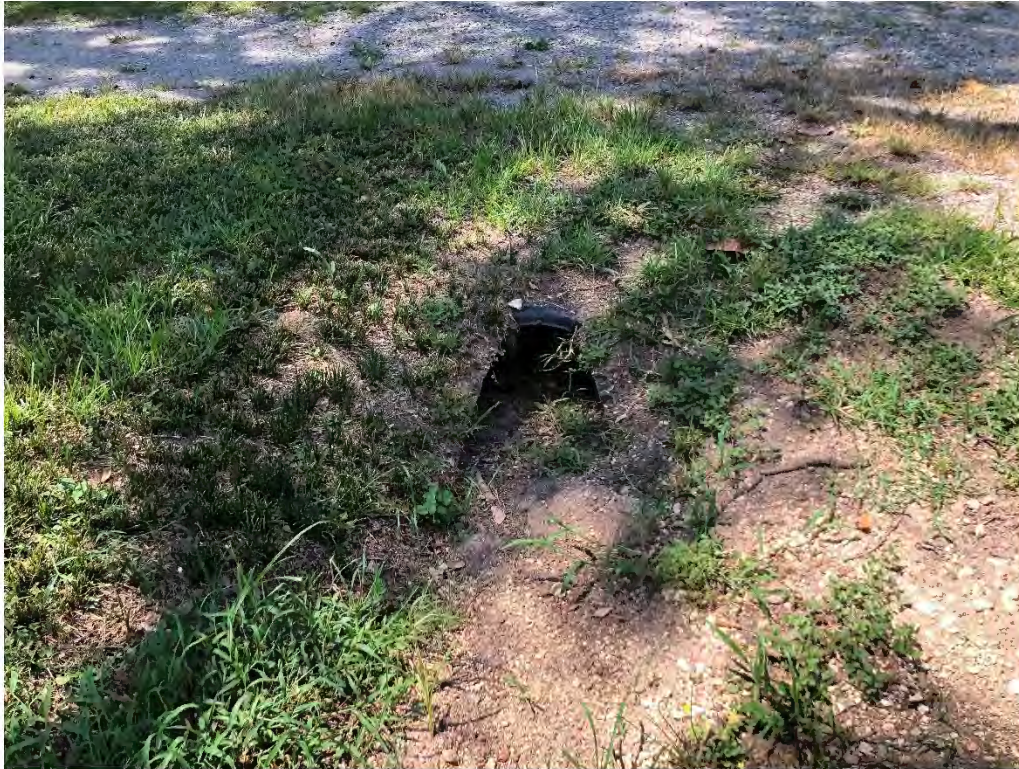
Figure 9603:
Photo taken of a pipe at the intersection of School Street and a driveway.

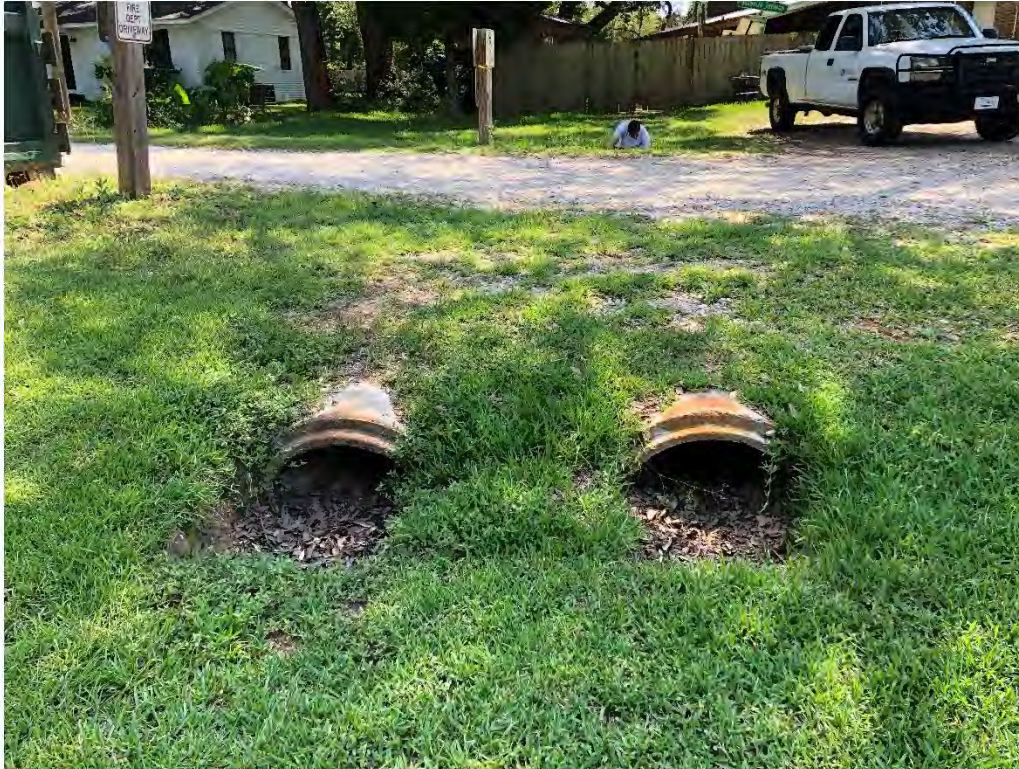
Figure 9607:
Photo taken facing East toward a silted MN-CO-21 across a driveway.

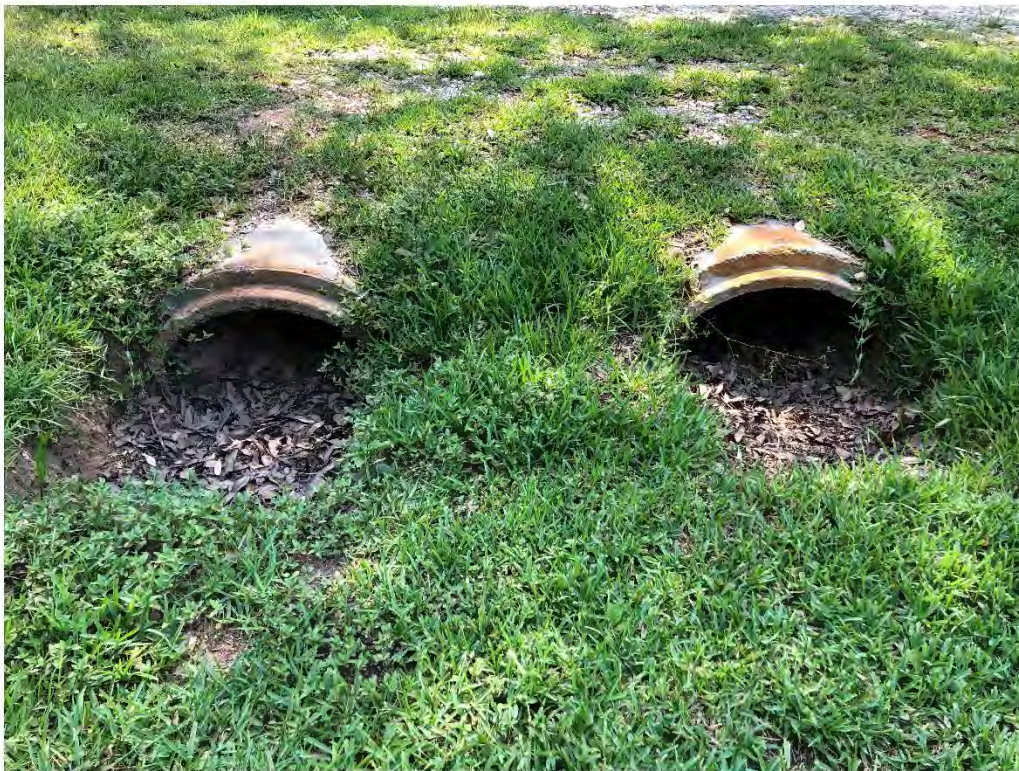
Figure 9608:
Photo taken facing East toward a silted MN-CO-21 across a driveway.

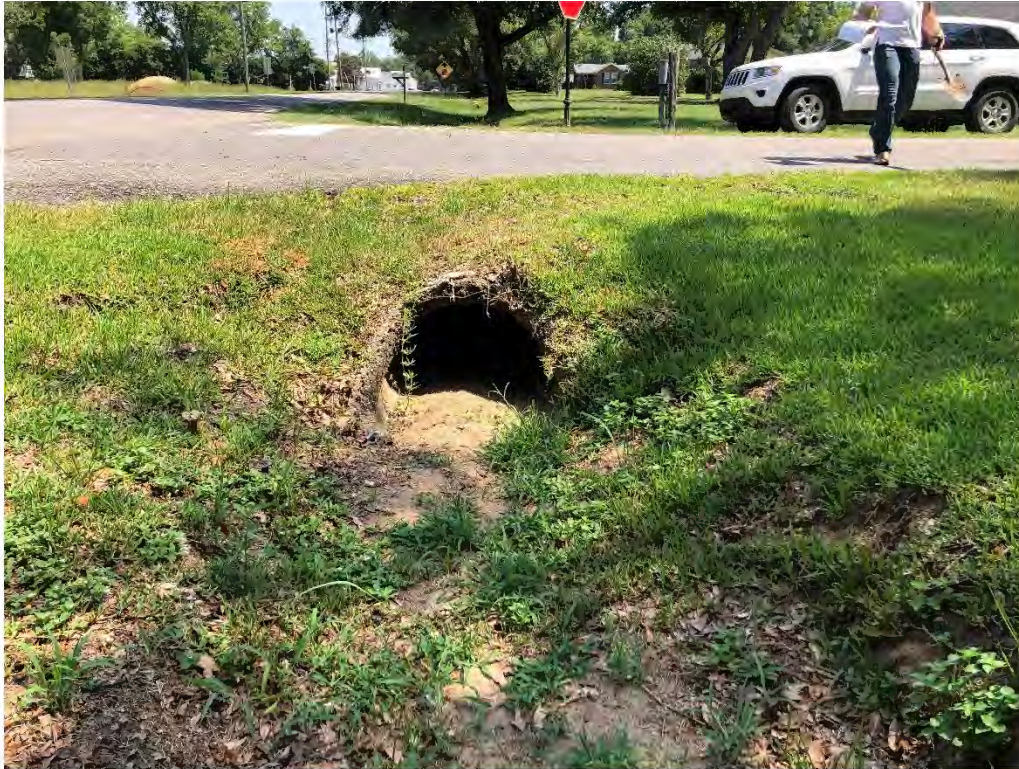
Figure 9609:
Photo taken facing North toward MN-CO-4 at the intersection of Cedar St and HWY 49.

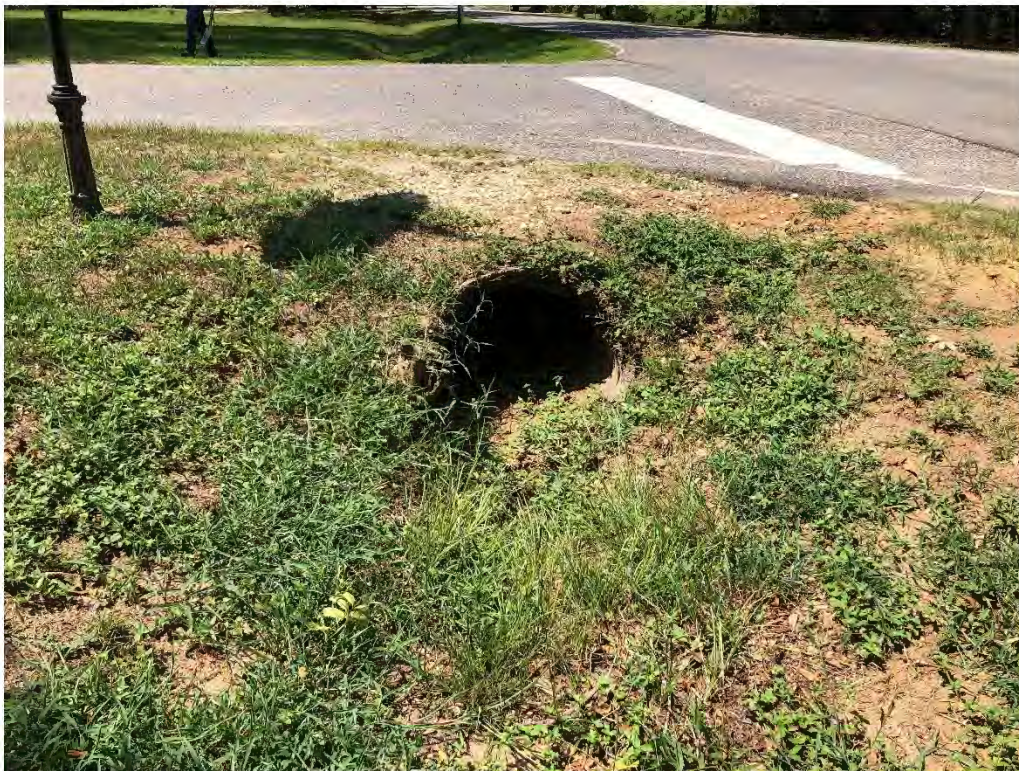
Figure 9612:
Photo taken facing South toward MN-CO-4 at the intersection HWY 49 and Cedar St.

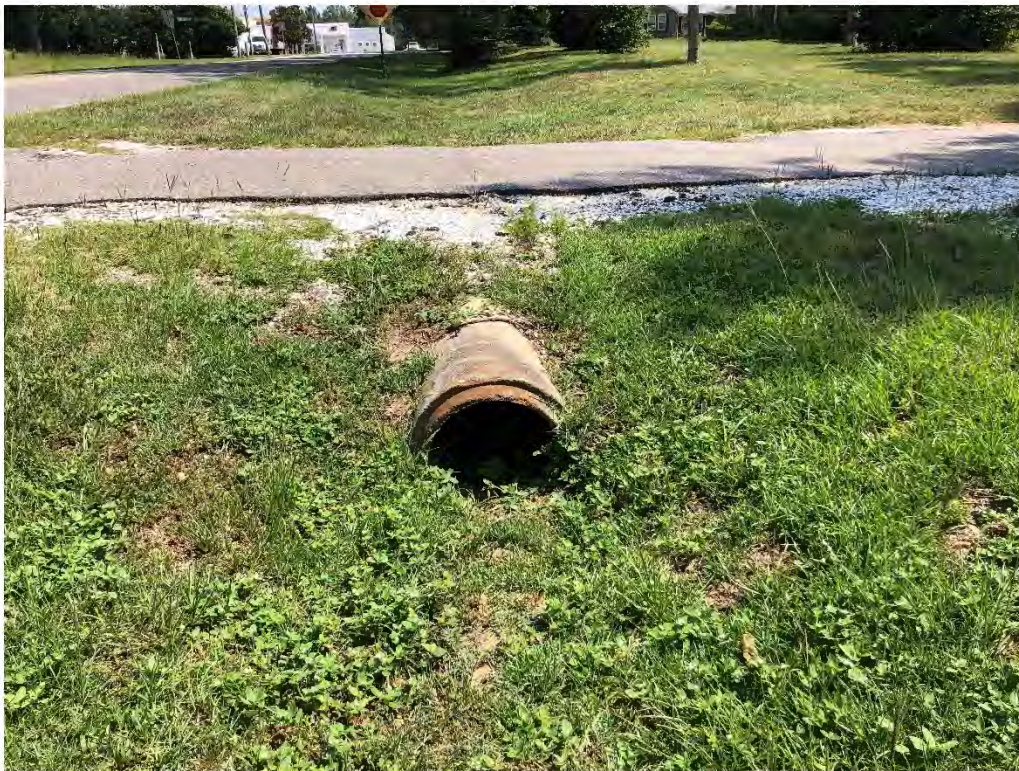
Figure 9613:
Photo taken facing North toward MN-CH-5 along HWY 49.

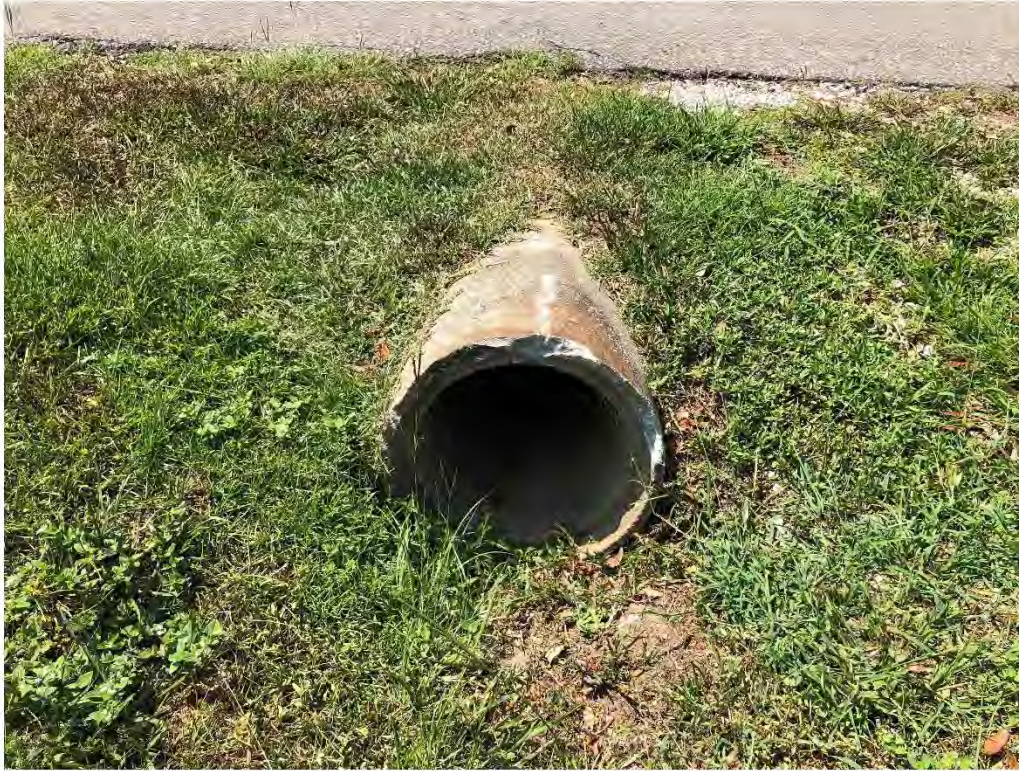
Figure 9614:
Photo taken facing North toward a silted MN-CO-3 at the intersection HWY 49 and a driveway.

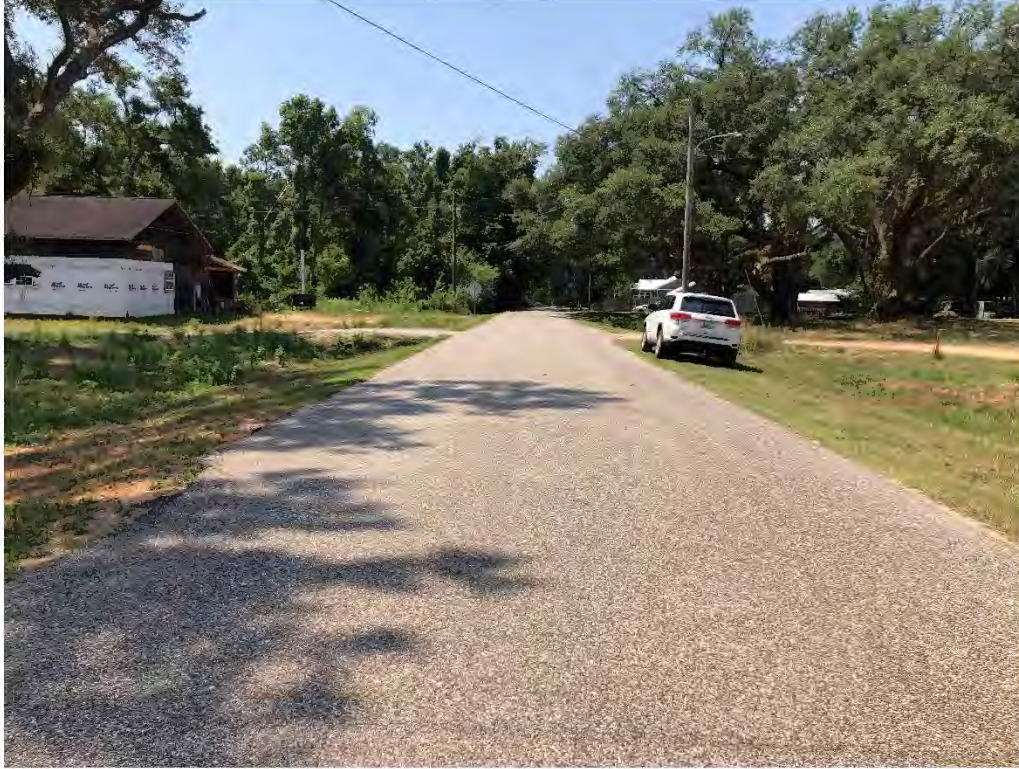
Figure 9618:
Photo taken facing East toward a very silted pipe at the intersection HWY 98 and a driveway.

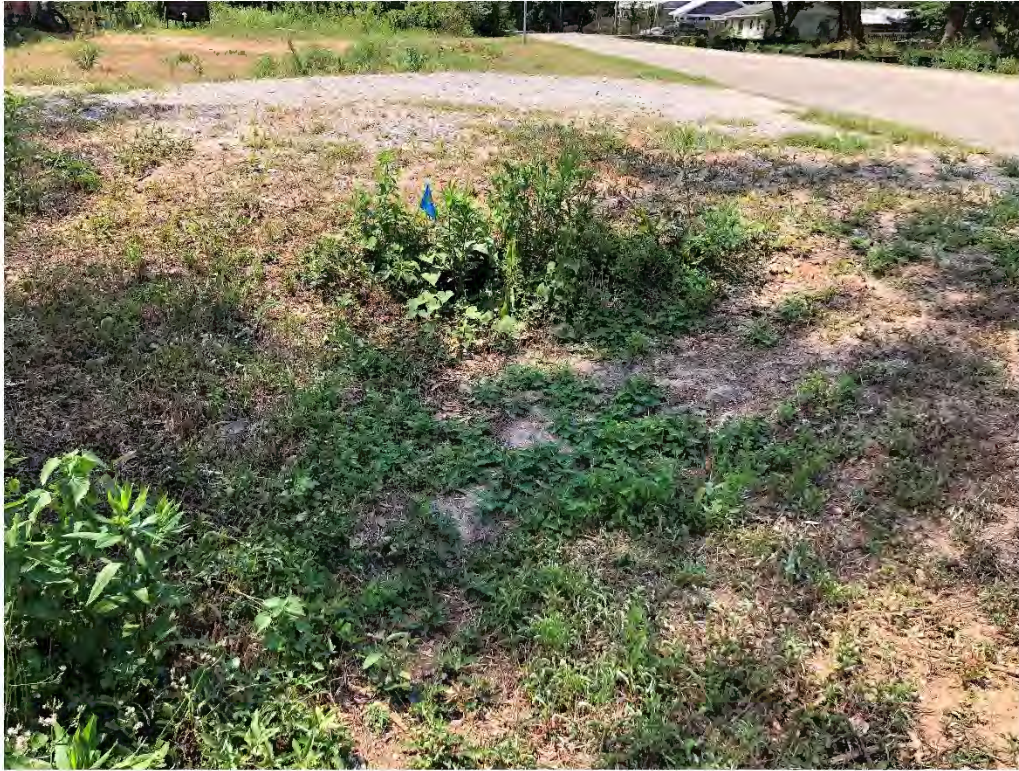
Figure 9620:
Photo taken facing East toward the southern ditch along HWY 98.

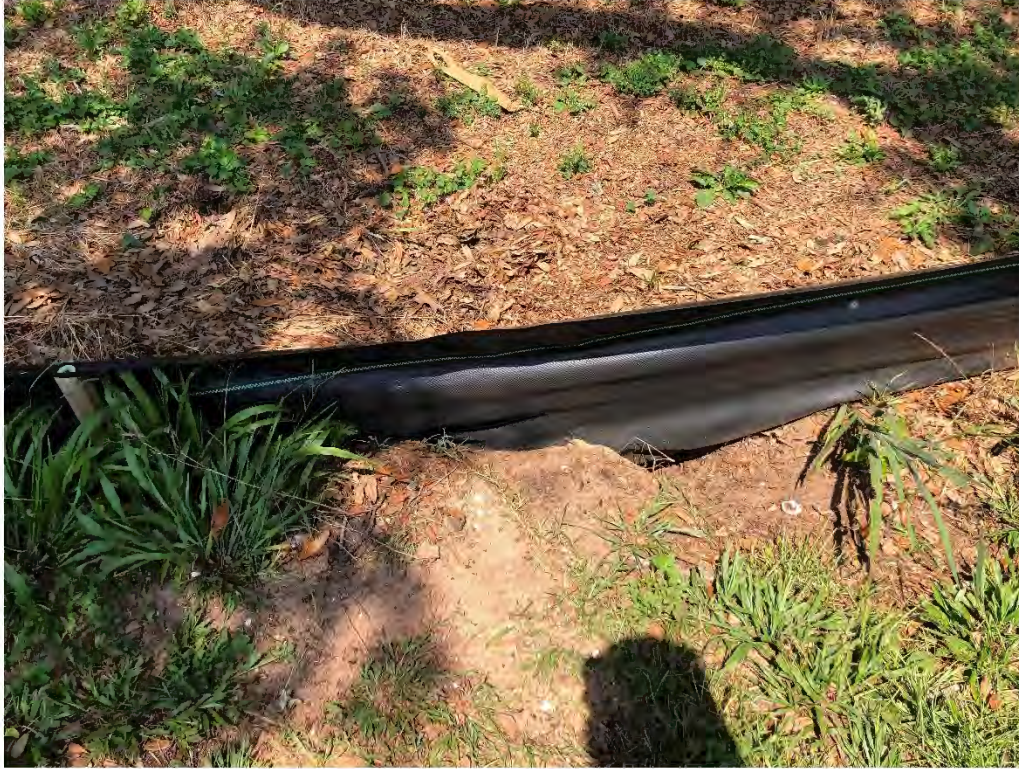
Figure 9624:
Photo taken facing North toward a very silted OAK-CO-7 across Jessamine St.

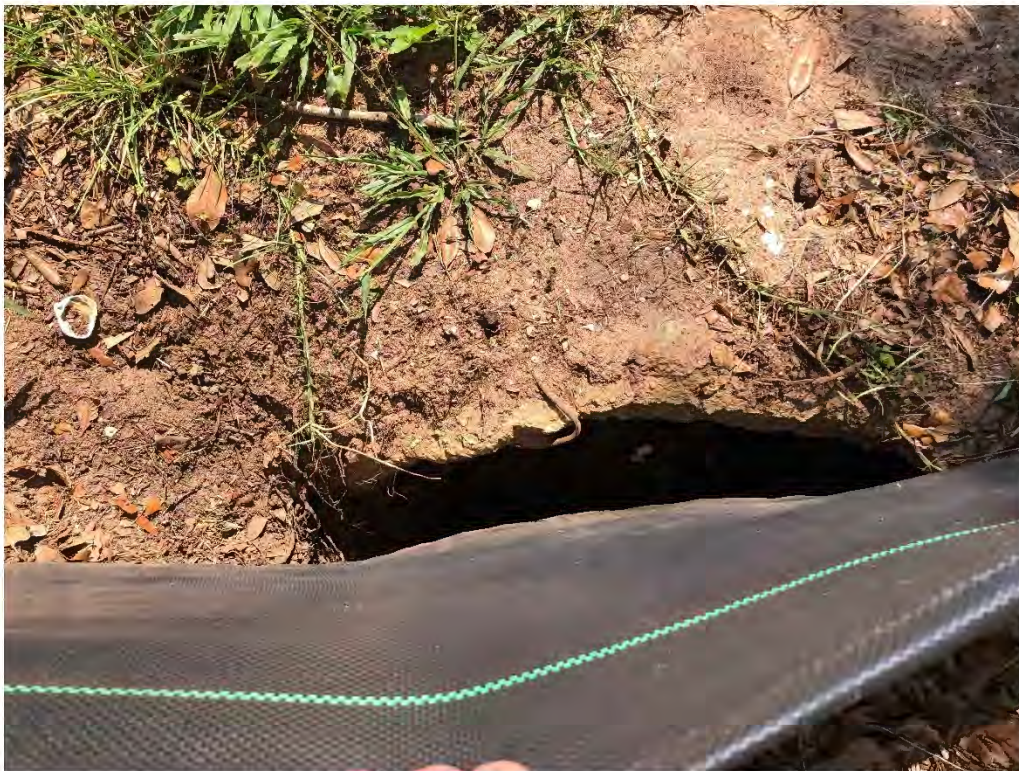
Figure 9625:
Photo taken facing West toward a crushed and very silted OAK-CO-6 across Jessamine St.
