Town of Magnolia Springs Comprehensive Drainage Masterplan

Town of Magnolia Springs
Magnolia Springs, Baldwin County, Alabama

VOLKERT

March 2023

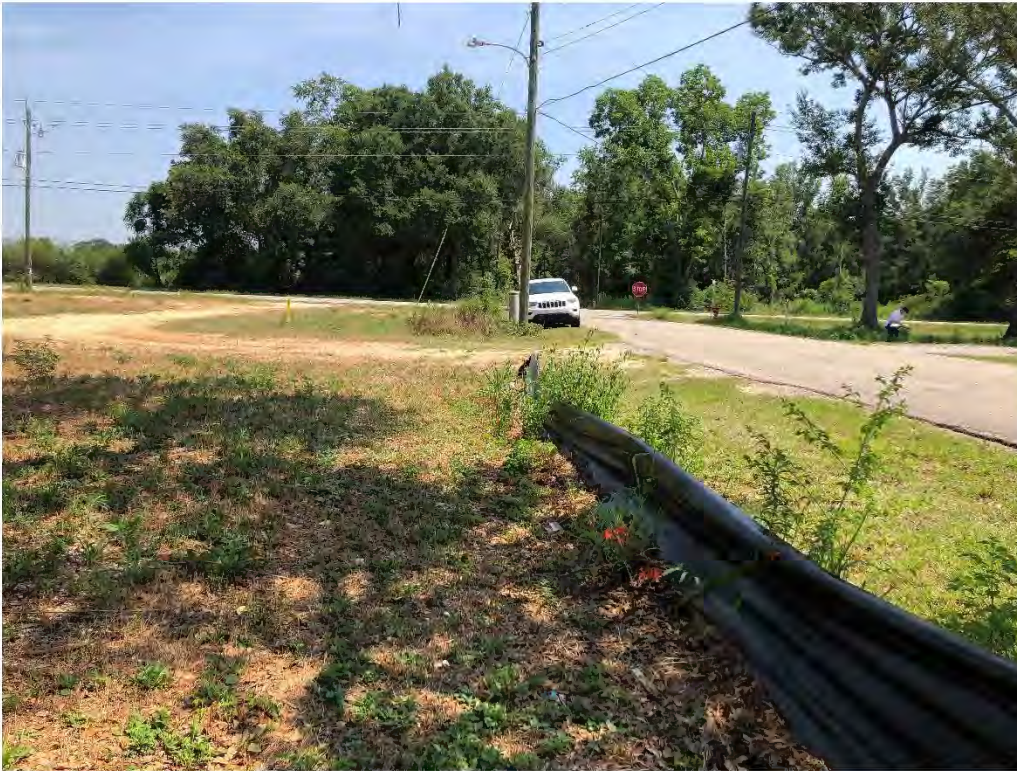
Figure 9627:
Photo taken of ditch with silt fence along Jessamine St.

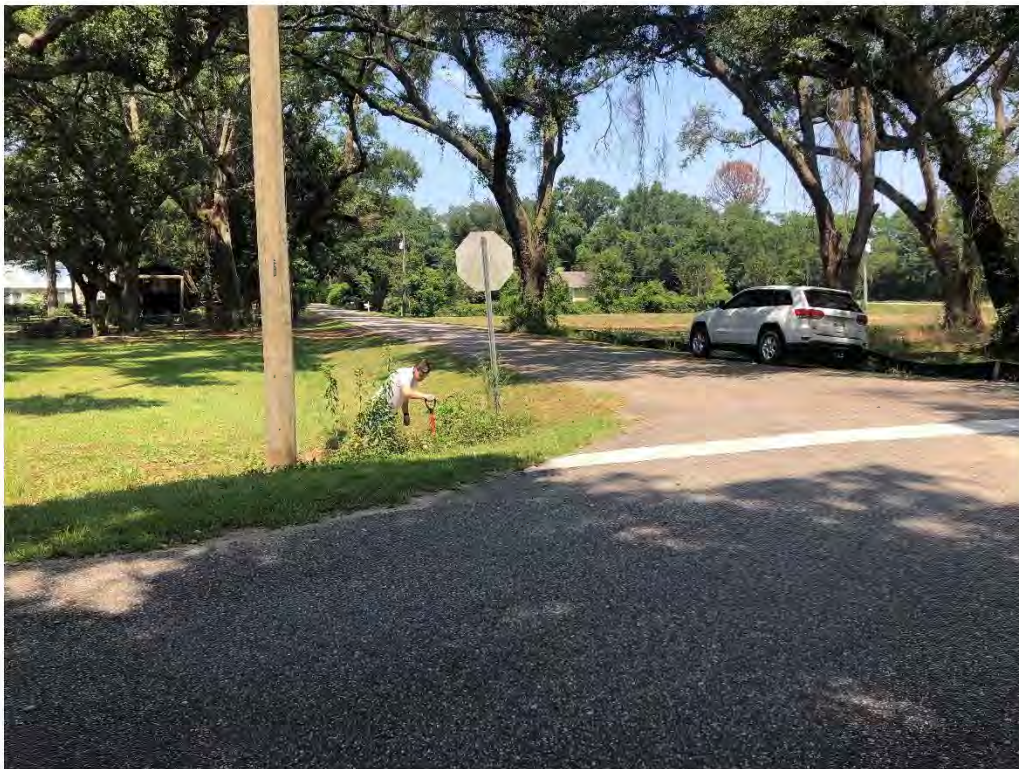
Figure 9633:
Photo taken facing North toward OAK-CH-10 that along Jessamine St.

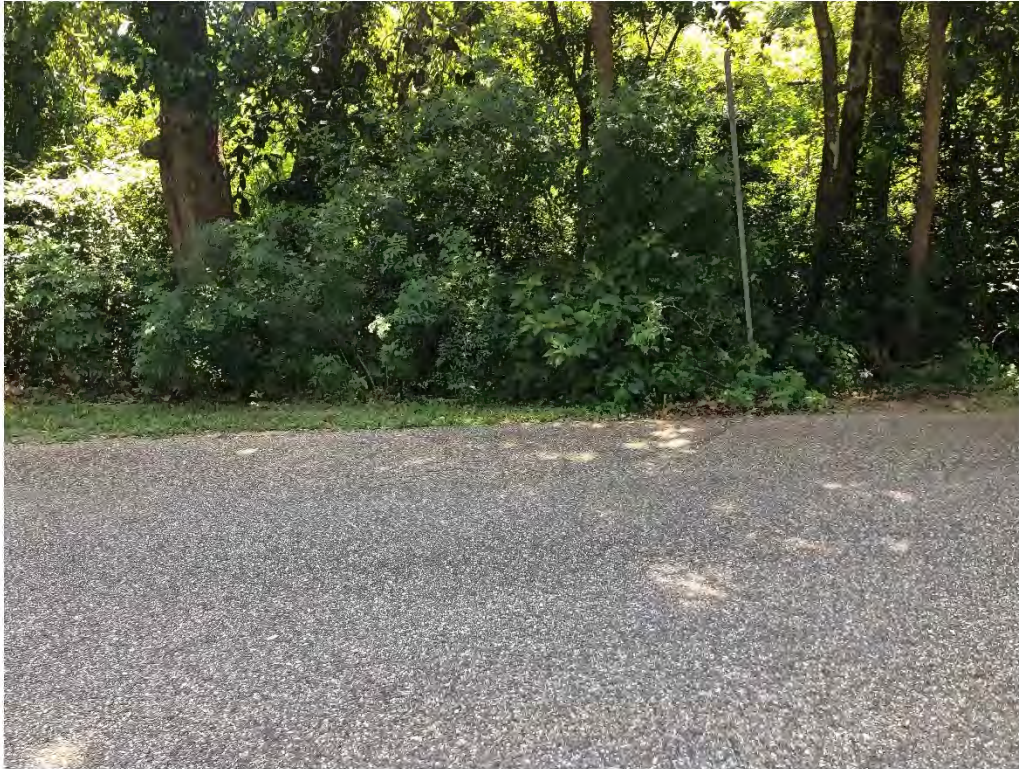
Figure 9634:
Photo taken facing West toward OAK-CH-13 along Jessamine St.

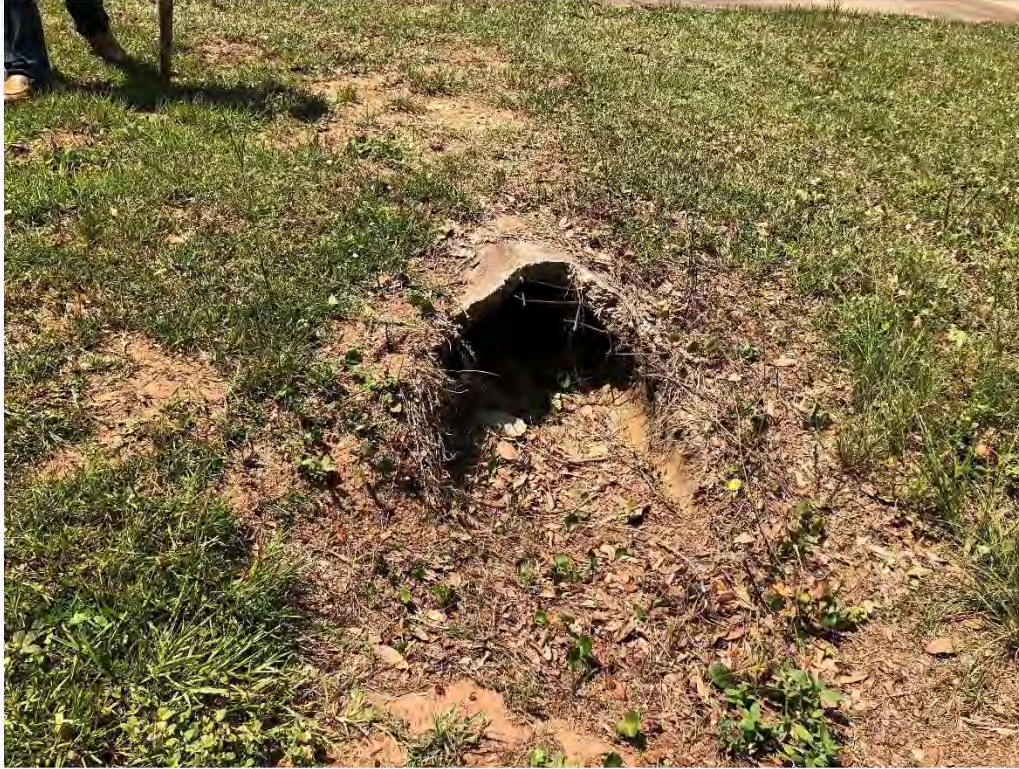
Figure 9636:
Photo taken facing South toward OAK-CH-11 along Jessamine St.

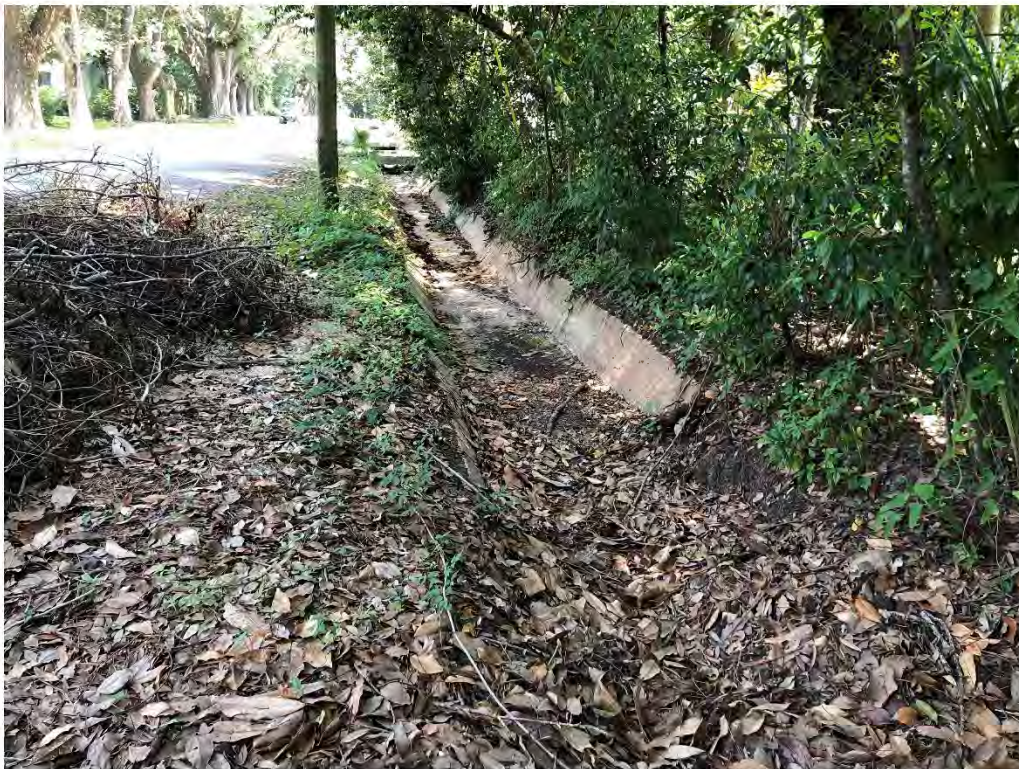
Figure 9641:
Photo taken facing South toward the roadway at the intersection of Jessamine St and McCoy Ln.

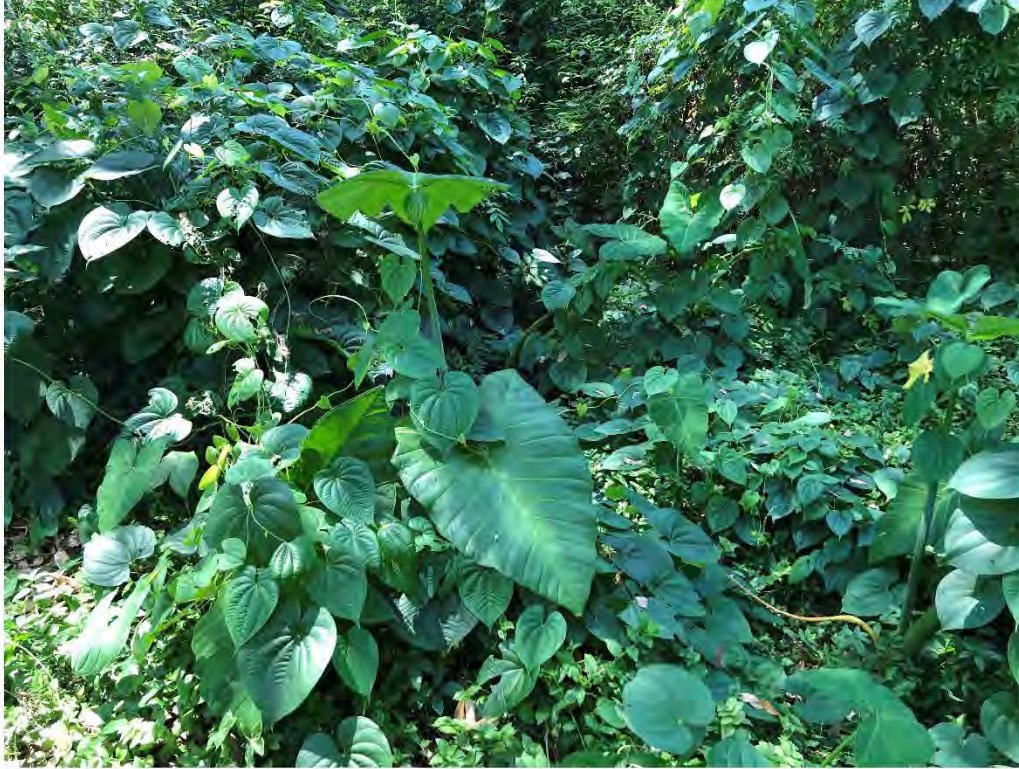
Figure 9644:
Photo taken facing East toward CH-200 along Jessamine St.

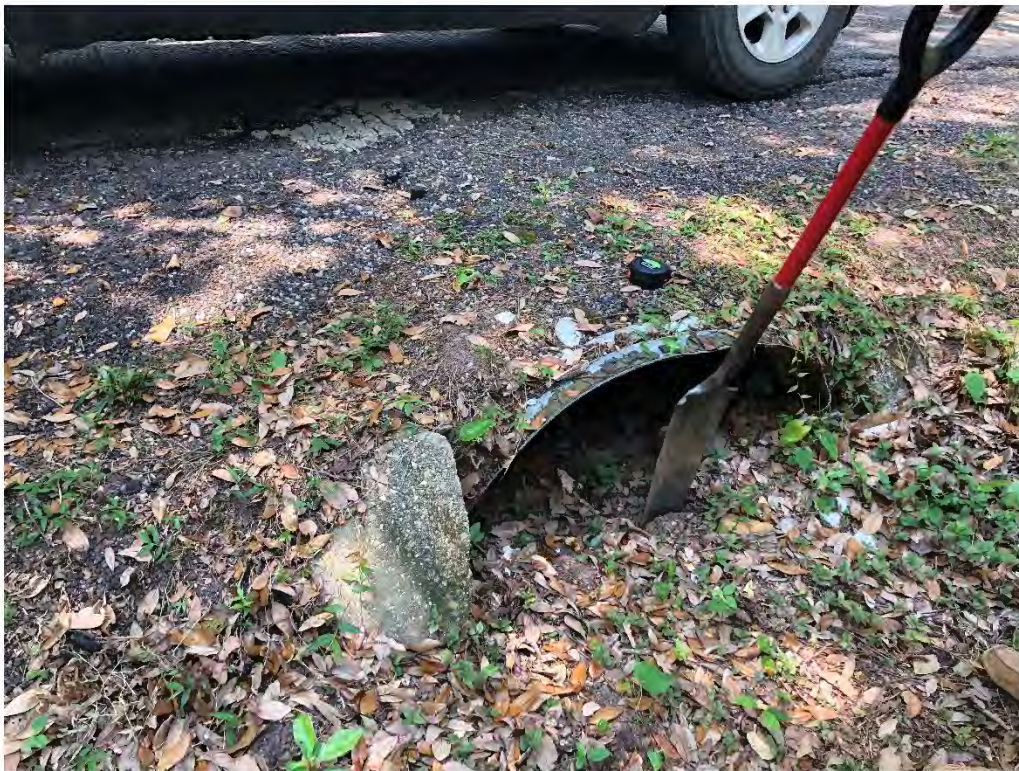
Figure 9645:
Photo of an overgrown OAK-CO-18 that crosses McCoy Ln.

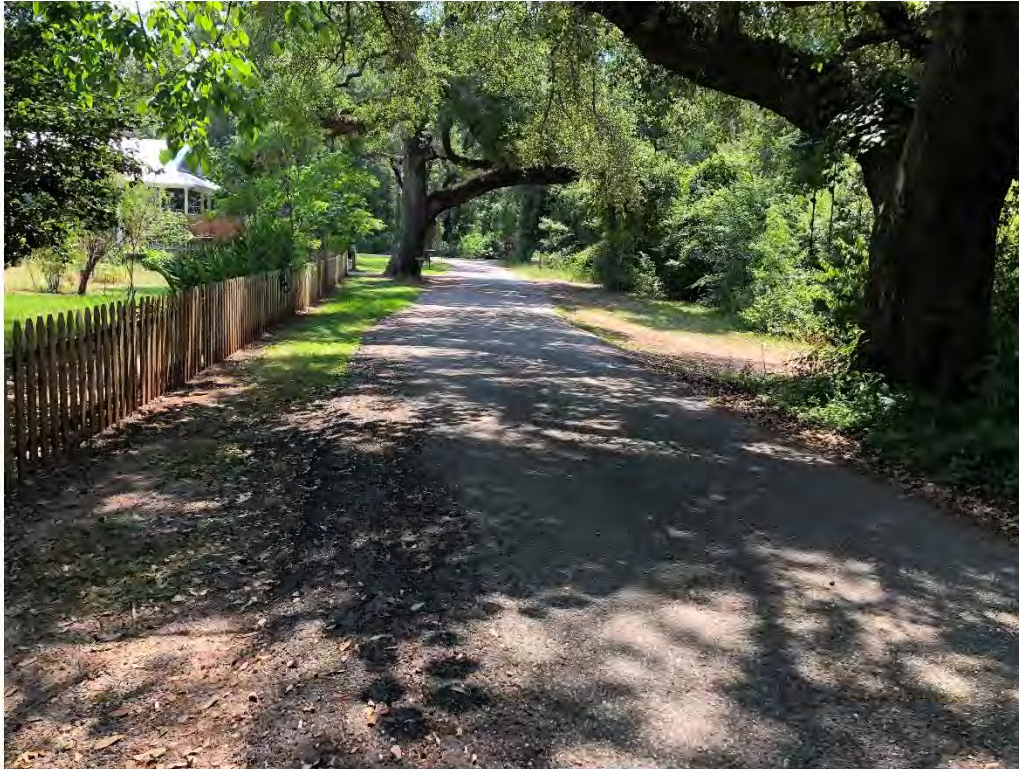
Figure 9646:
Photo of a silted OAK-CO-18 that crosses McCoy Ln.

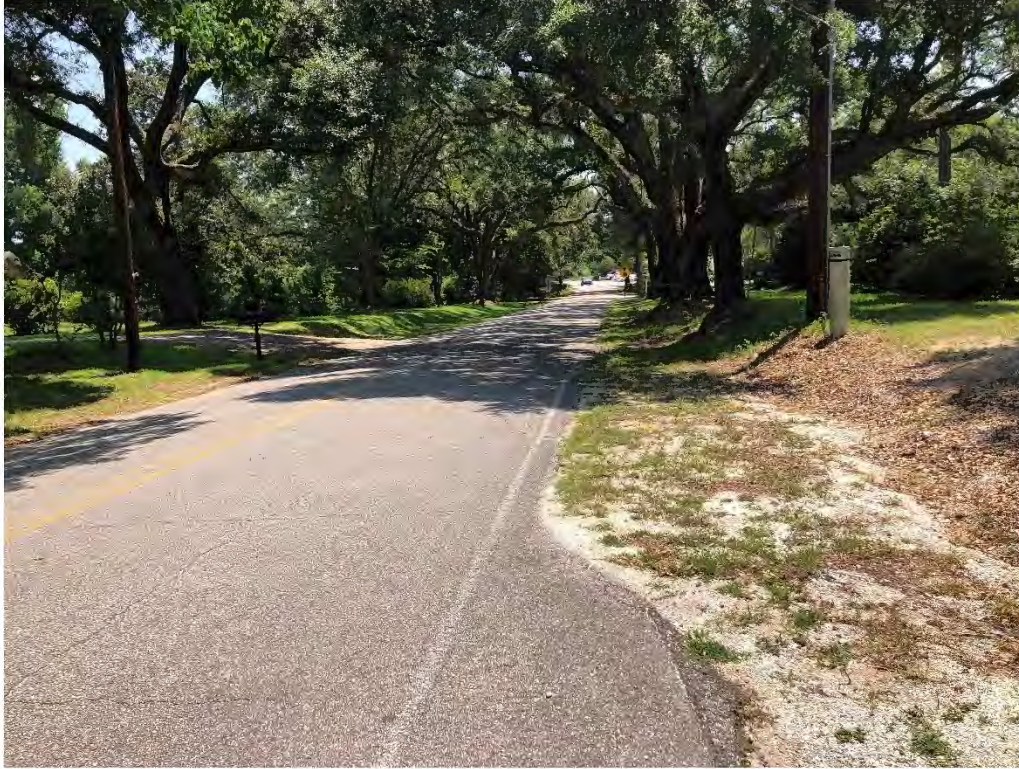
Figure 9657:

Photo taken facing SW toward a silted OAK-CO-22 at the intersection of Oak St and a driveway.

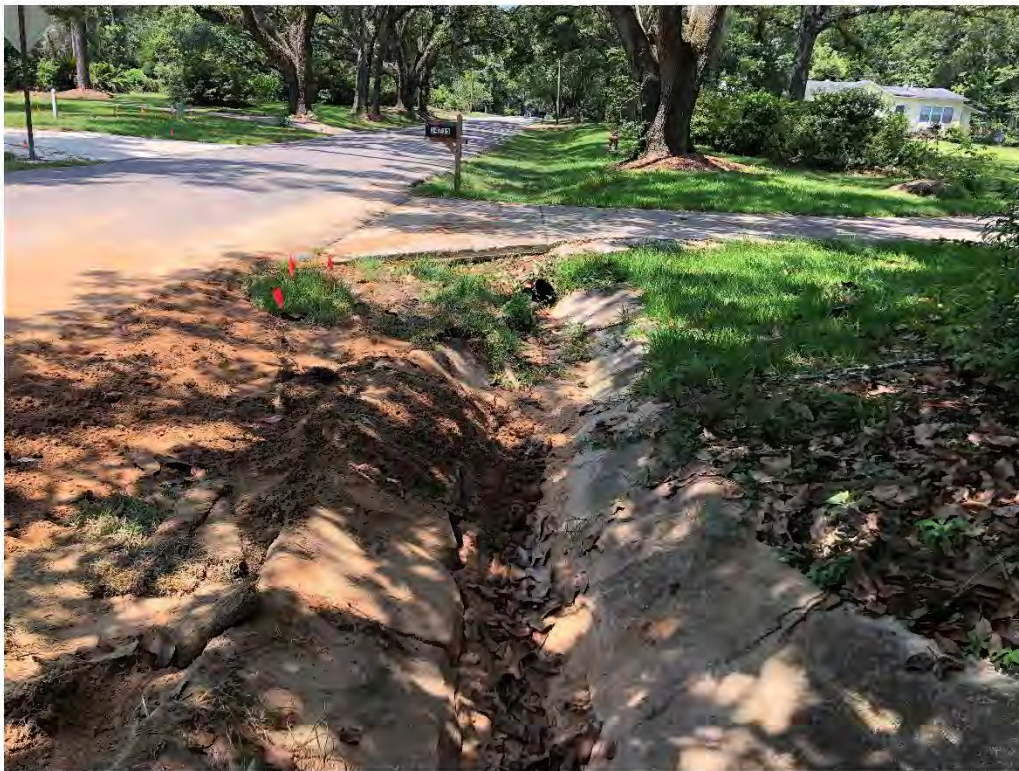
Figure 9658:
Photo taken facing NE toward OAK-CH-34 at the intersection of Oak St and a driveway.

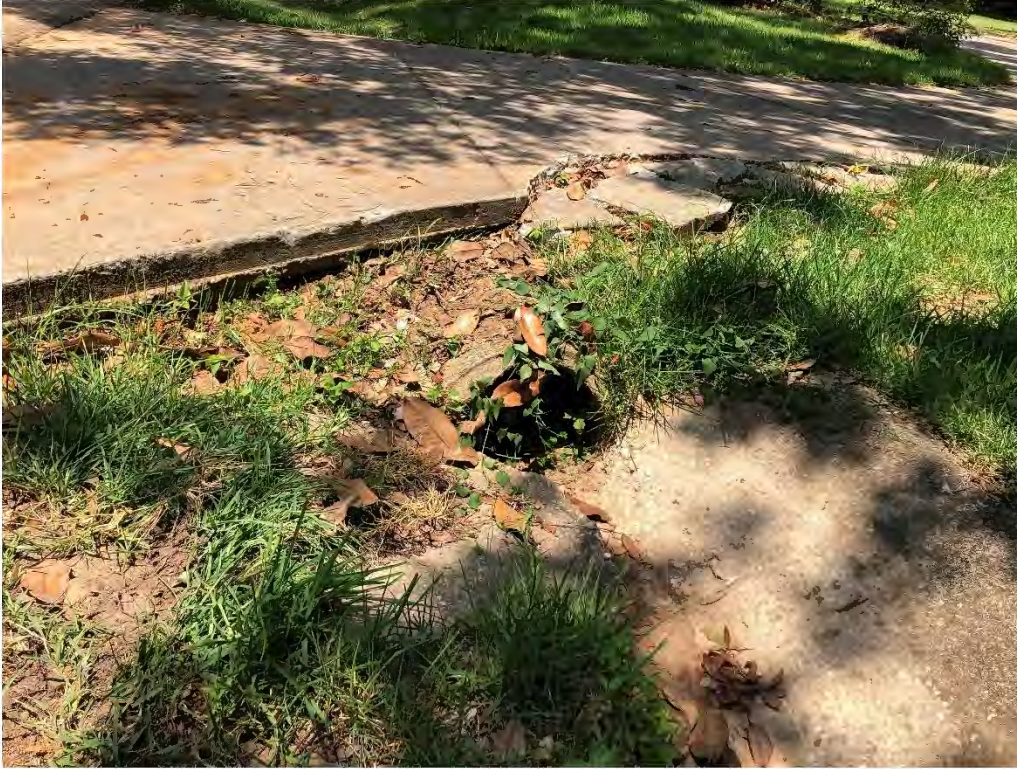
Figure 9660:
Photo taken facing SW toward a concrete ditch that is full of dirt along Oak St.

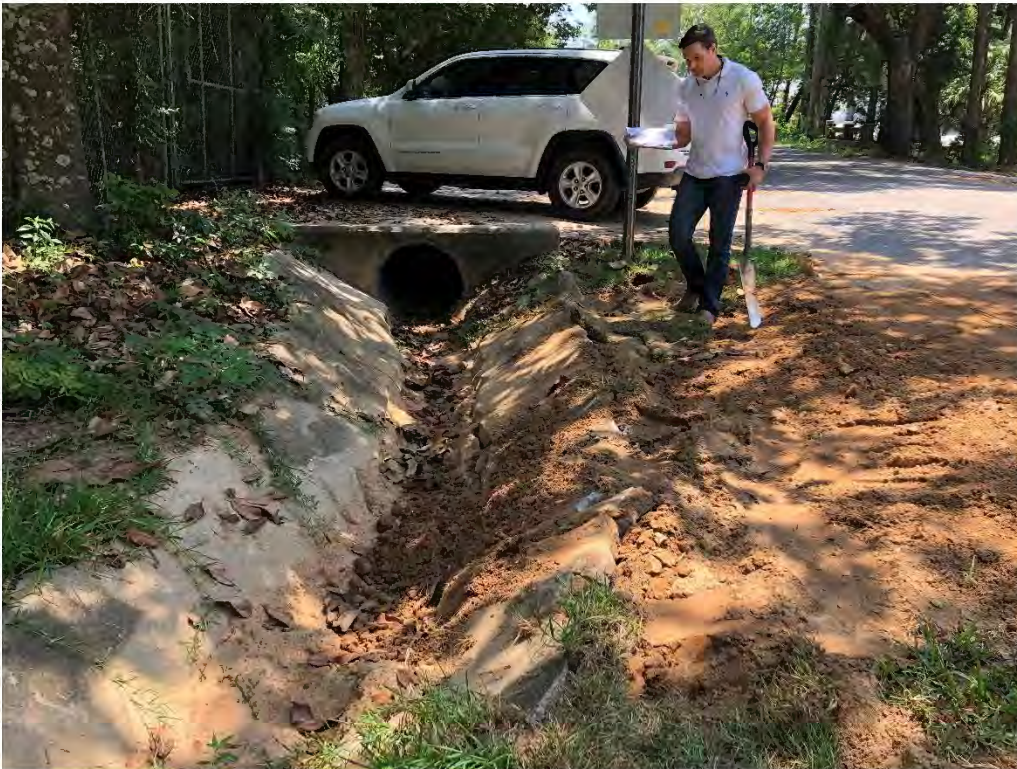
Figure 9661:
Photo taken facing SW toward a concrete ditch that is full of dirt along Oak St.

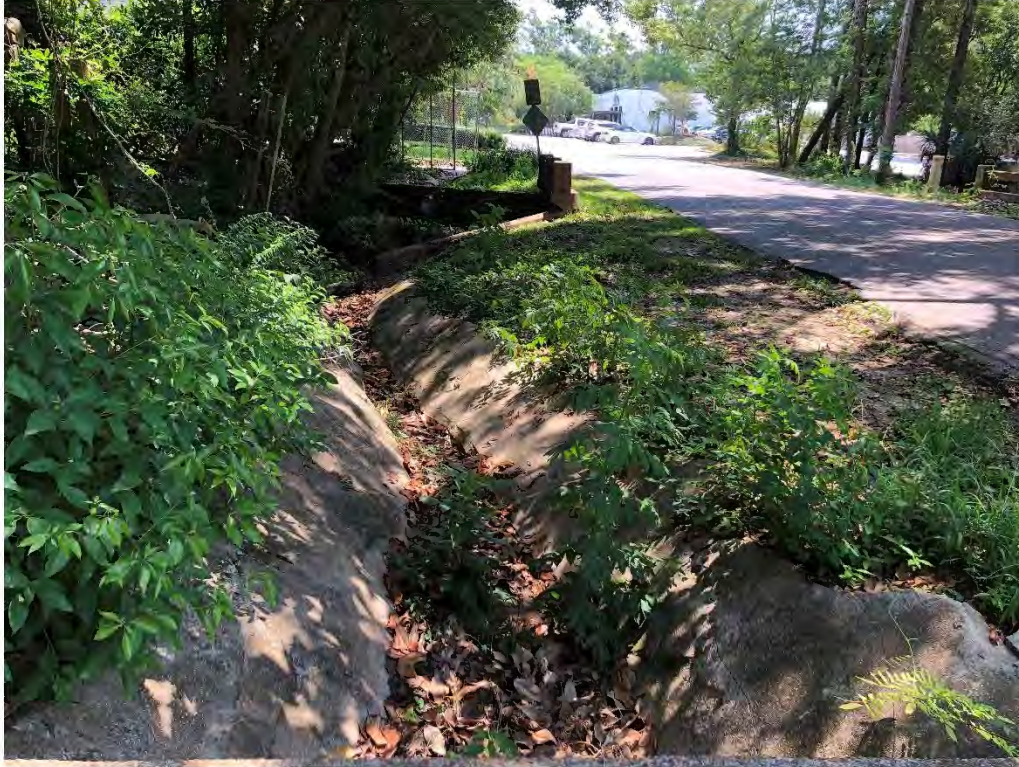
Figure 9665:

Photo taken facing NE toward OAK-CO-25 at the intersection of Oak St and a residential driveway.

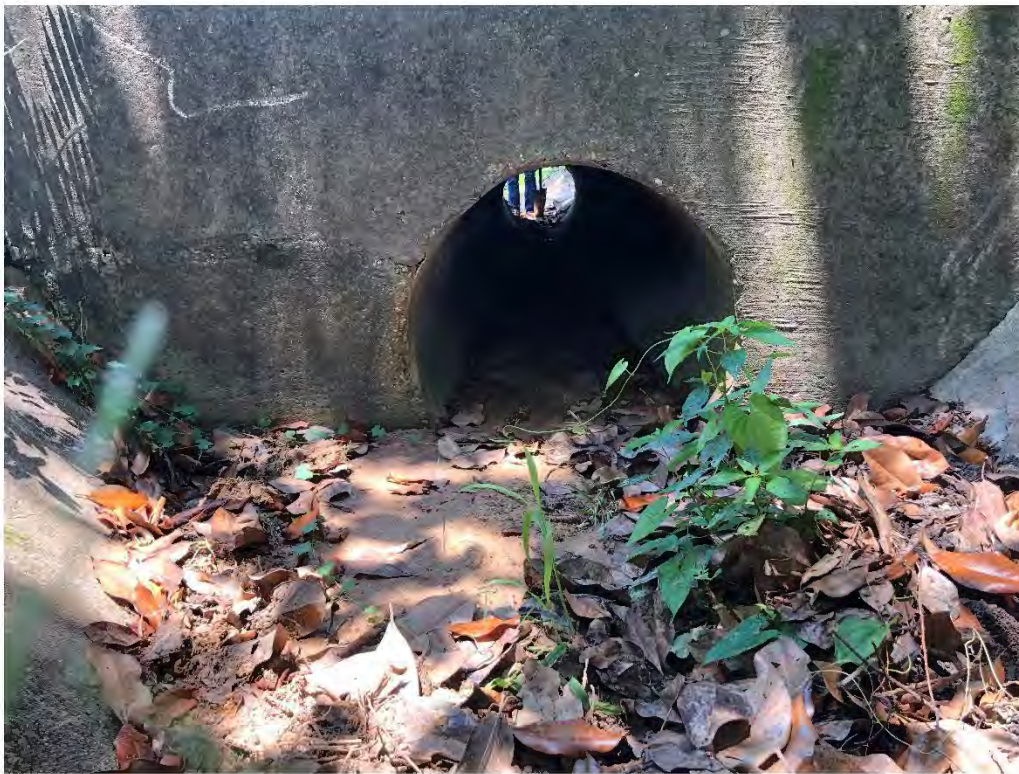
Figure 9666:
Photo taken of a concrete ditch with moderate debris along Oak St.

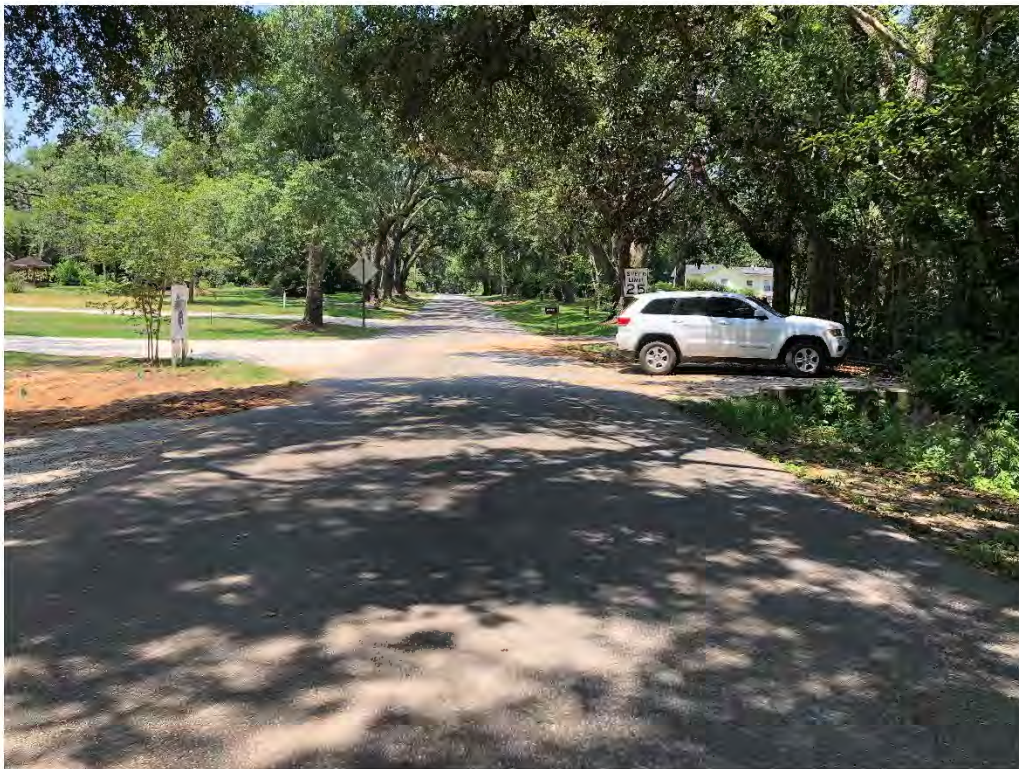
Figure 9670:
Photo taken facing West toward Oak St.

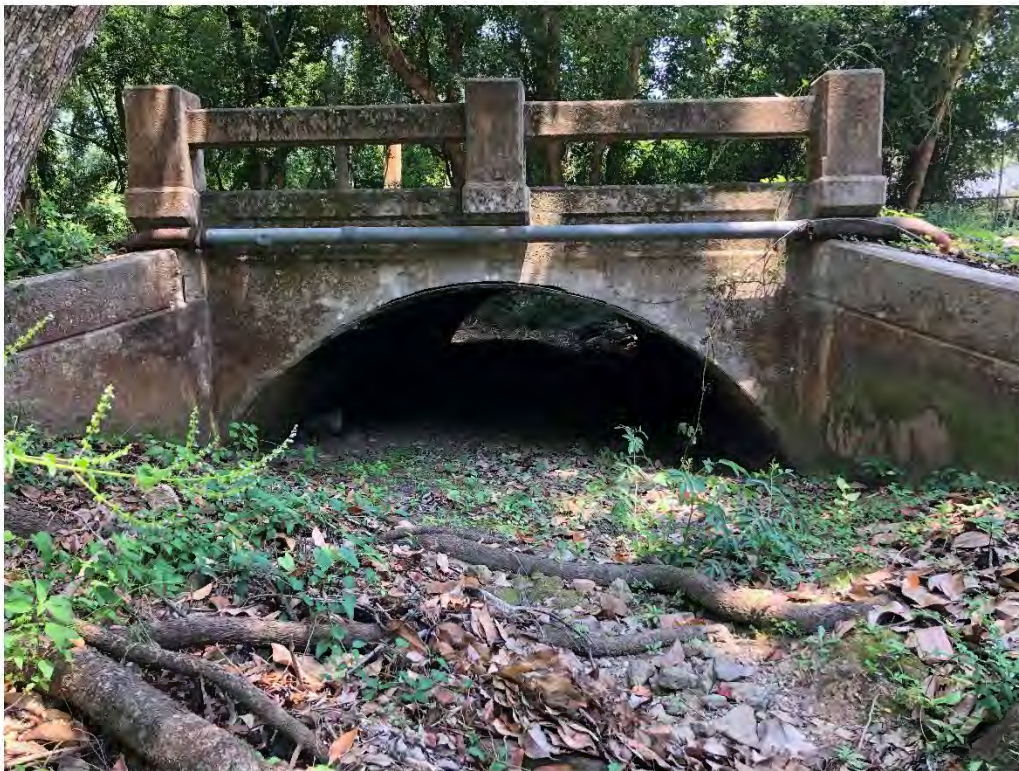
Figure 9675:
Photo taken facing North toward a very silted OAK-CO-27 along Oak St.

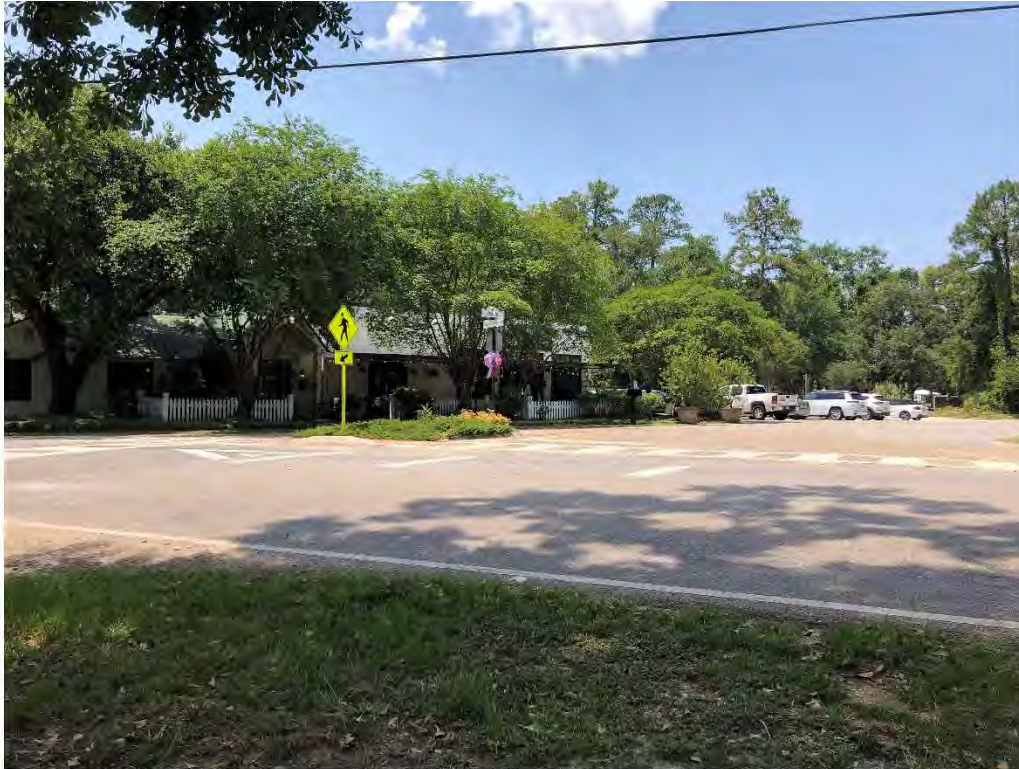
Figure 9683:
Photo taken facing SW toward HWY 49 near Jesse's Restaurant.

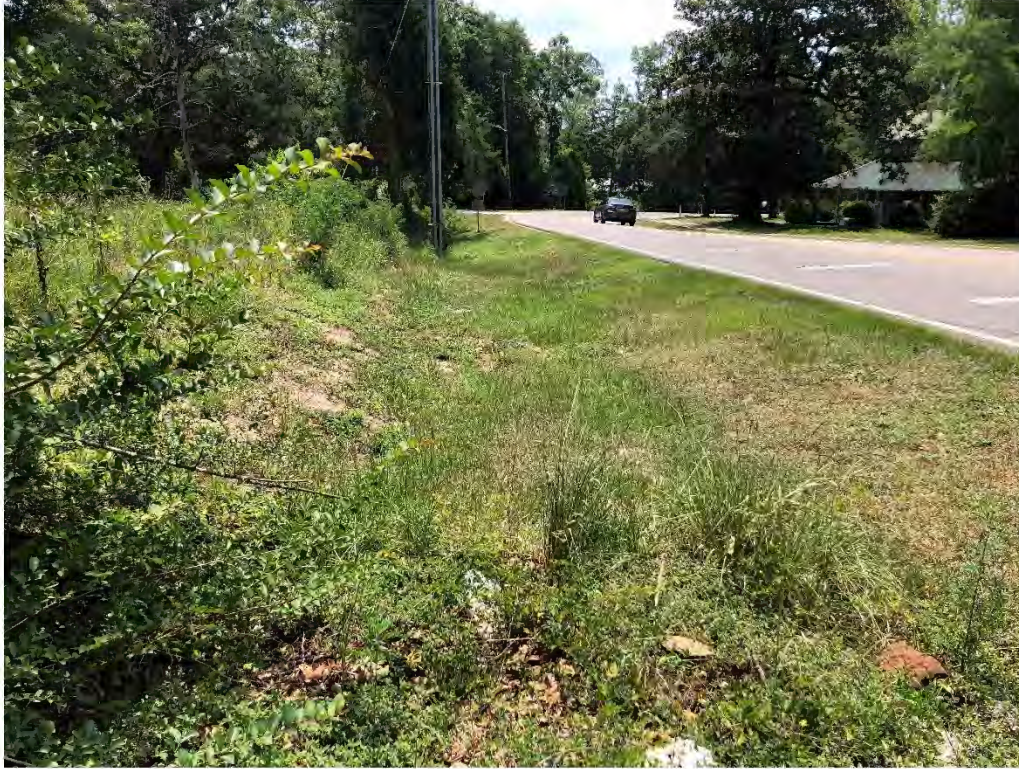
Figure 9686:
Photo taken facing South toward MN-CH-21 along HWY 49.

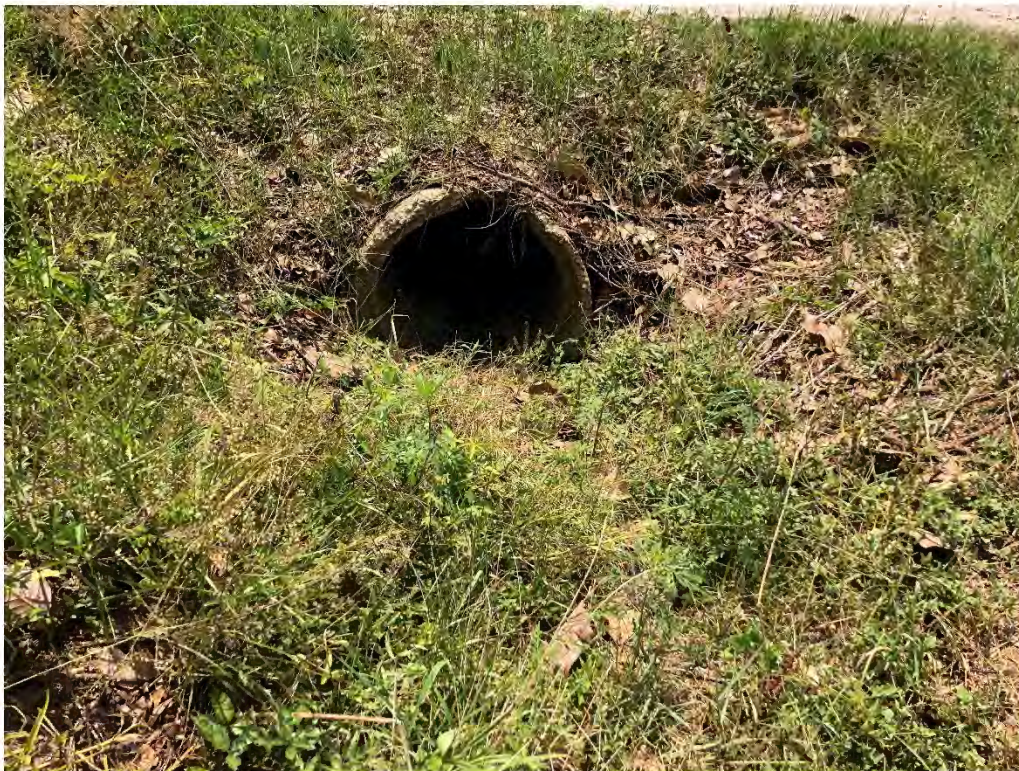
Figure 9687:
Photo taken of MN-CO-18 at the intersection of HWY 49 and a driveway.

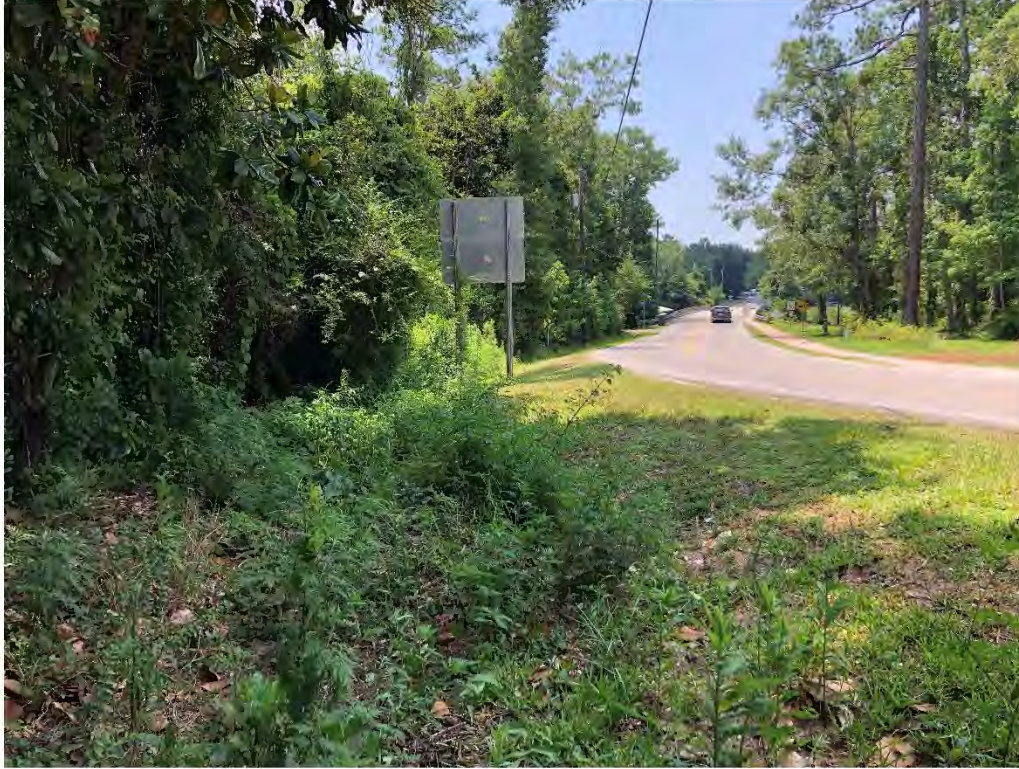
Figure 9690:
Photo taken facing South toward MN-CH-22 along HWY 49.

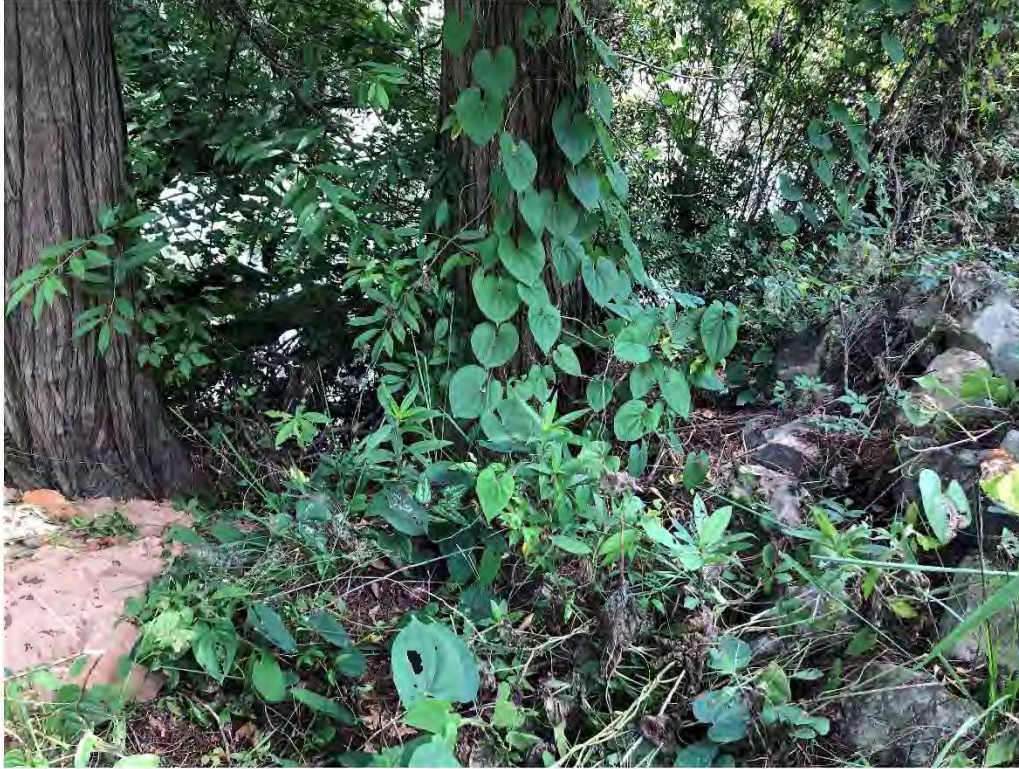
Figure 9693:
Photo taken facing South toward MN-CH-23 along HWY 49.

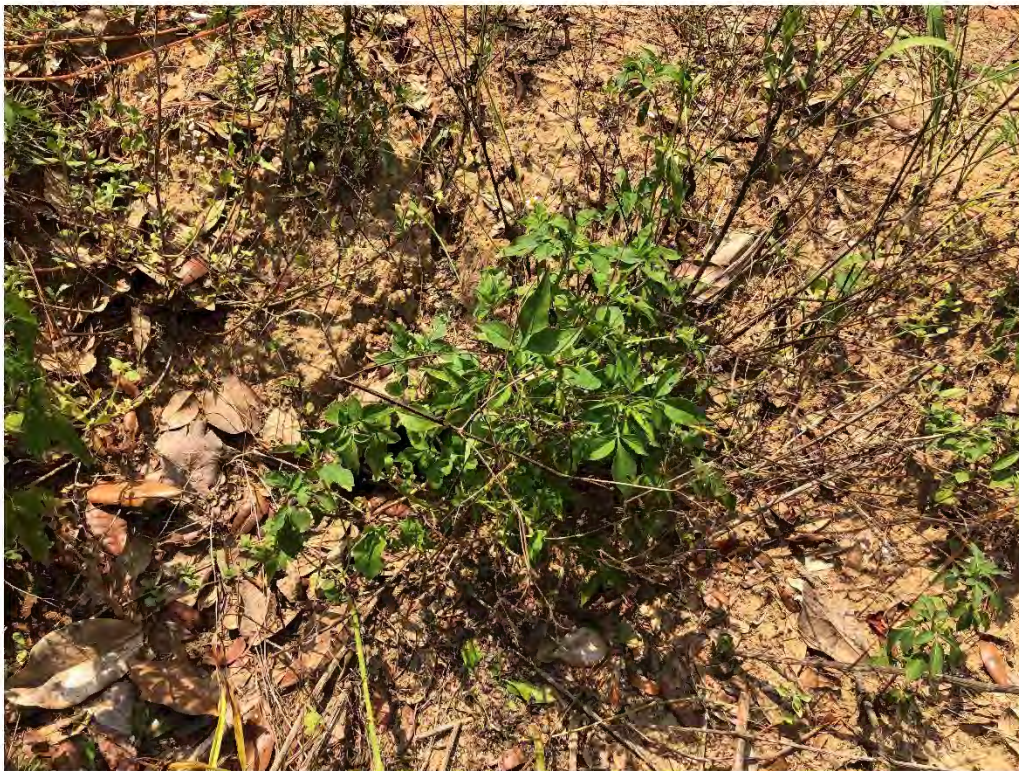
Figure 9700:
Photo taken facing North toward MS-CO-1 at the intersection of HWY 49 and Richards Ln.

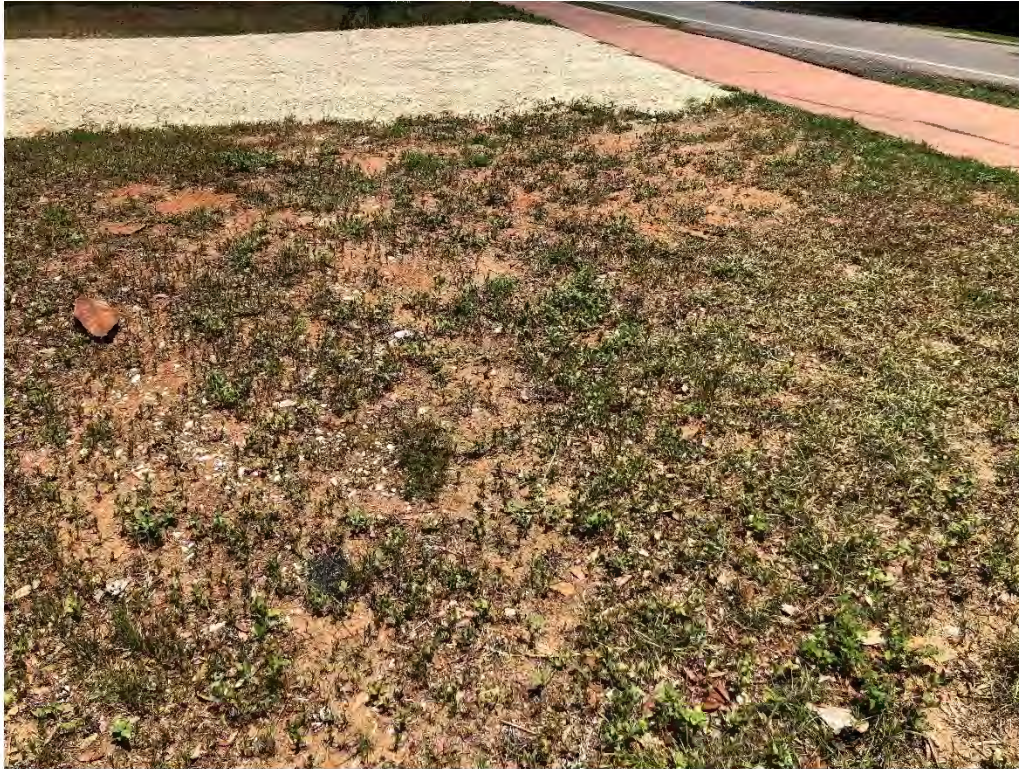
Figure 9701:
Photo taken facing South toward a silted MS-CO-1 at the intersection of HWY 49 and Richards Ln.
