Town of Magnolia Springs Comprehensive Drainage Masterplan

Town of Magnolia Springs
Magnolia Springs, Baldwin County, Alabama

VOLKERT

March 2023

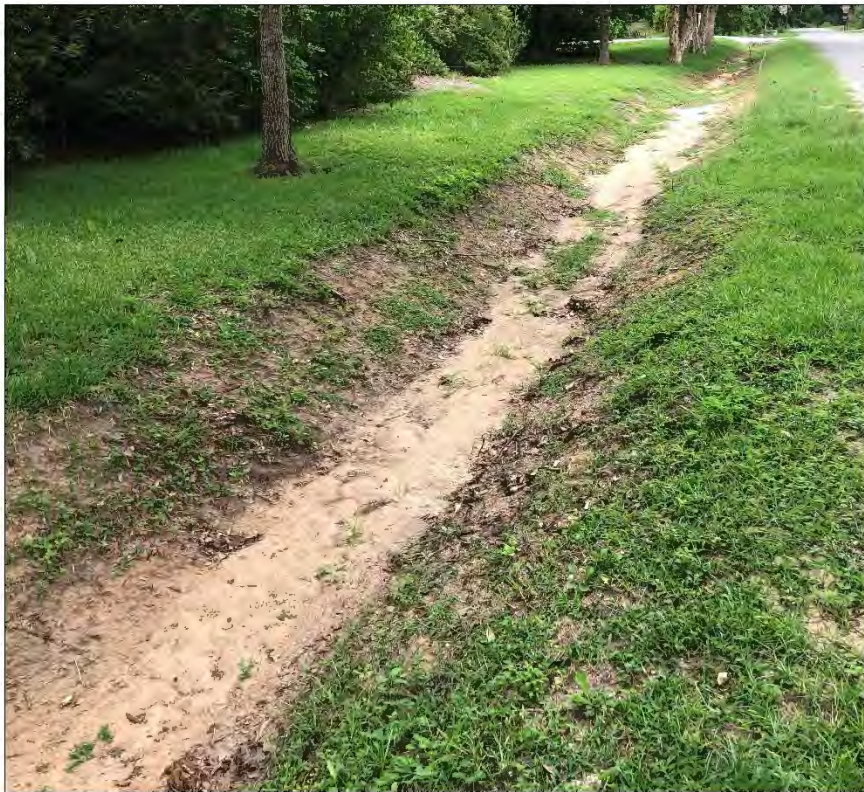
Figure 4. General view of eroding ditch.

Category 2 improvements are items that should be completed in the near future but are not an immediate concern. These improvements include pipe replacements, pipe end treatments and ditch regrading to provide adequate flow capacity and minimize erosion and siltation. Figures 3-5 below show examples of areas where category 2 improvements are recommended.

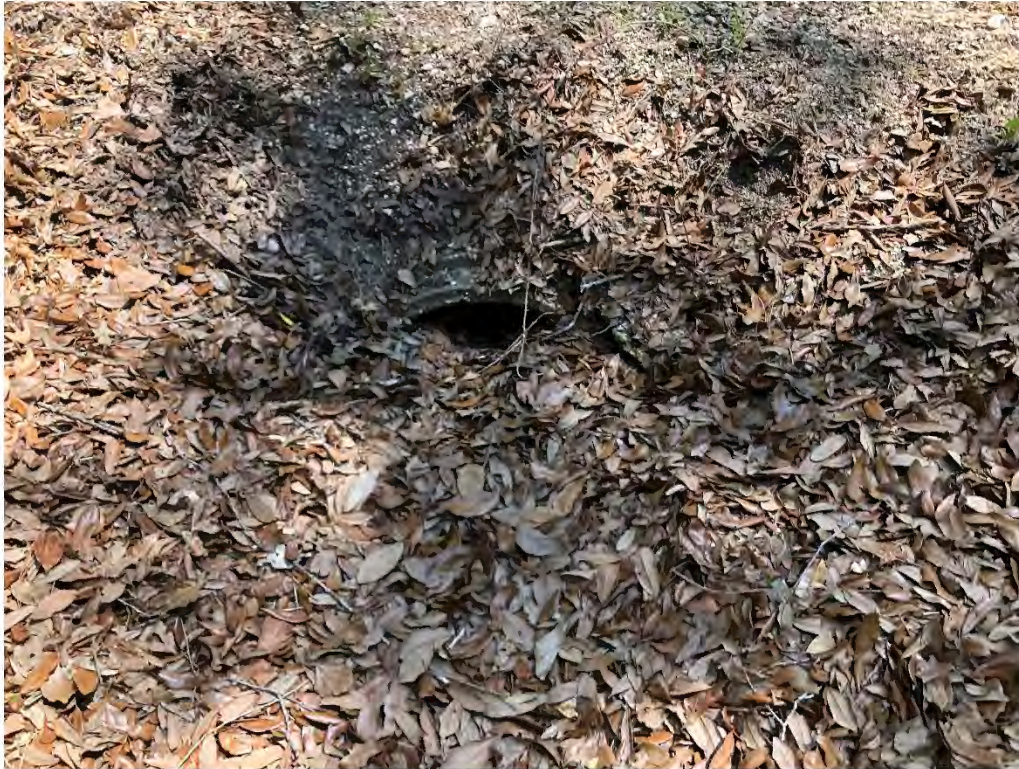
Figure 9039:

Photo taken facing South toward a silted W-CO-2 at the intersection of Woodland Ave and a driveway.

It is recommended to provide maintenance of silted in pipes and ditches, as noted in the photo pages provided in Appendix C. In addition to general maintenance of existing infrastructure, the proposed drainage improvements were consolidated into projects based on category and location. The projects were then ranked based on priority using a MCDA Matrix. All proposed improvements and correlating projects are provided in detail in Appendix H and the proposed projects are summarized below.

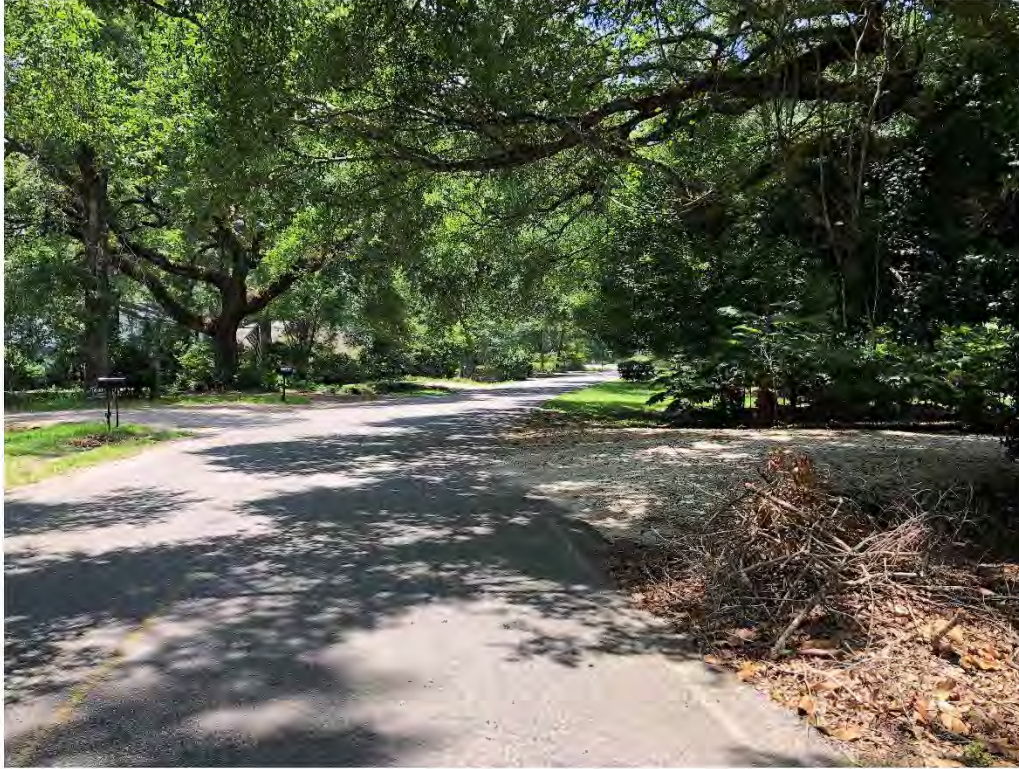
Figure 9084:
Photo taken facing West toward P-CH-36 along Oak St.

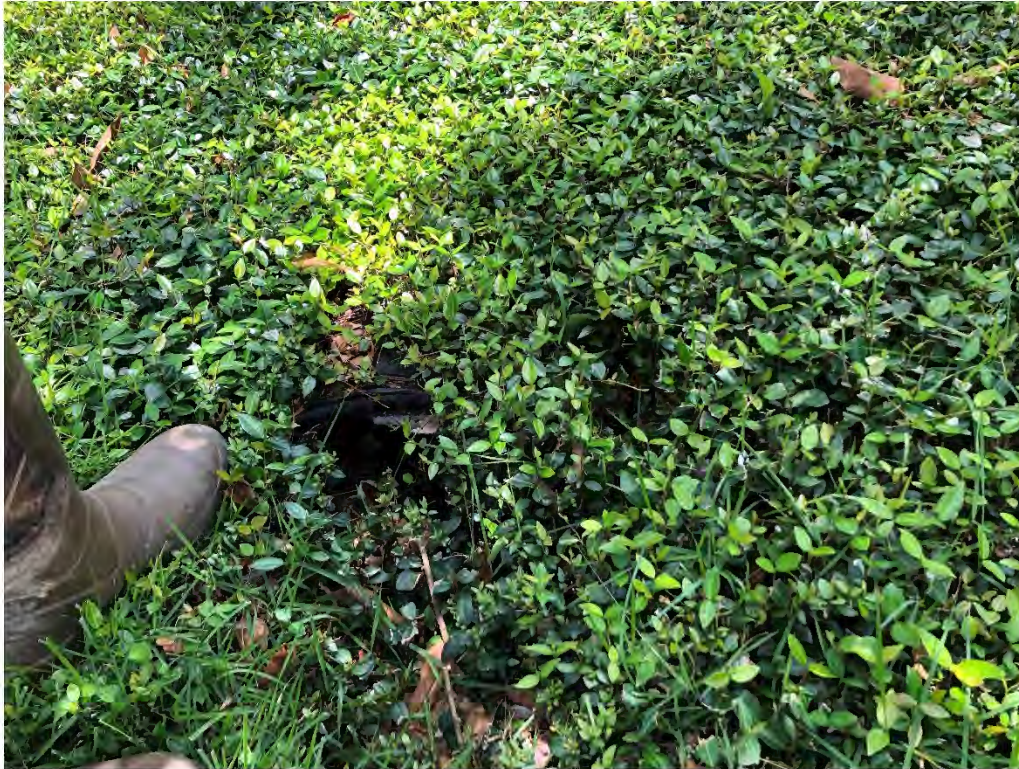
Figure 9088:
Photo taken facing East toward an overgrown P-CO-26 along Oak St.

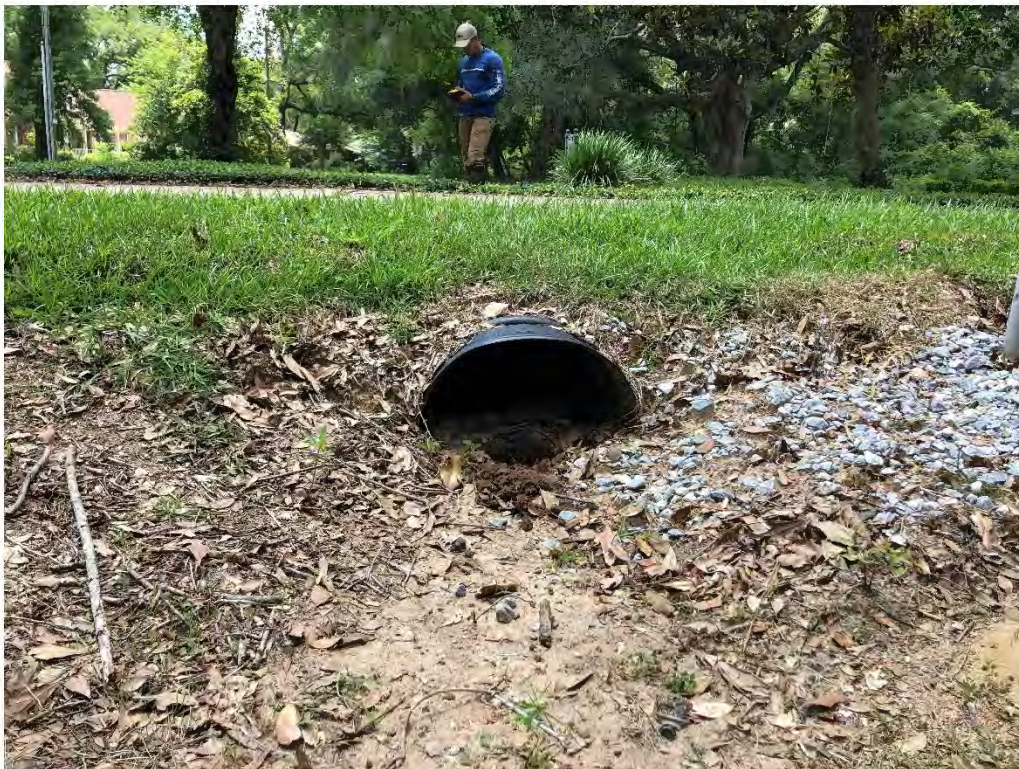
Figure 9089:
Photo taken facing West toward a silted P-CO-26 along Oak St.

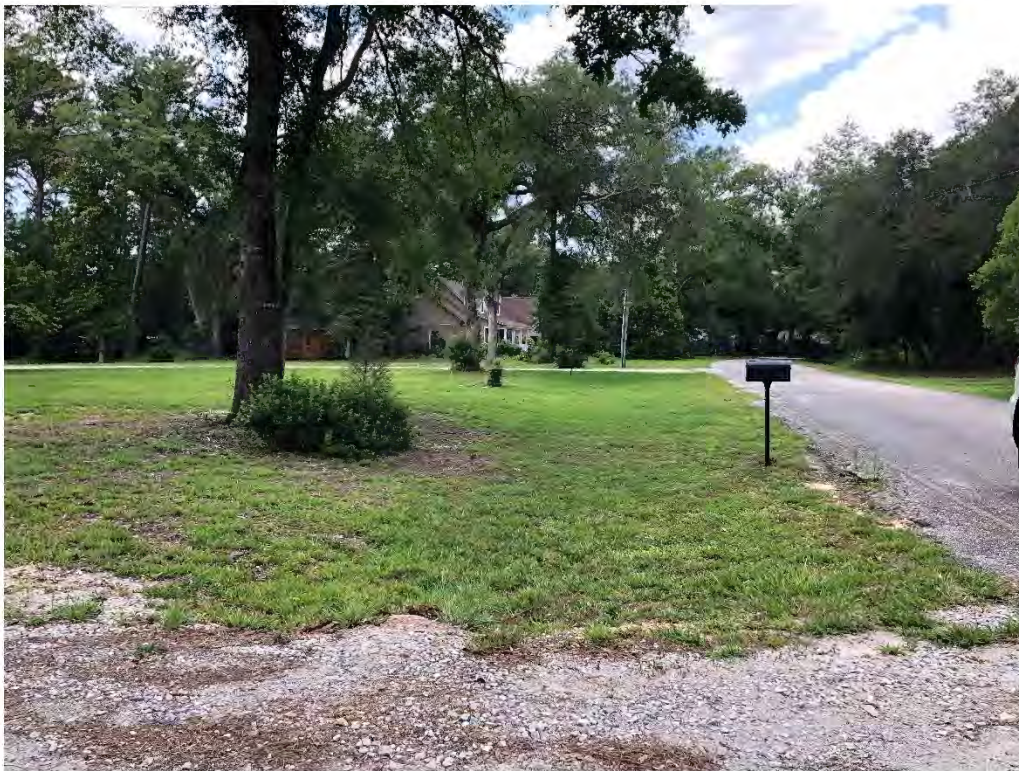
Figure 9096:
Photo taken of a very silted P-CO-26 along Oak St.

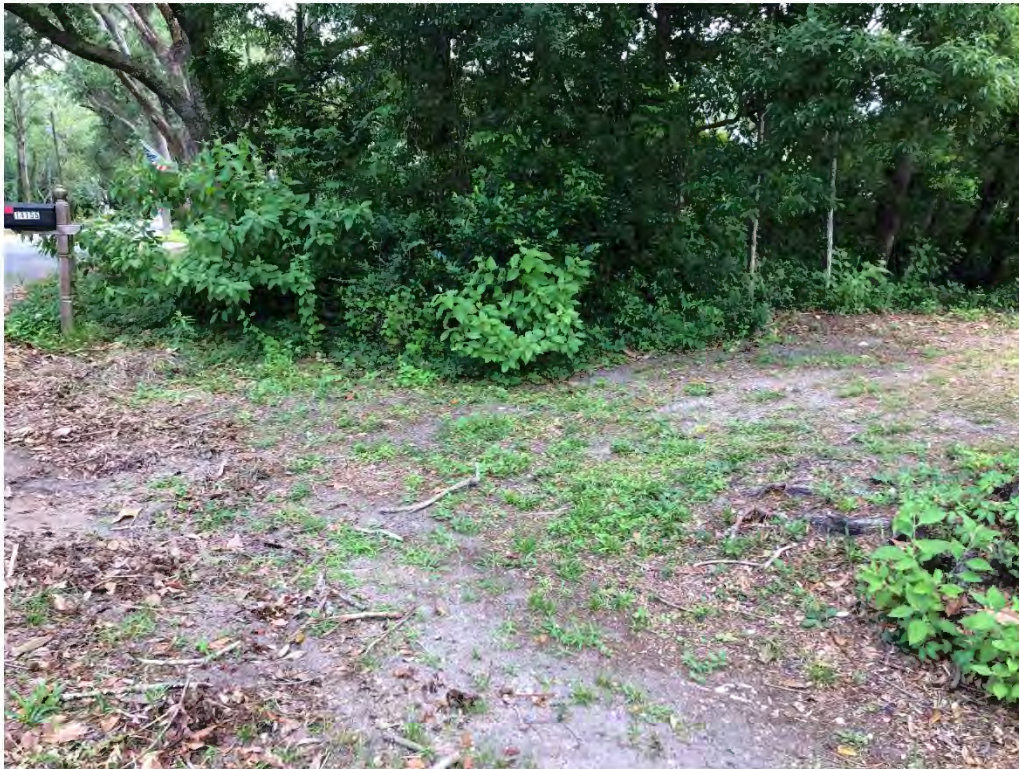
Figure 9098:
Photo taken facing South toward a gravel-filled P-CH-29 along Oak St.

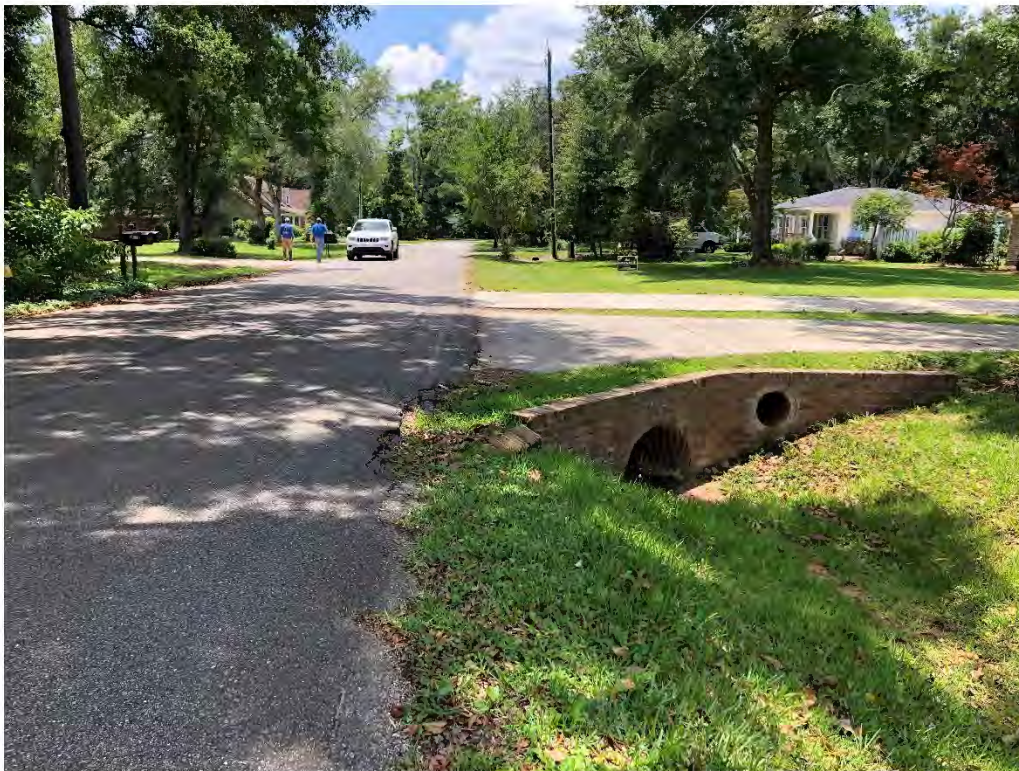
Figure 9104:
Photo taken facing East toward the grassed P-CH-26 along Oak St.

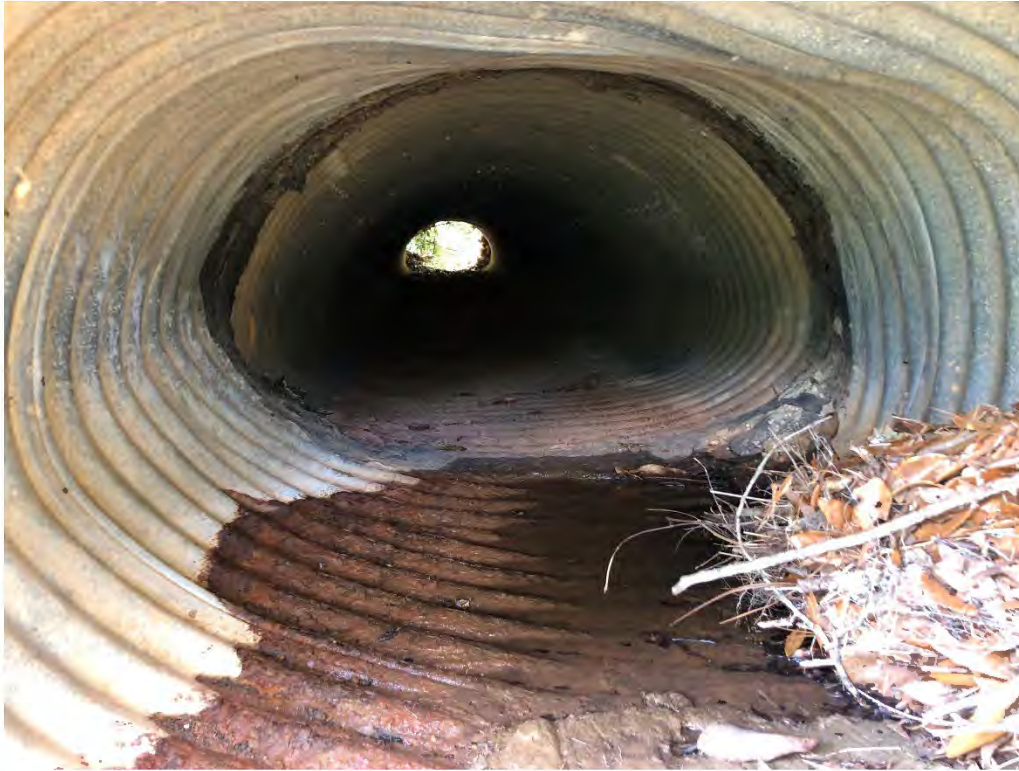
Figure 9112:
Photo taken facing West toward a crushed corrugated metal P-CH-28 along Oak St.

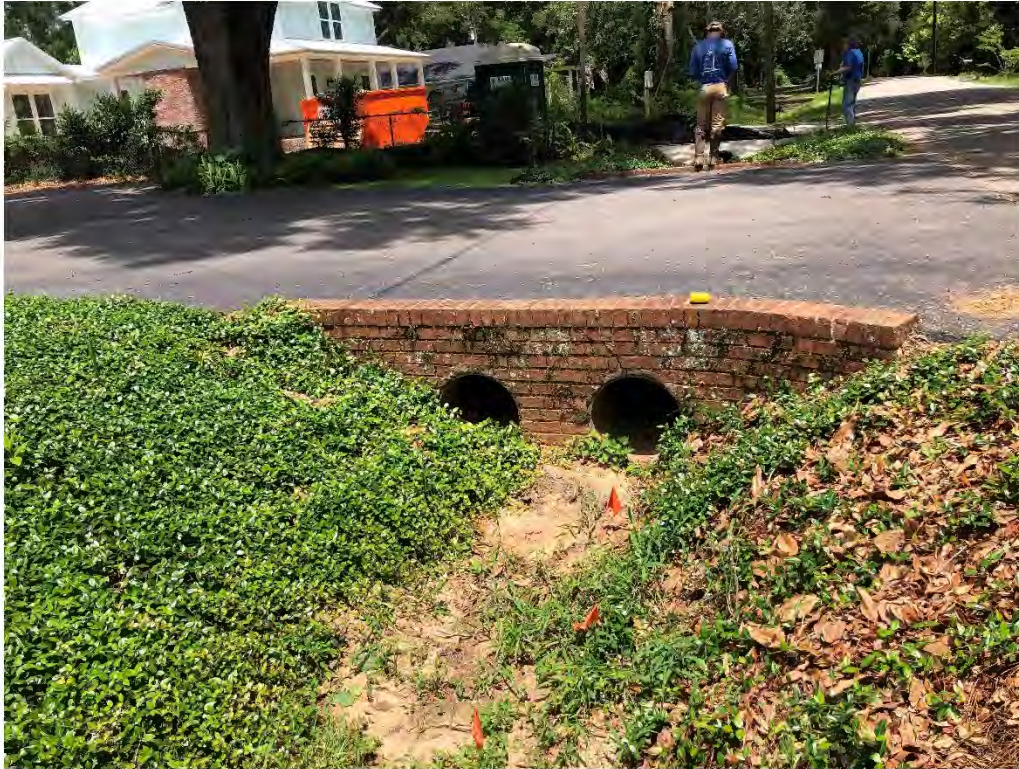
Photo taken facing North toward an overgrown P-CO-28 along Oak St.

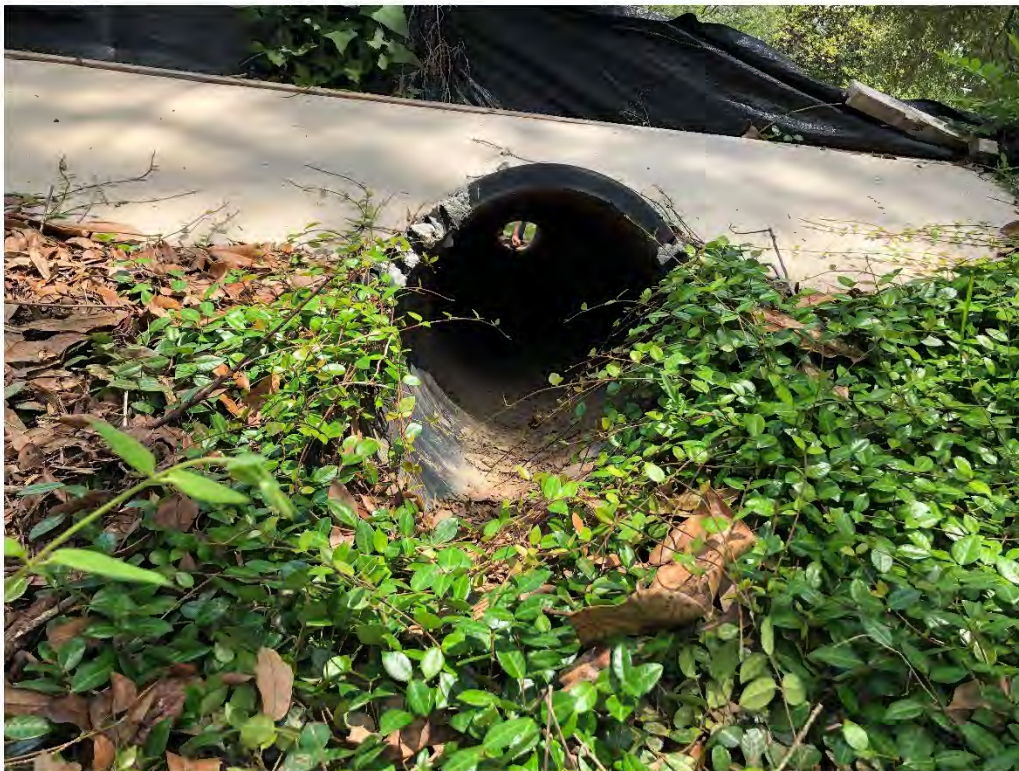
Figure 9120:
Photo taken facing West toward an overgrown P-CO-24 along Oak St.

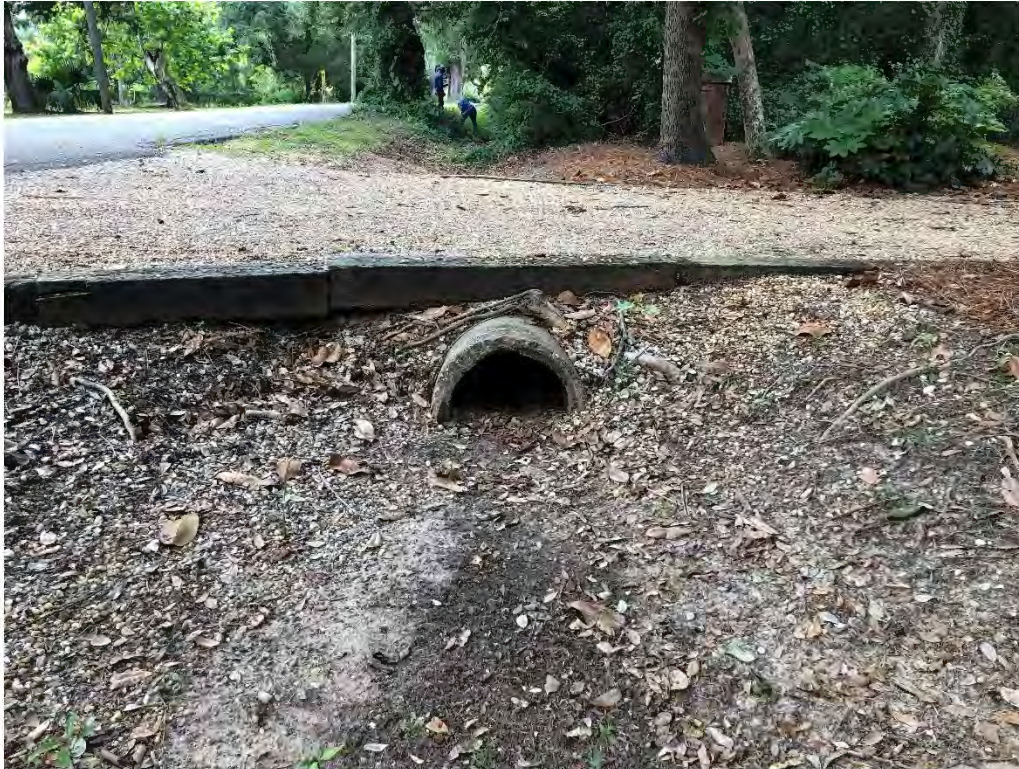
Figure 9145:
Photo taken facing West toward a silted P-CO-20 along Oak St.

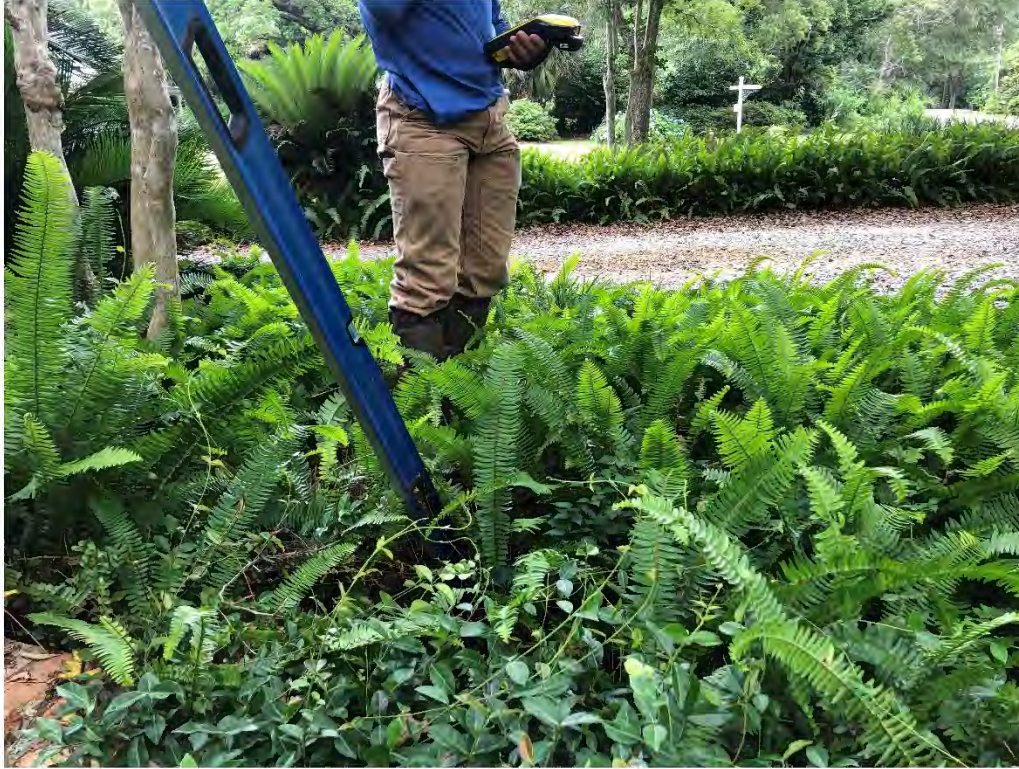
Figure 9149:
Photo taken facing East toward an overgrown P-CO-20 along Oak St.

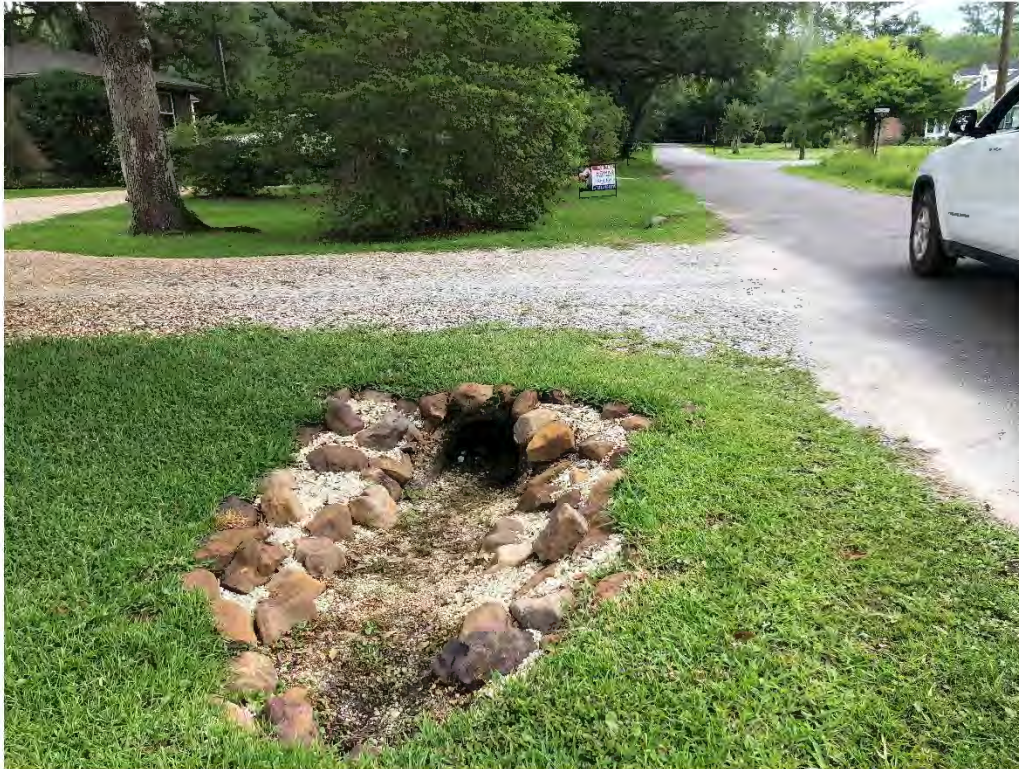
Figure 9154:
Photo taken facing NE toward a silted BB-CO-14 along Island Ave.

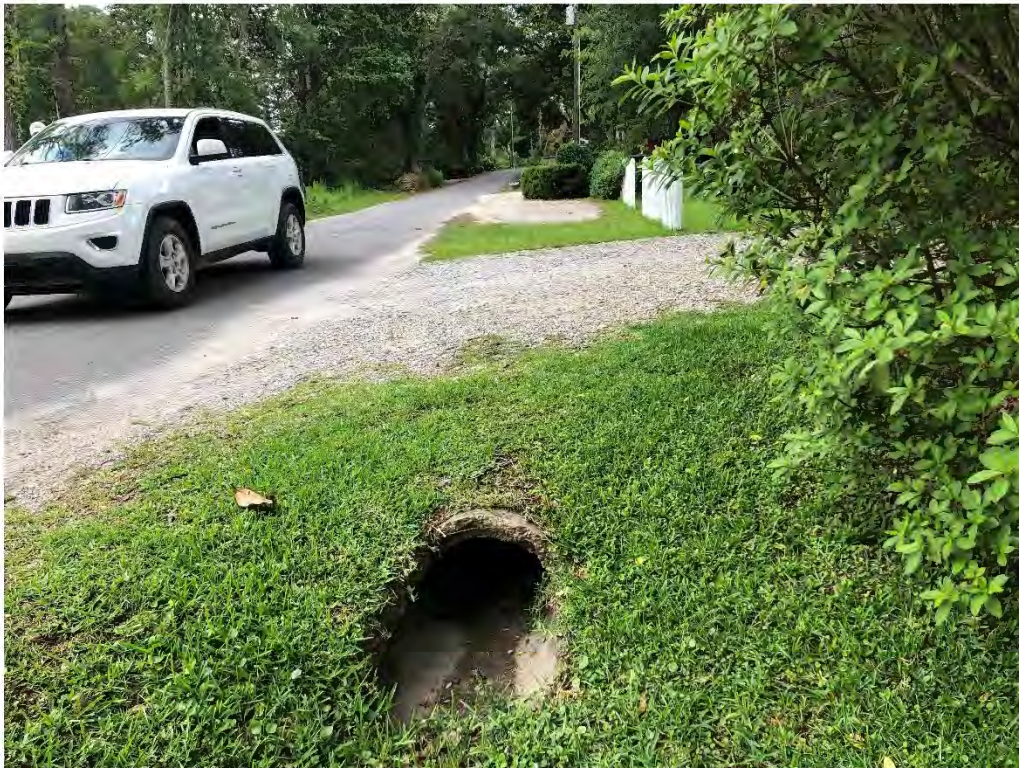
Figure 9155:
Photo taken facing SW toward a silted BB-CO-14 along Island Ave.

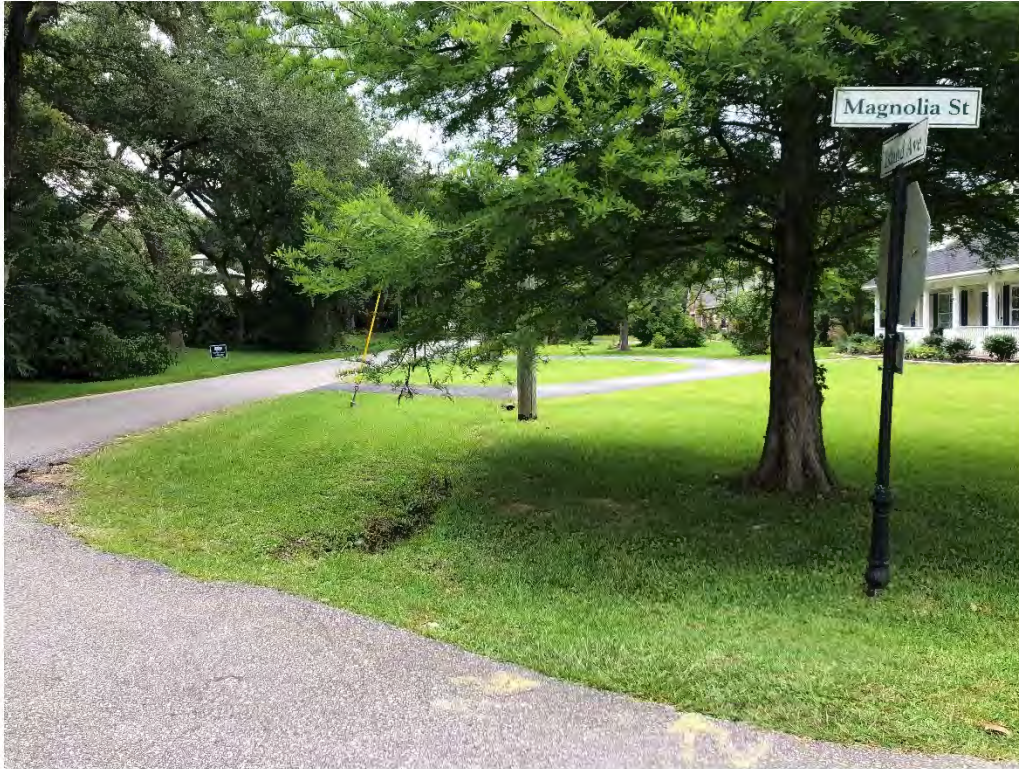
Figure 9159:
Photo taken facing NE toward a grassed BB-CH-14 along Island Ave.

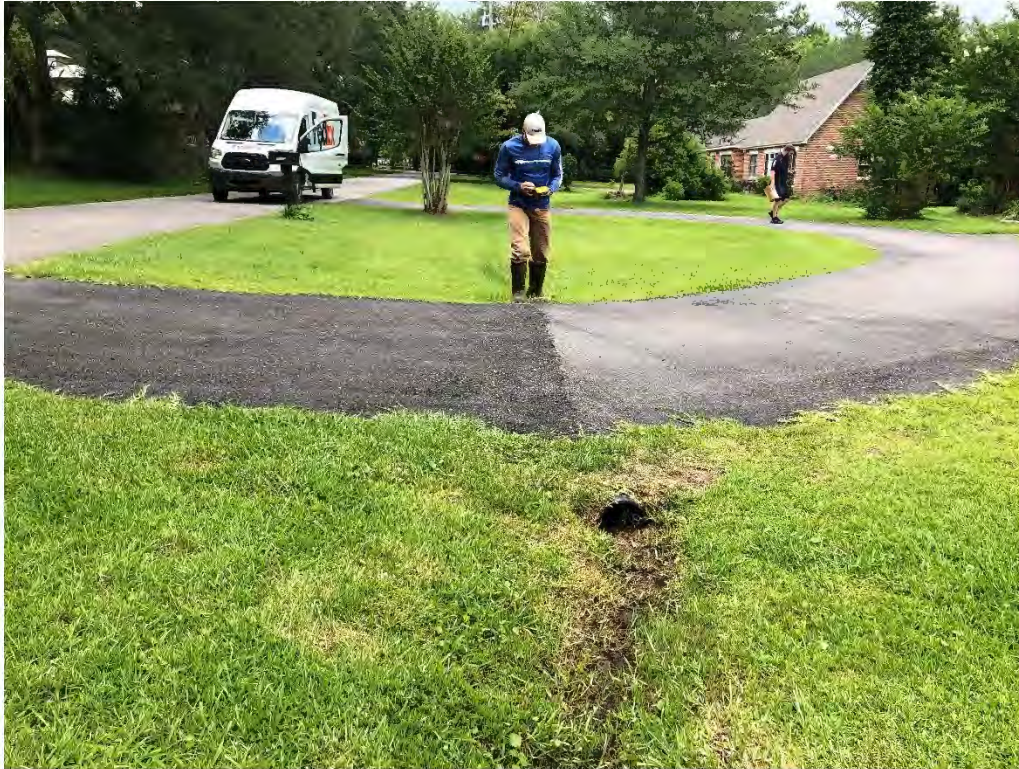
Figure 9161:
Photo taken facing NE toward an overgrown BB-CO-16 along Island Ave.

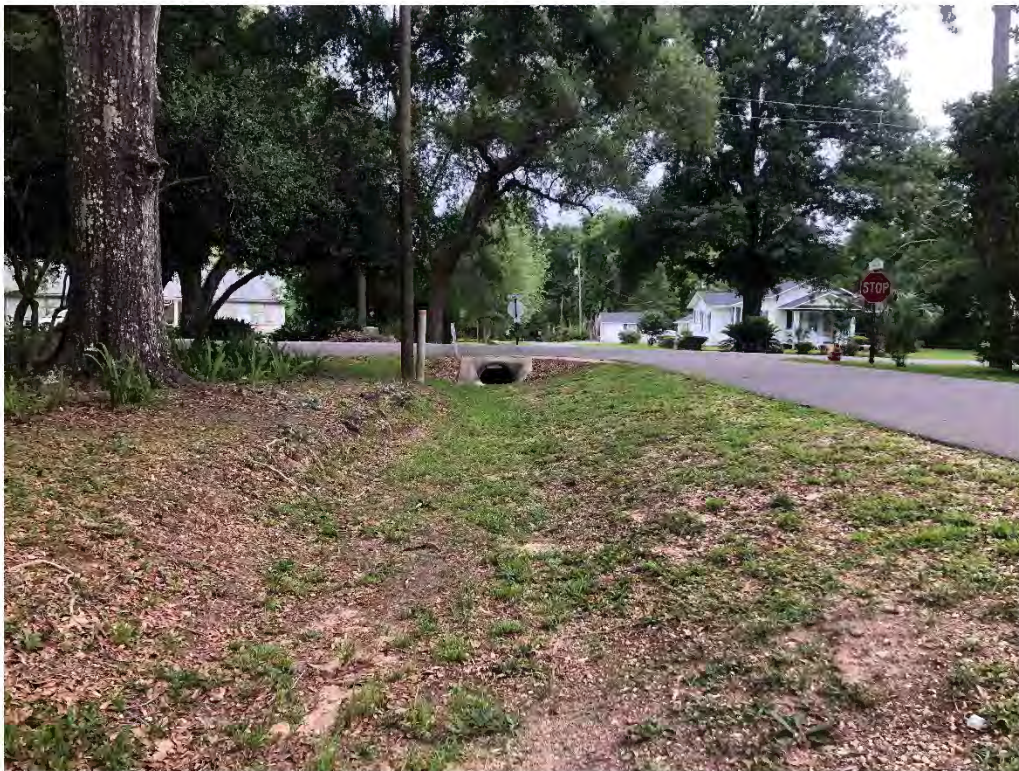
Figure 9194:
Photo taken facing South toward BB-CO-7 at the intersection of Oak St. and Bay St.

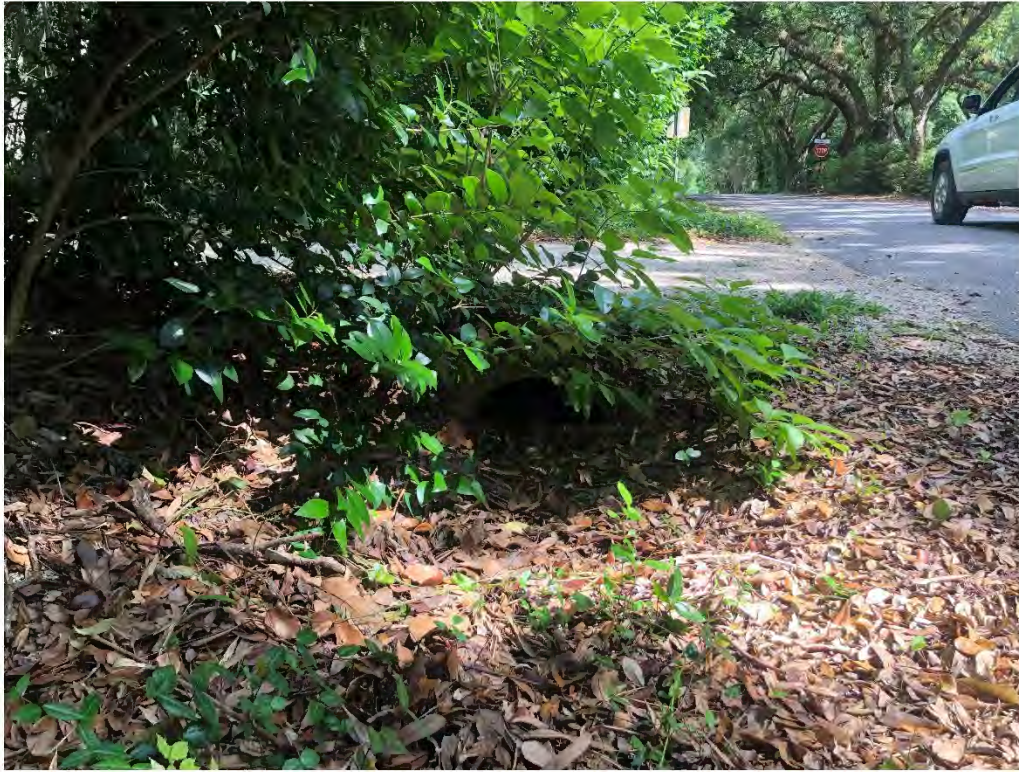
Figure 9225:
Photo taken of the intersection of Oak St and Jessamine St.

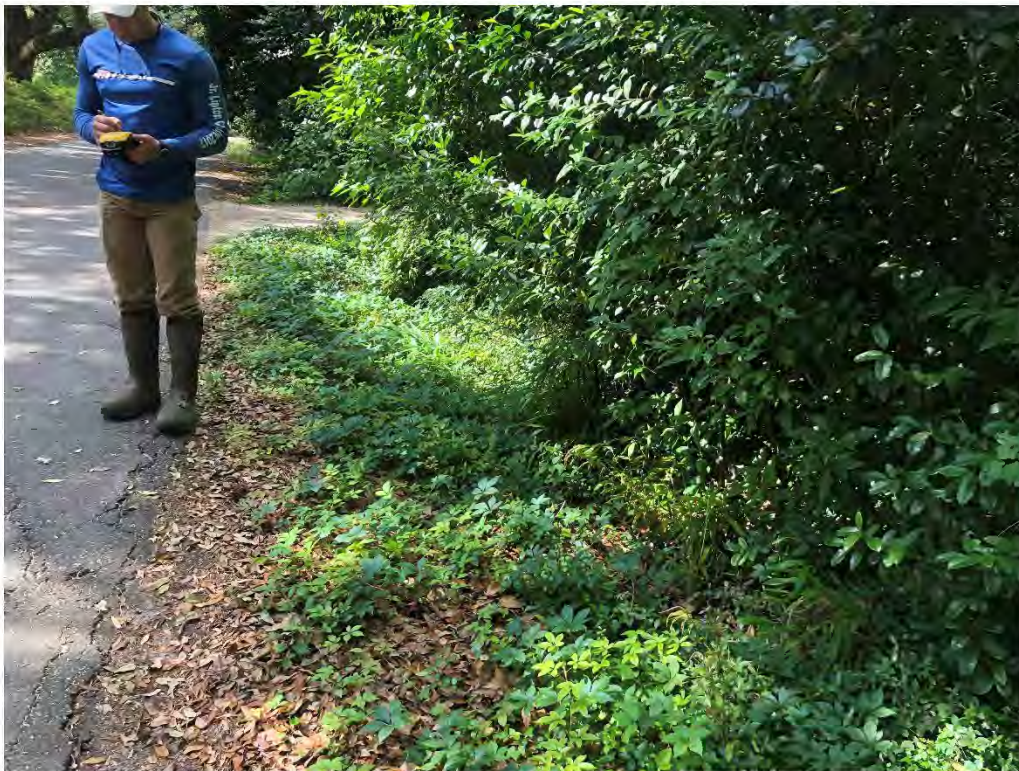
Figure 9227:
Photo taken facing South toward the intersection of Oak St and Jessamine St.

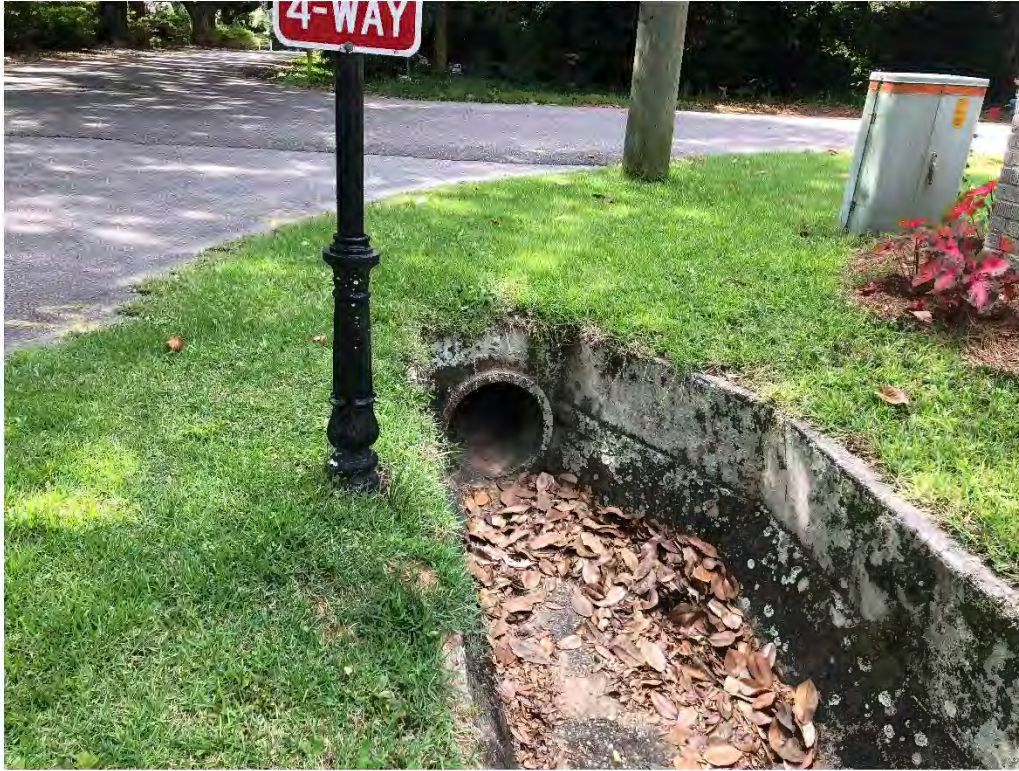
Figure 9228:
Photo taken facing South toward J-CO-3 at the intersection of Oak St and Jessamine St.

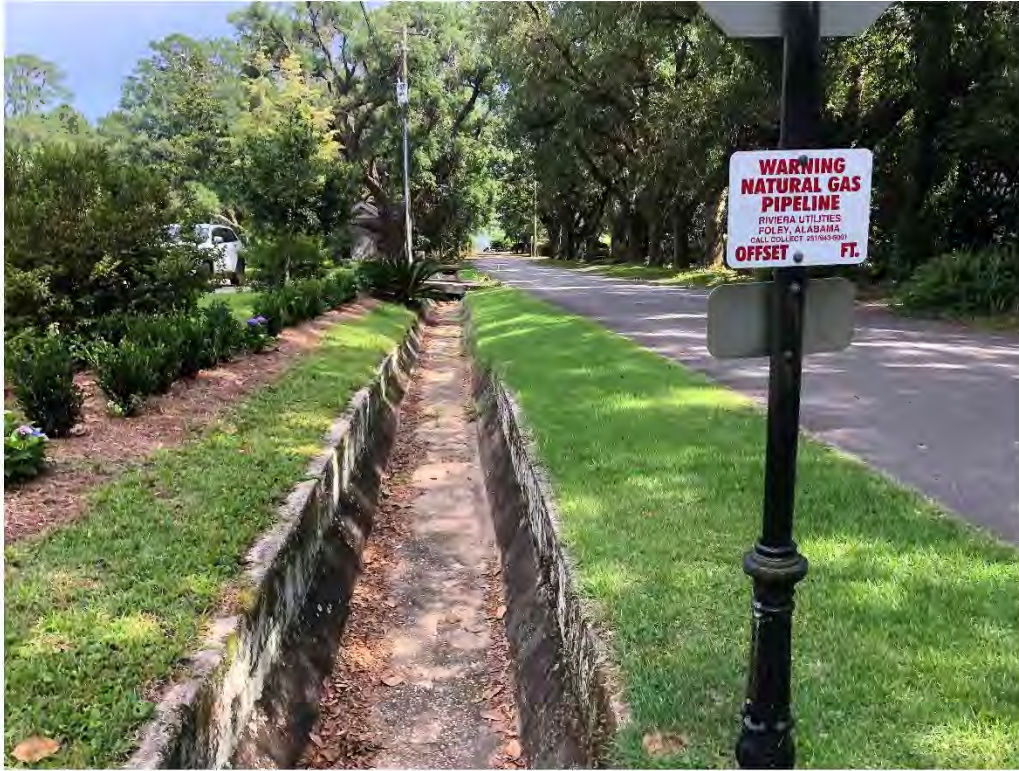
Figure 9230:
Photo taken facing South toward CH-200 along Jessamine St.

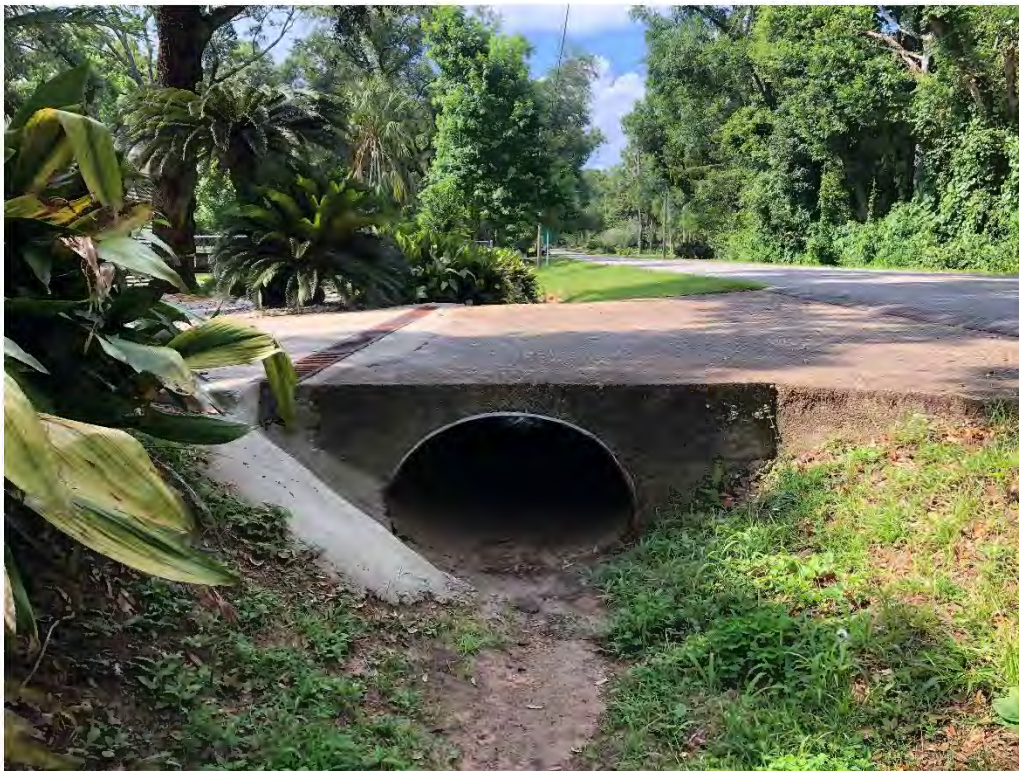
Figure 9233:

Photo taken facing North toward P-CO-18 at the intersection of Pecan Grove St and a residential driveway.

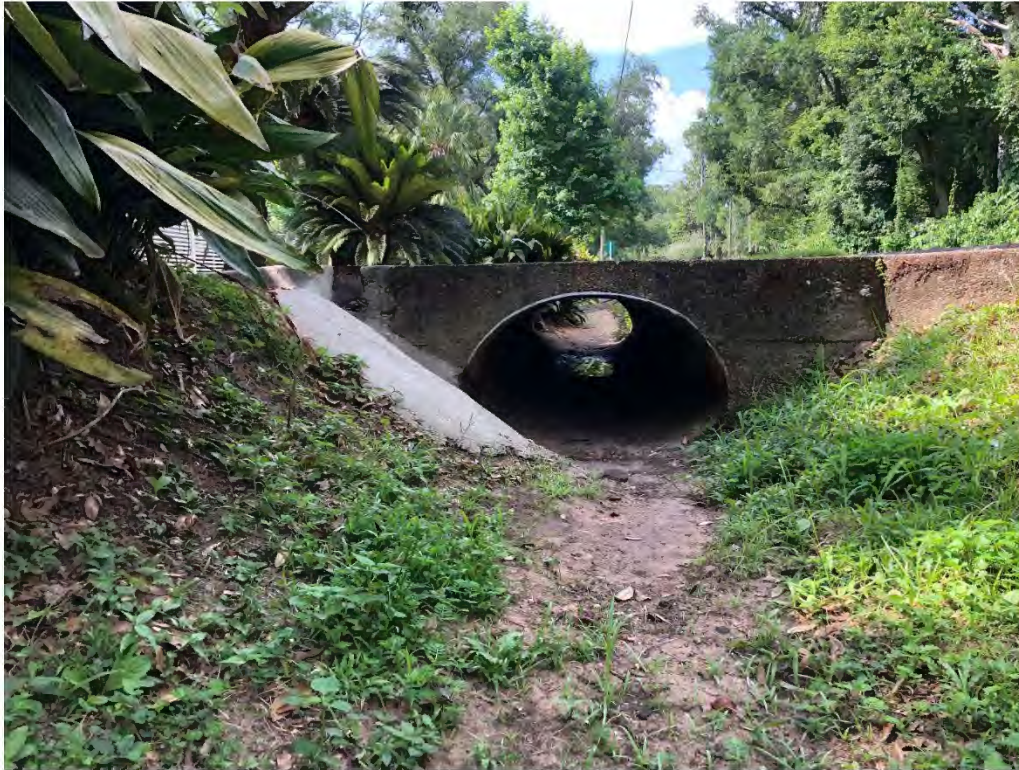
Figure 9234:

Photo taken facing North toward P-CO-19 at the intersection of Pecan Grove St and a residential driveway.

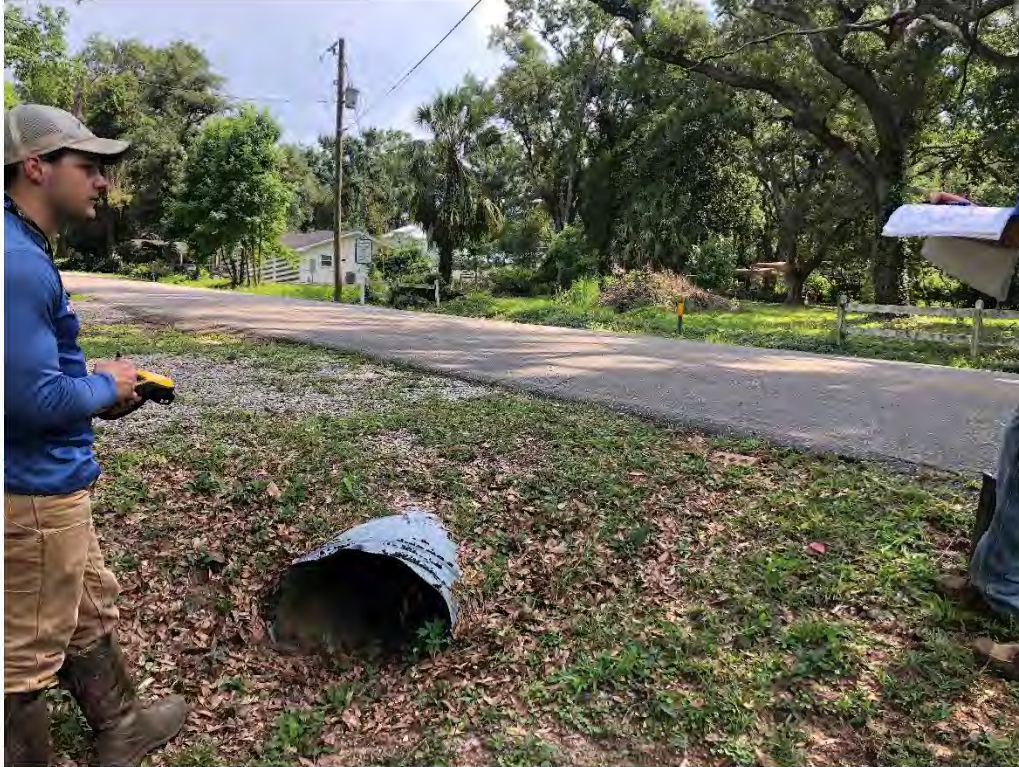
Figure 9240:
Photo taken facing SW toward a silted P-CO-17 along Pecan Grove St.

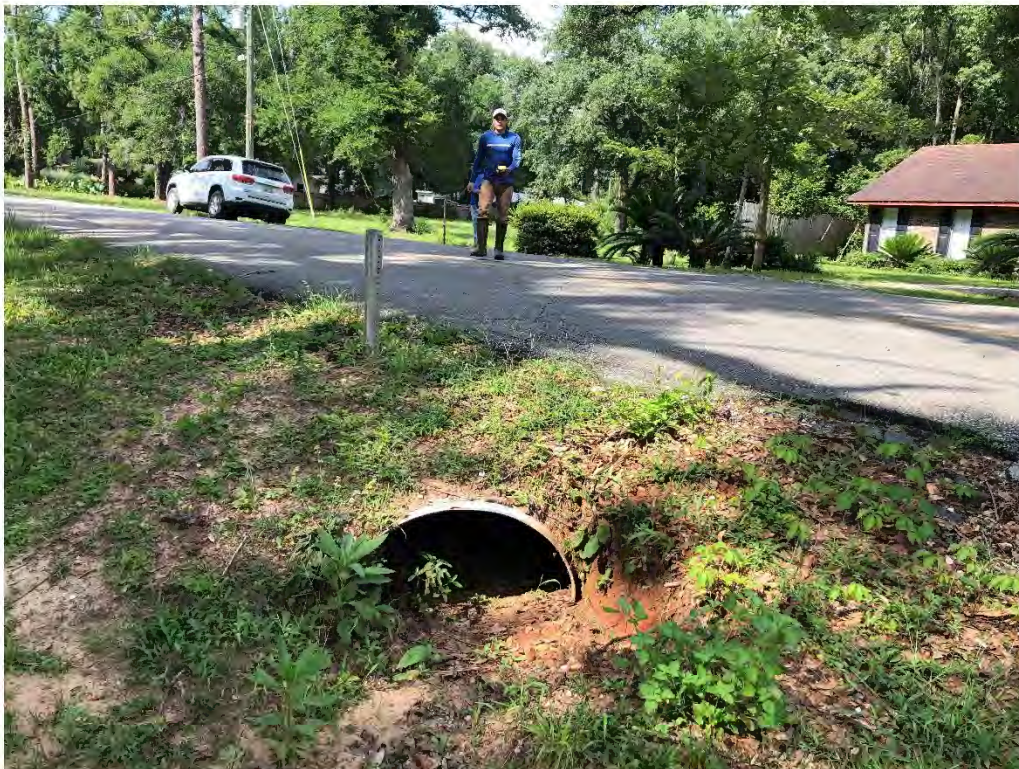
Figure 9242:
Photo taken facing SW toward a silted P-CO-17 along Pecan Grove St.

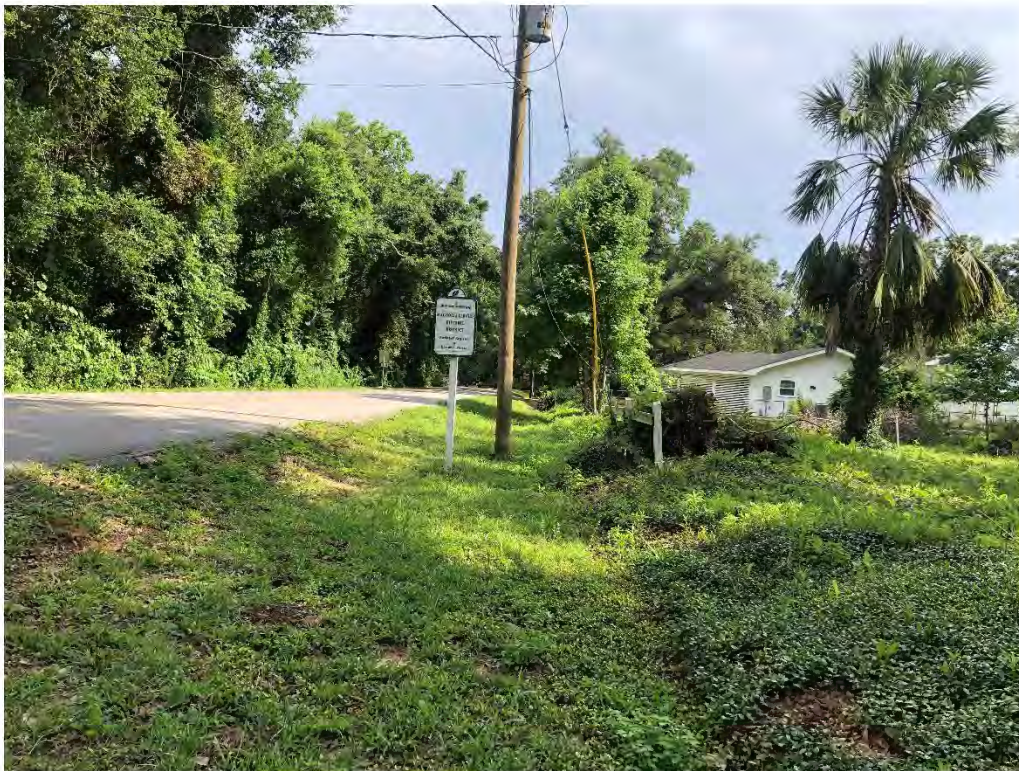
Figure 9244:
Photo taken facing South toward P-CH-19 along Pecan Grove St.

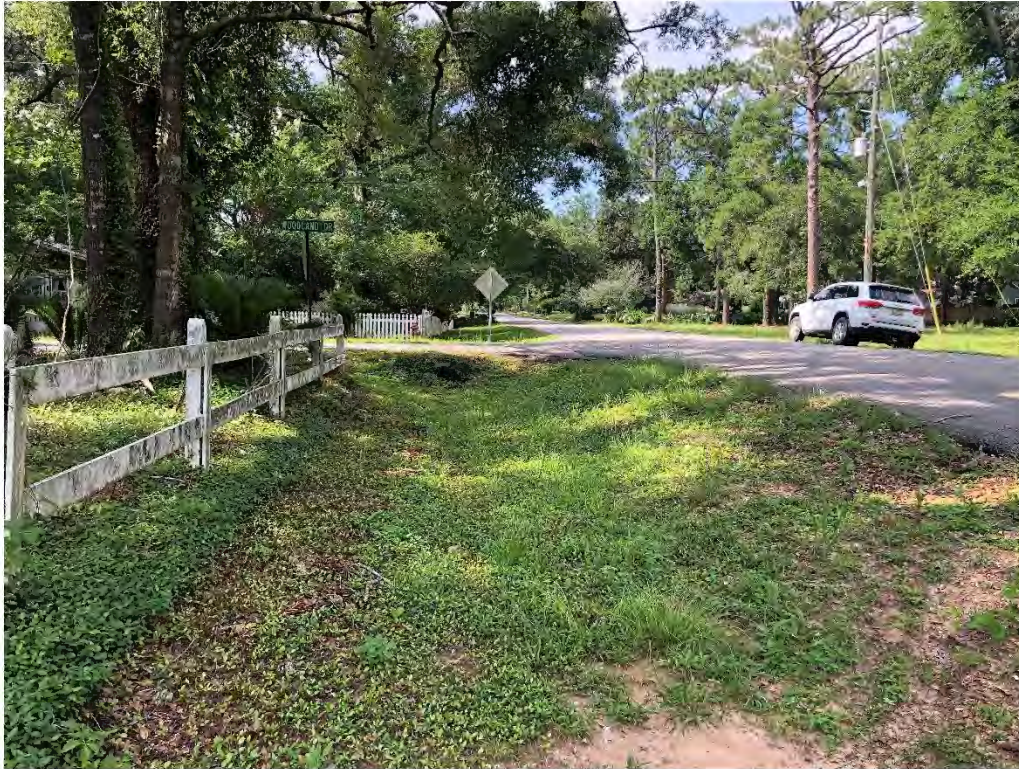
Figure 9245:
Photo taken facing North toward P-CH-18 at the intersection of Pecan Grove St and Woodland Ave.
