Town of Magnolia Springs Comprehensive Drainage Masterplan

Town of Magnolia Springs
Magnolia Springs, Baldwin County, Alabama

VOLKERT

March 2023

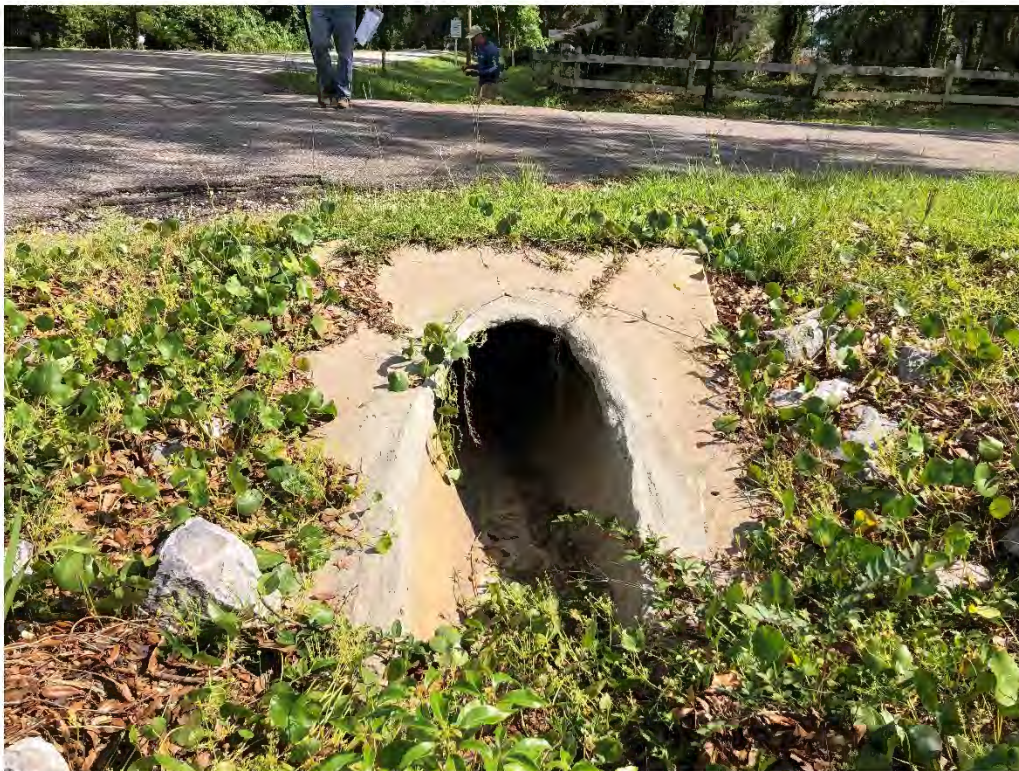
Figure 9247:
Photo taken facing South toward P-CH-18 at the intersection of Pecan Grove St and Woodland Ave.

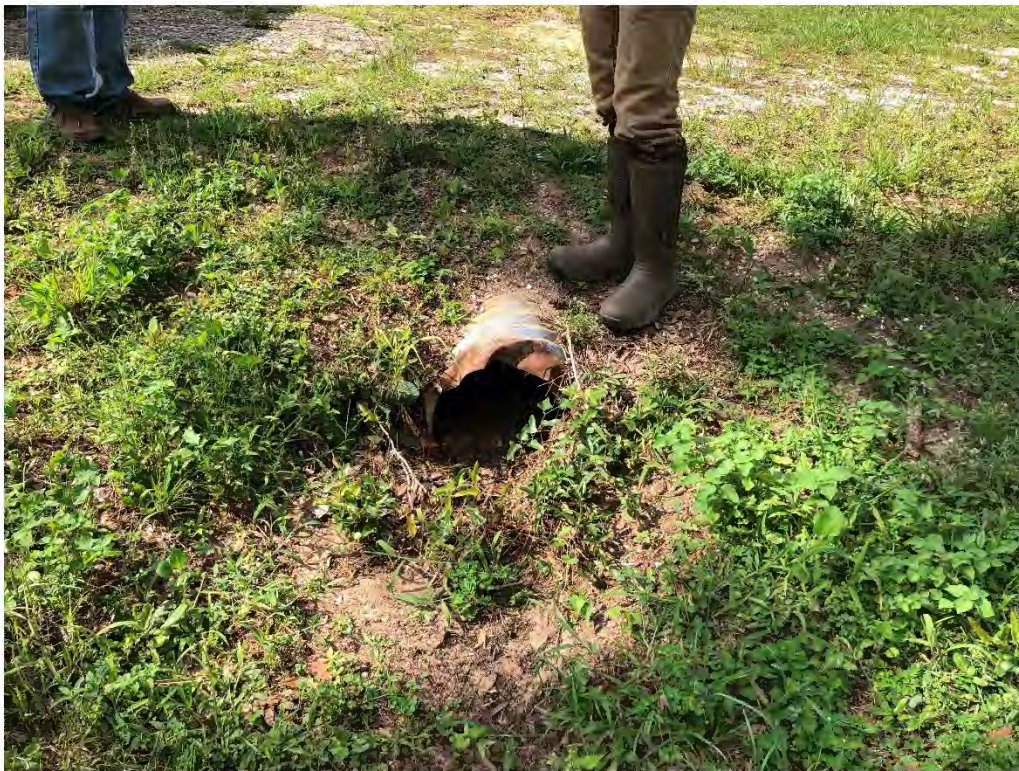
Figure 9252:
Photo taken facing North toward P-CO-15 along Pecan Grove St.

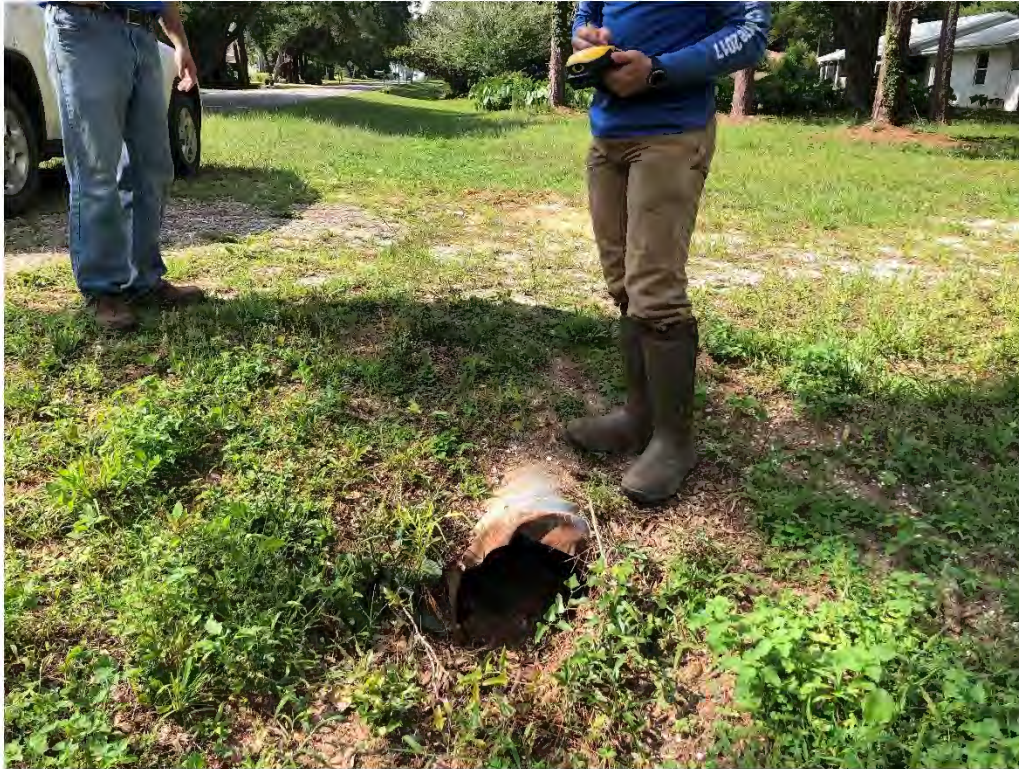
Figure 9253:
Photo taken facing North toward P-CO-15 along Pecan Grove St.

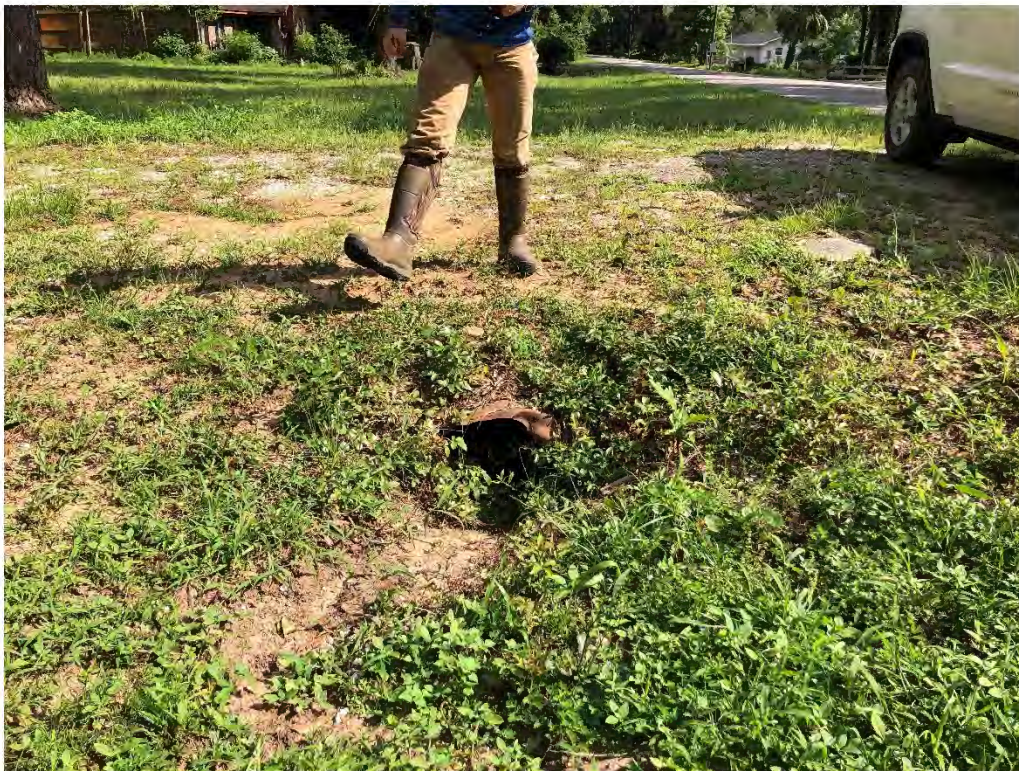
Figure 9254:
Photo taken facing South toward P-CO-15 along Pecan Grove St.

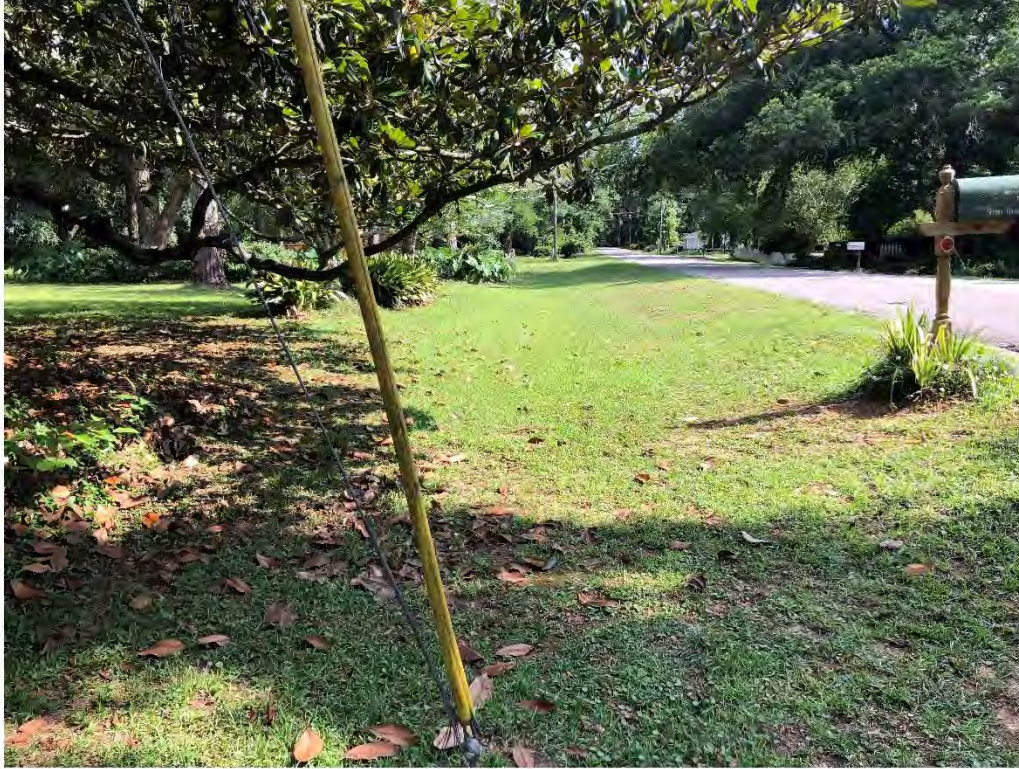
Figure 9255:
Photo taken facing South toward P-CH-17 along Pecan Grove St.

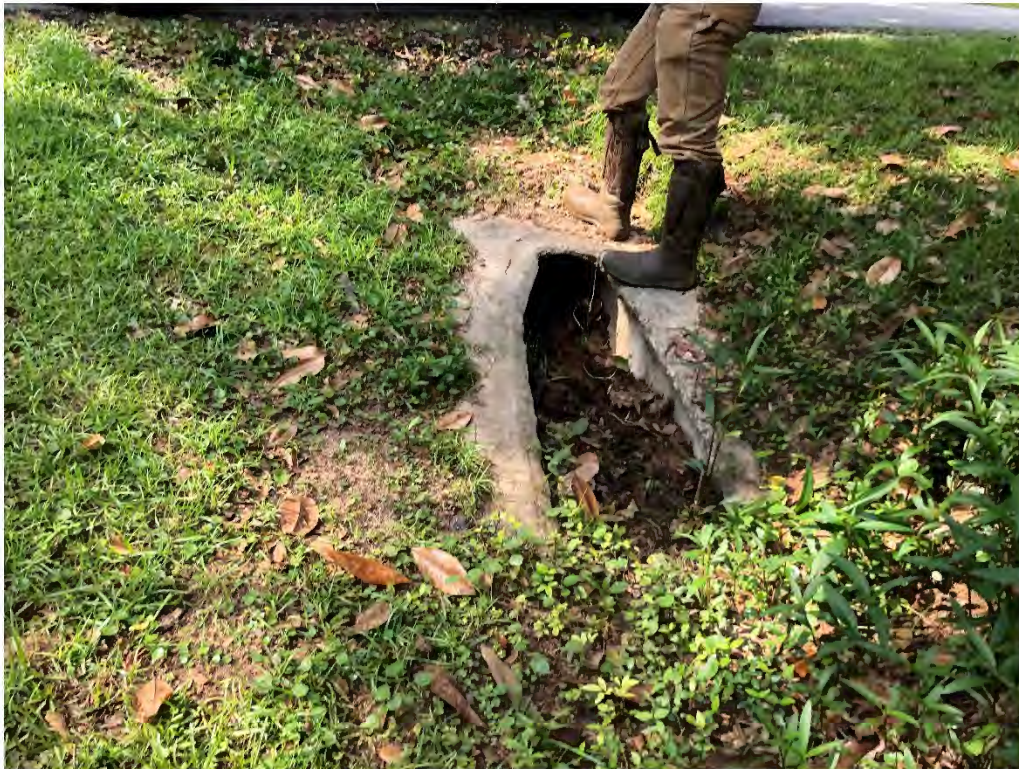
Figure 9256:
Photo taken facing North toward P-CO-14 at the intersection of Pecan Grove St and Short Ave.

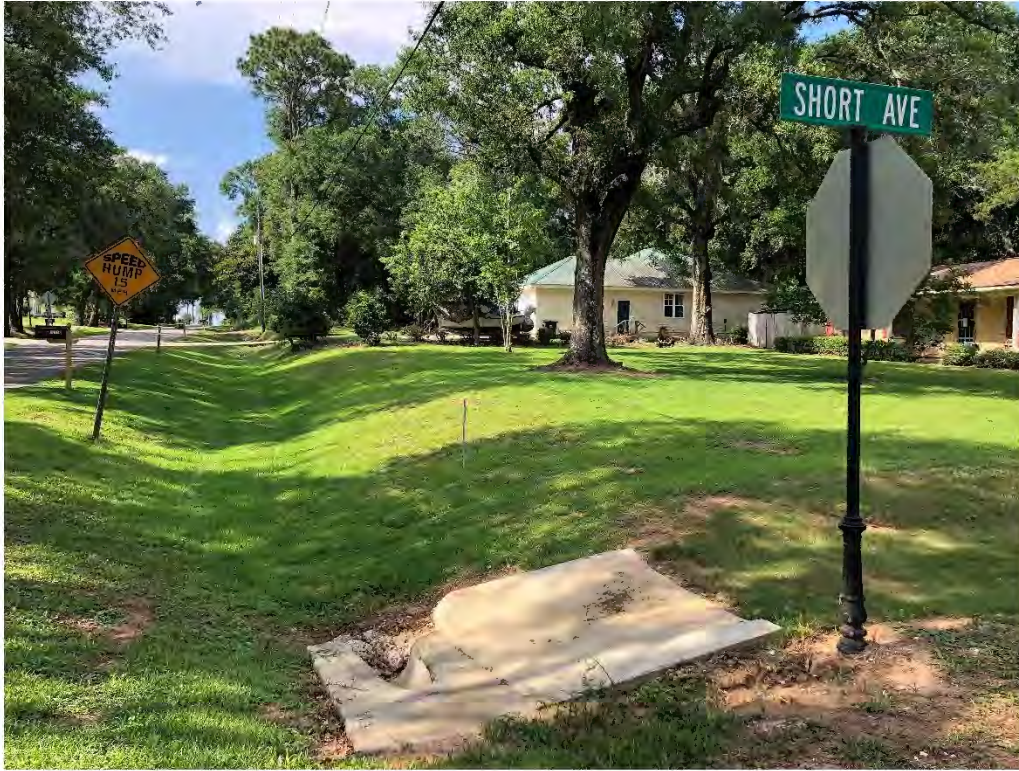
Figure 9257:
Photo taken facing North toward P-CH-14 along Pecan Grove St.

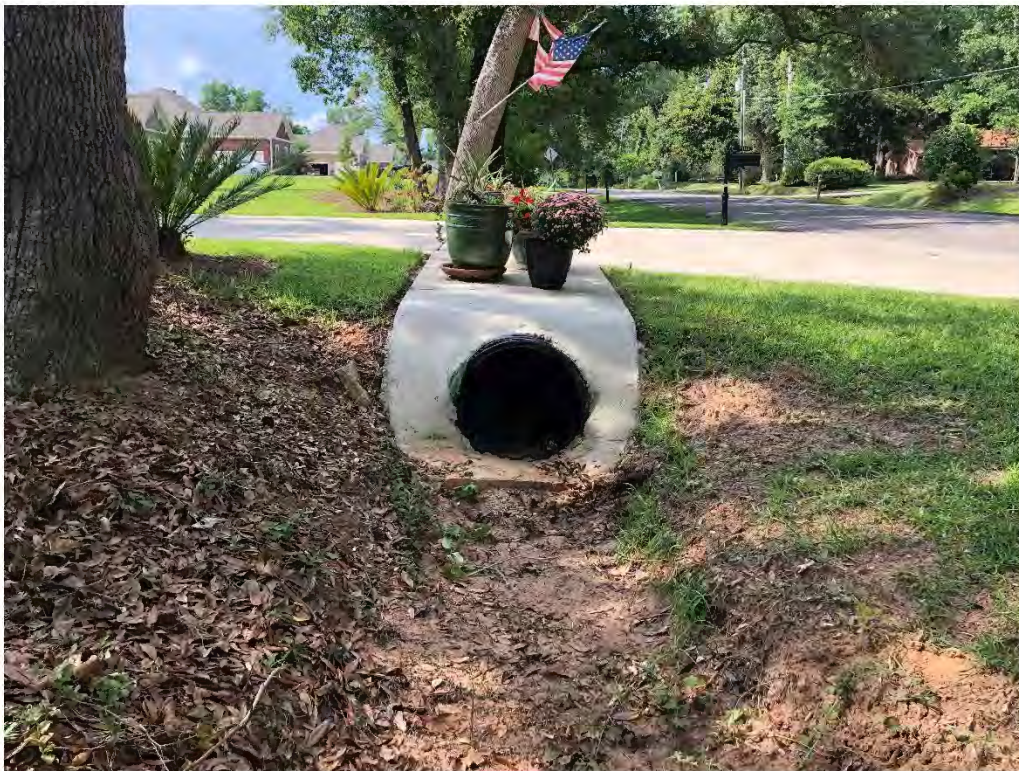
Figure 9260:

Photo taken facing North toward P-CO-13 at the intersection of Pecan Grove St and a residential driveway.

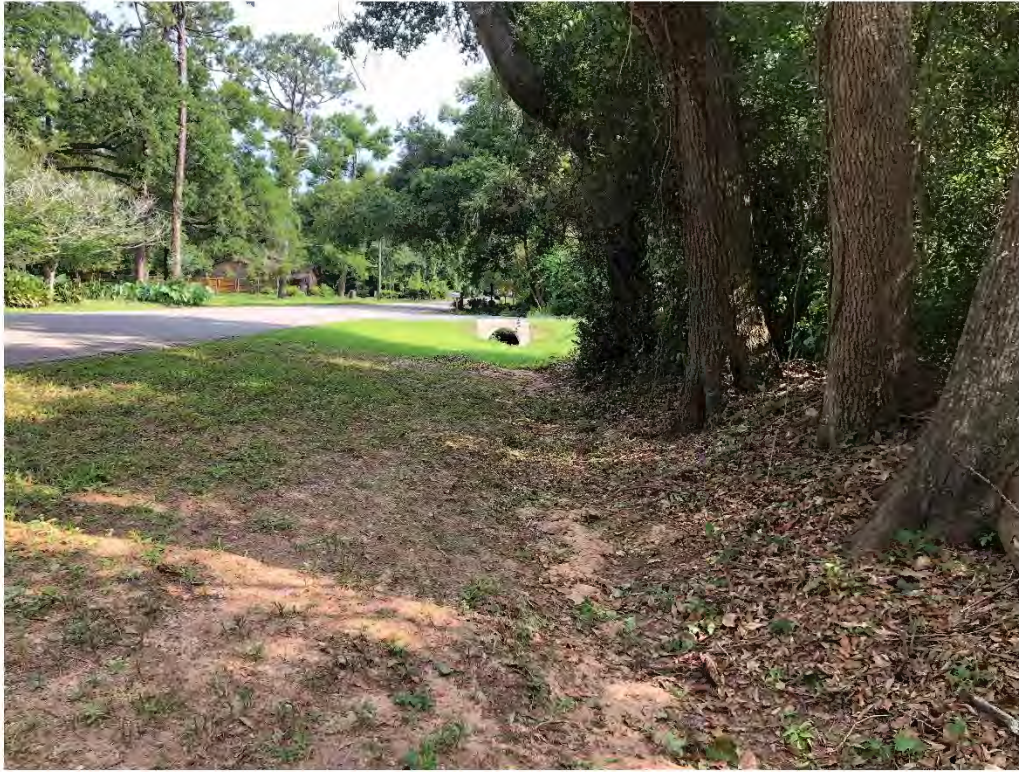
Figure 9261:

Photo taken facing South toward P-CO-16 at the intersection of Pecan Grove St and Woodland Ave.

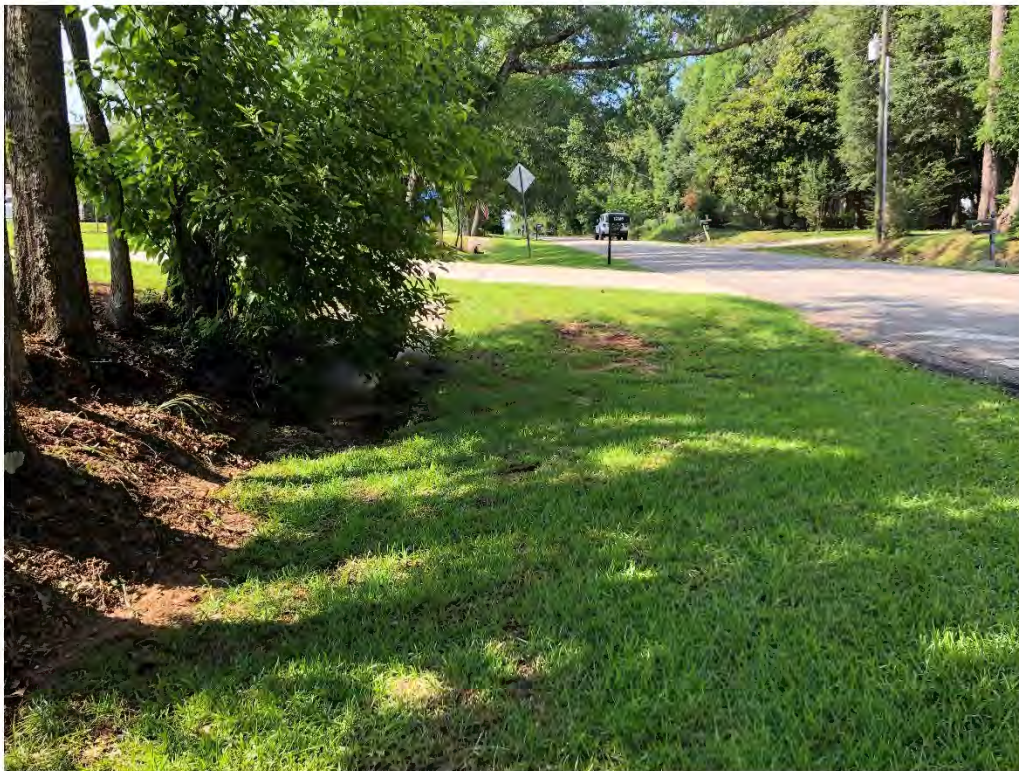
Figure 9263:

Photo taken facing North toward P-CH-13 along Pecan Grove St.

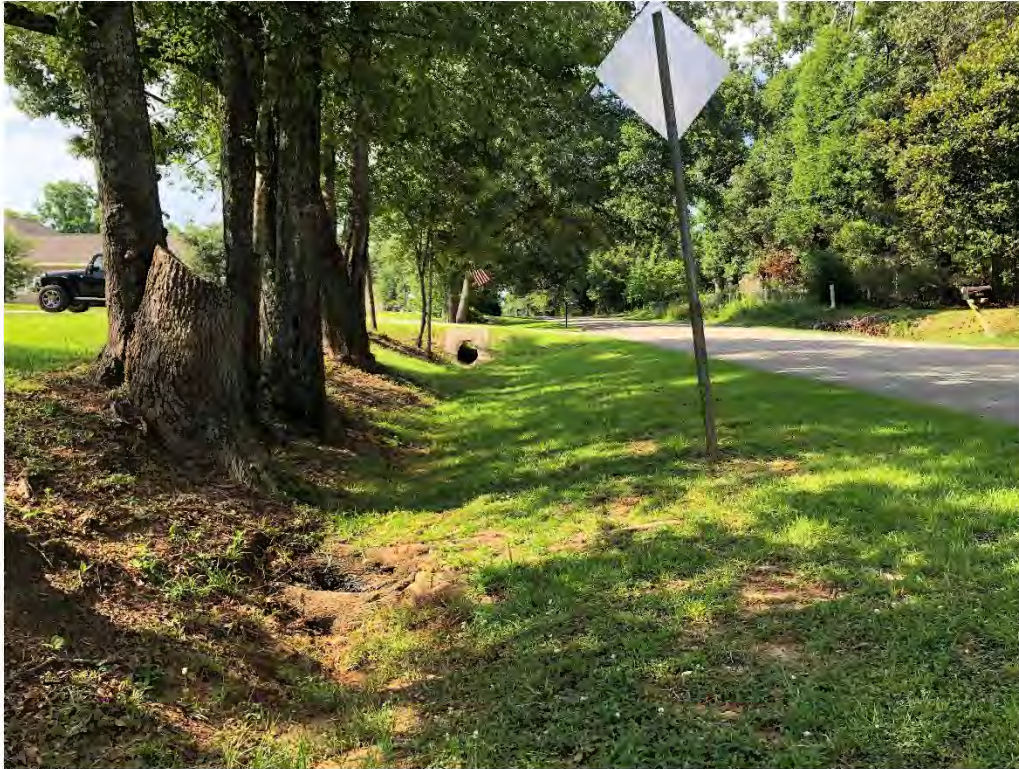
Figure 9268:
Photo taken facing North toward P-CH-11 along Pecan Grove St.

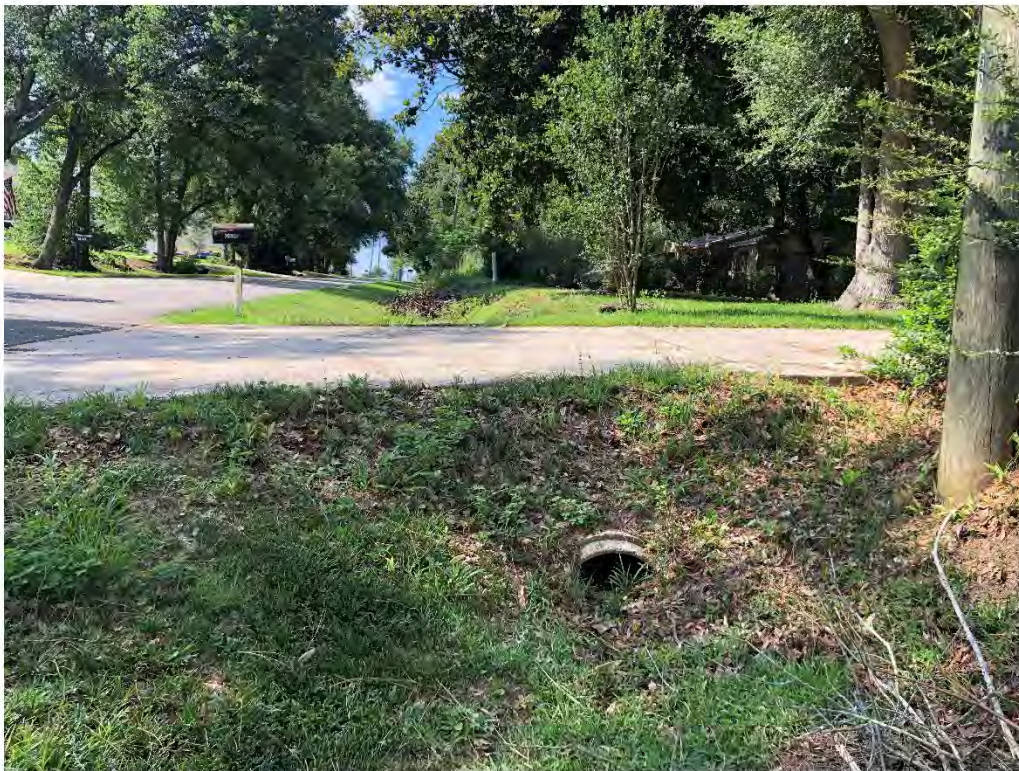
Figure 9269:

Photo taken facing North toward P-CO-10 at the intersection of Pecan Grove St and a residential driveway.

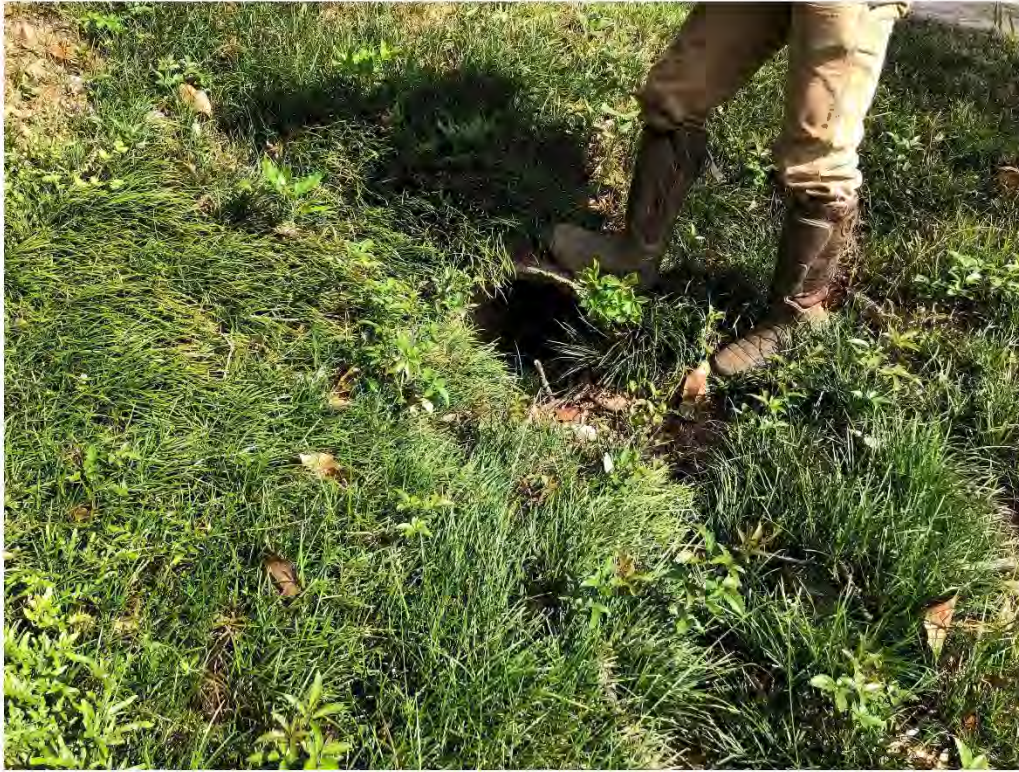
Figure 9270:

Photo taken facing South toward P-CO-10 at the intersection of Pecan Grove St and a residential driveway.

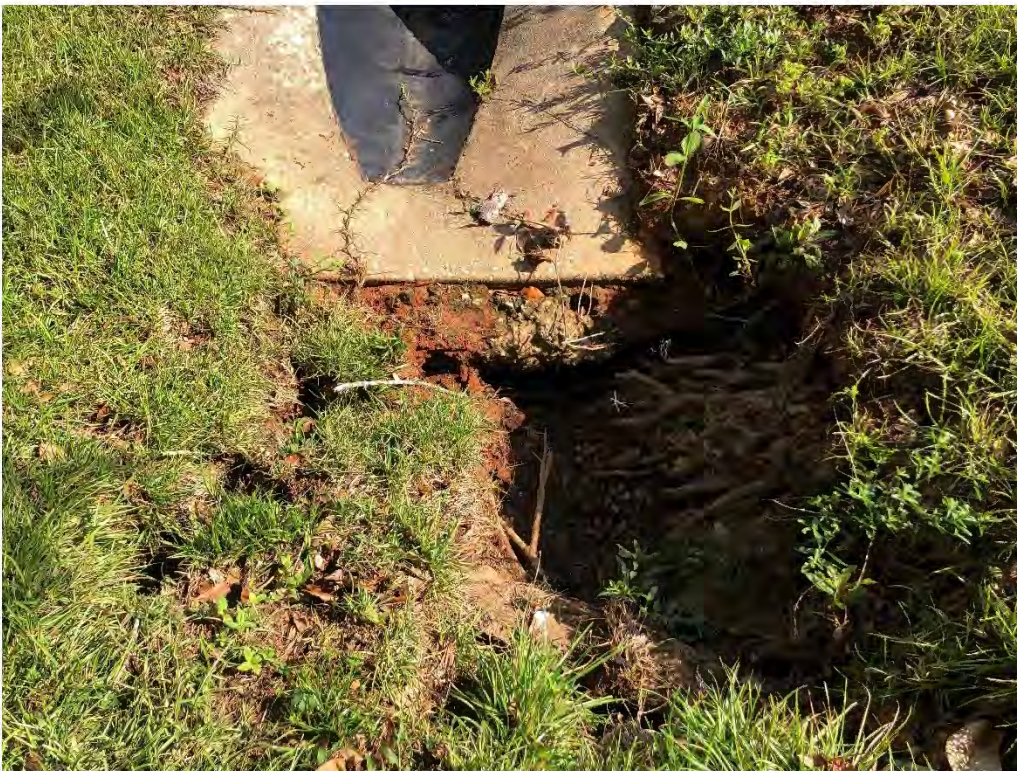
Figure 9272:

Photo taken facing South toward P-CO-9 at the intersection of Pecan Grove St and a residential driveway.

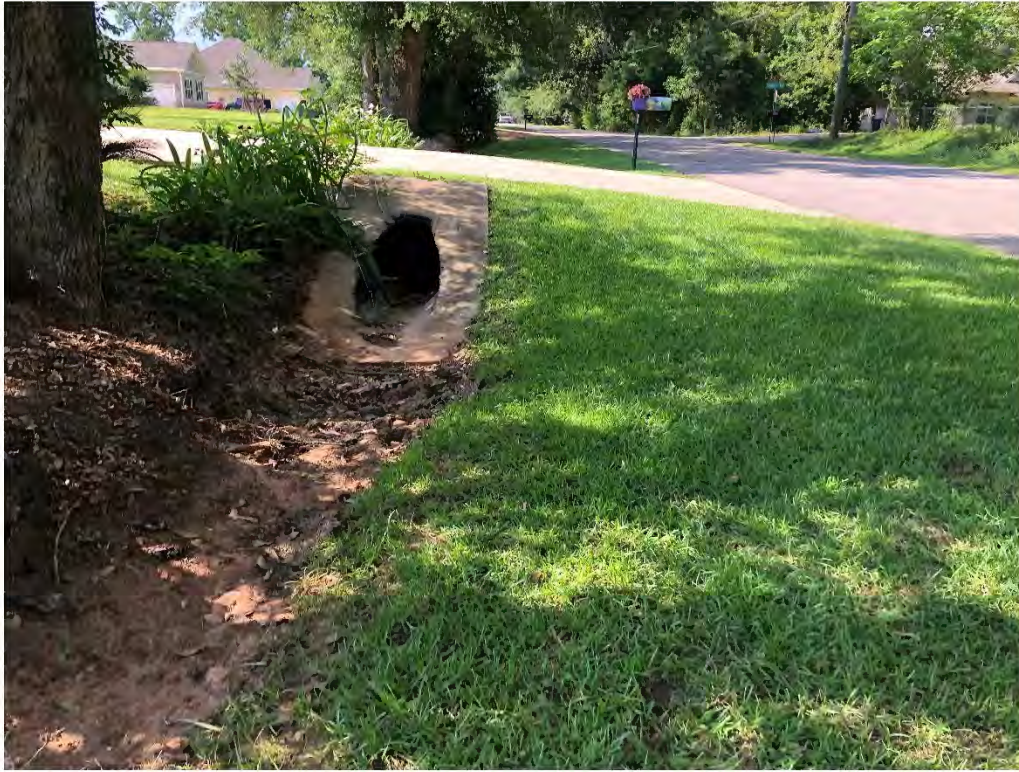
Figure 9273:

Photo taken facing North toward P-CO-8 at the intersection of Pecan Grove St and a residential driveway.

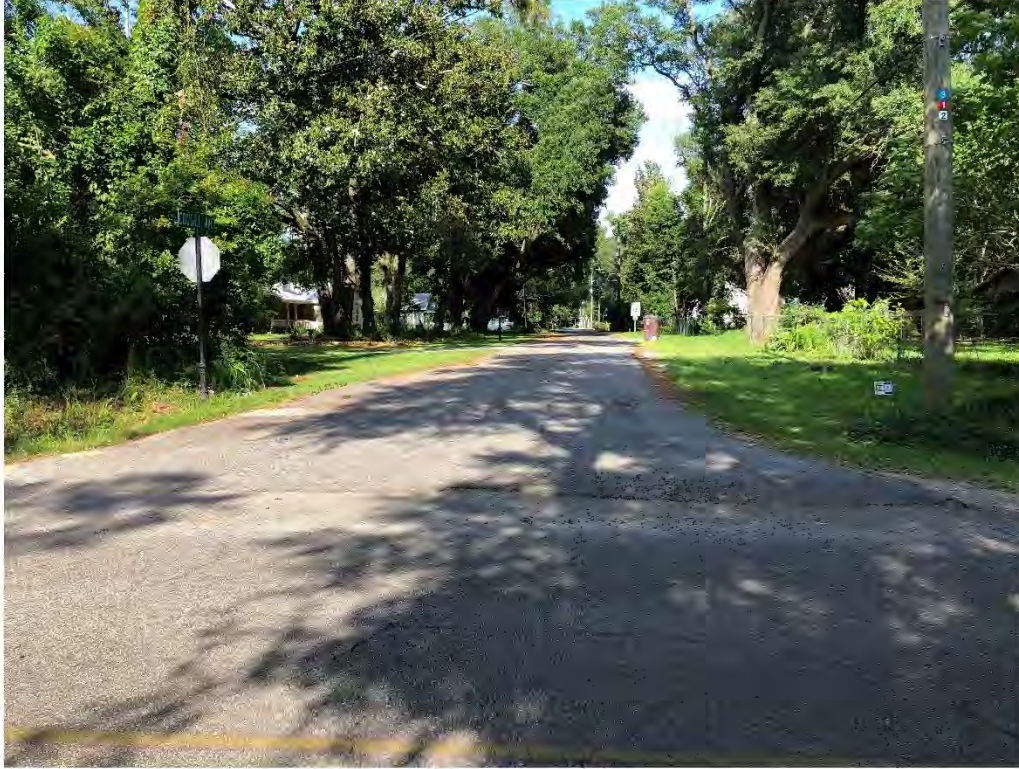
Figure 9275:
Photo taken facing East toward P-CO-7 at the intersection of Pecan Grove St and Coughl Ave.

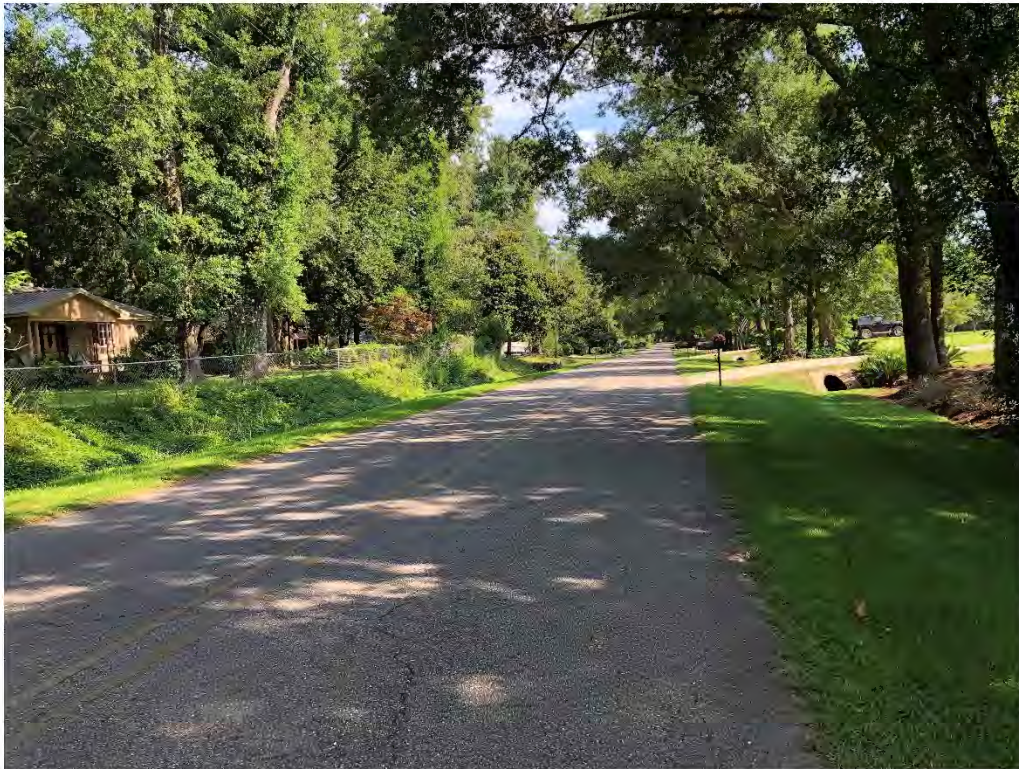
Figure 9276:
Photo taken facing South toward P-CH-9 along Pecan Grove St.

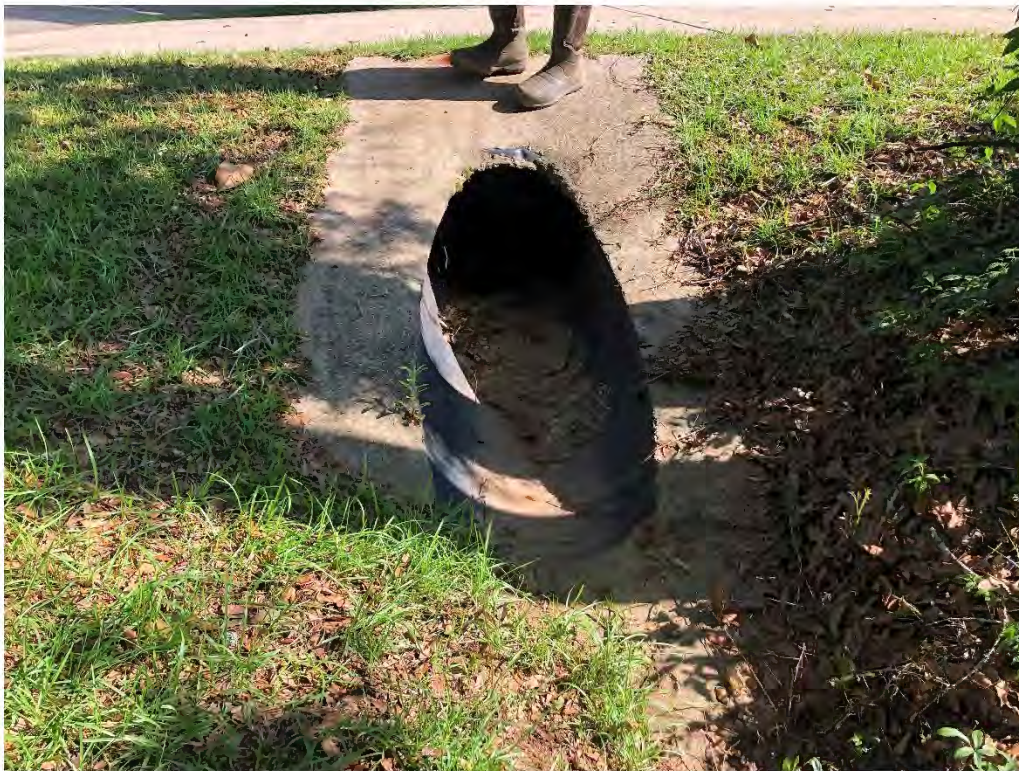
Figure 9278:

Photo taken facing South toward P-CO-5 at the intersection of Pecan Grove St and a residential driveway.

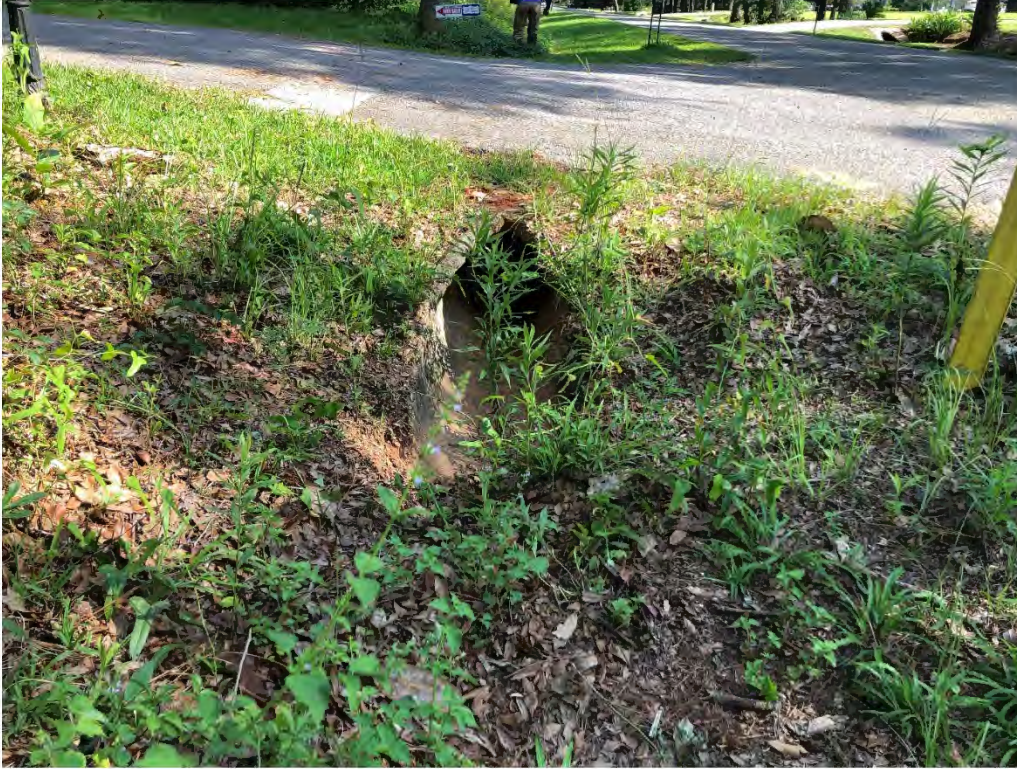
Figure 9280:
Photo taken facing South toward P-CO-7 at the intersection of Pecan Grove St and Coughil Ave.

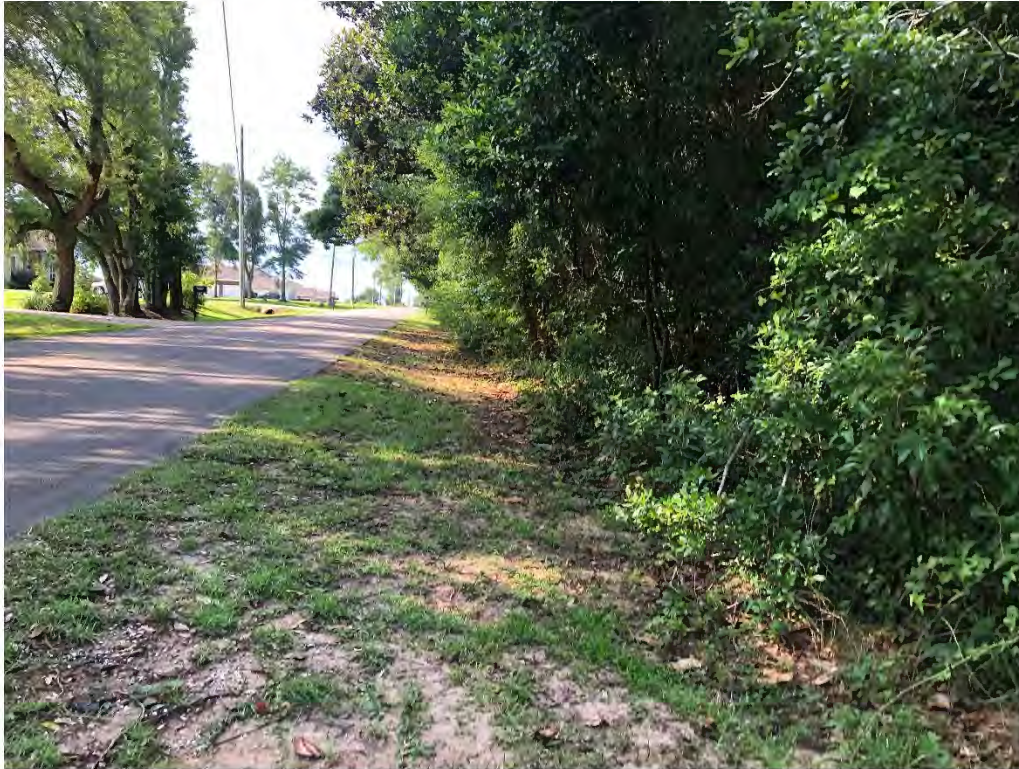
Figure 9282:
Photo taken facing North toward P-CH-5 along Pecan Grove St.

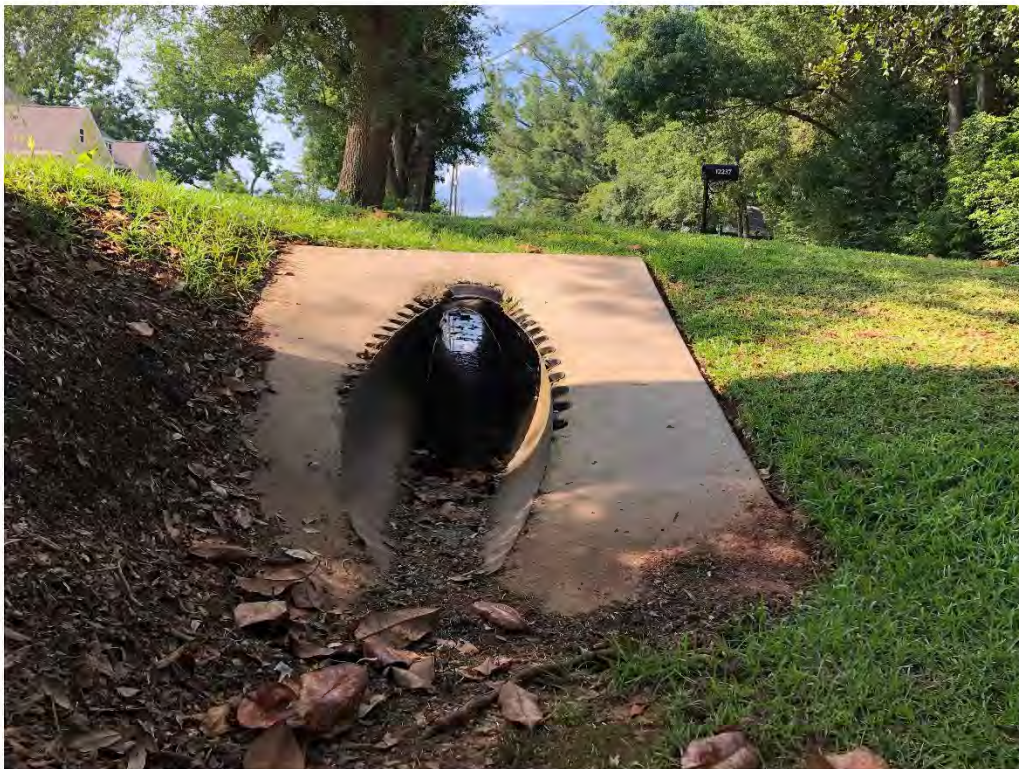
Figure 9284:

Photo taken facing North toward P-CO-5 at the intersection of Pecan Grove St and a residential driveway.

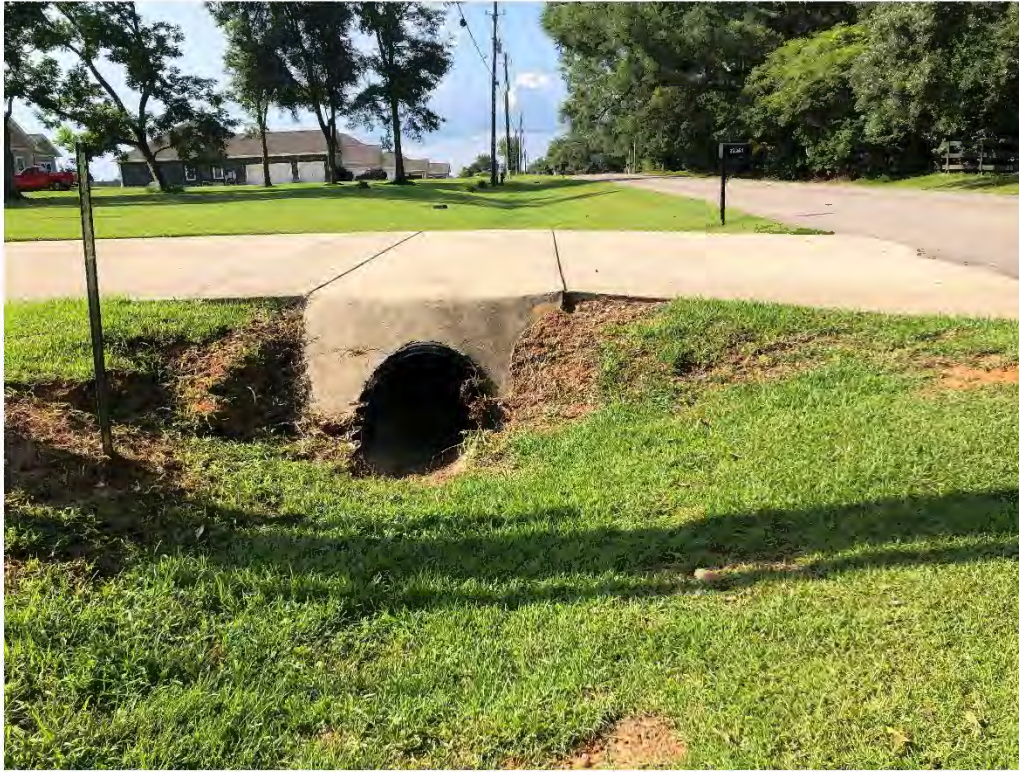
Figure 9287:

Photo taken facing North toward P-CO-4 at the intersection of Pecan Grove St and a residential driveway.

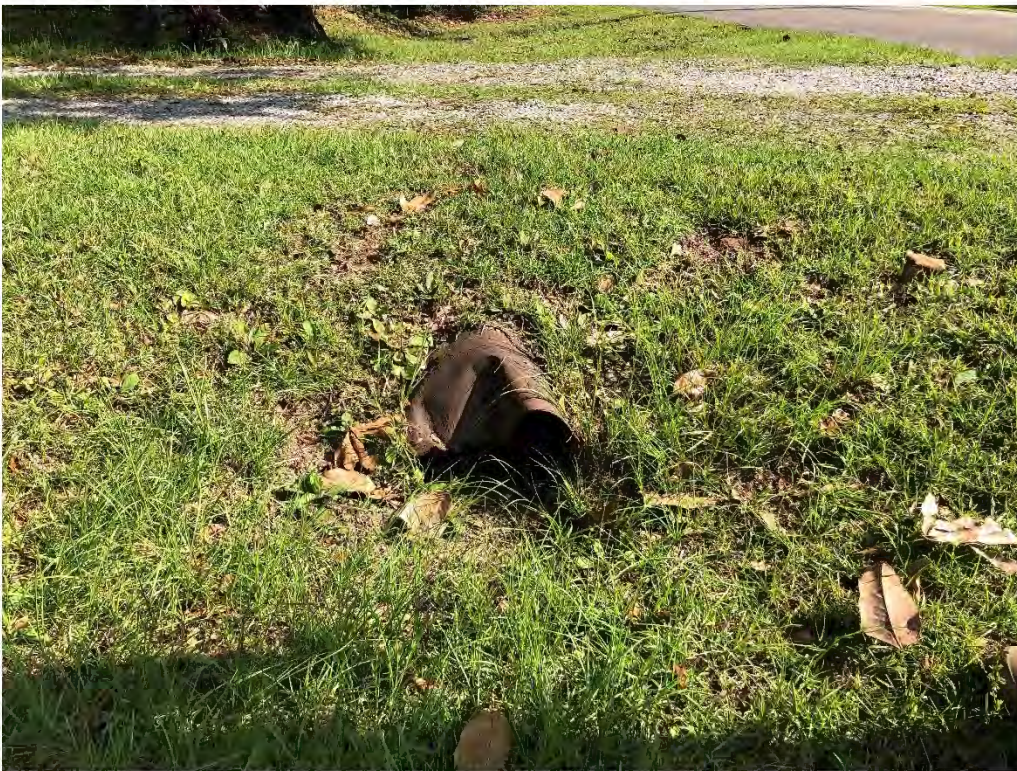
Figure 9289:

Photo taken facing South toward a crushed P-CO-3 at the intersection of Pecan Grove St and a residential driveway.

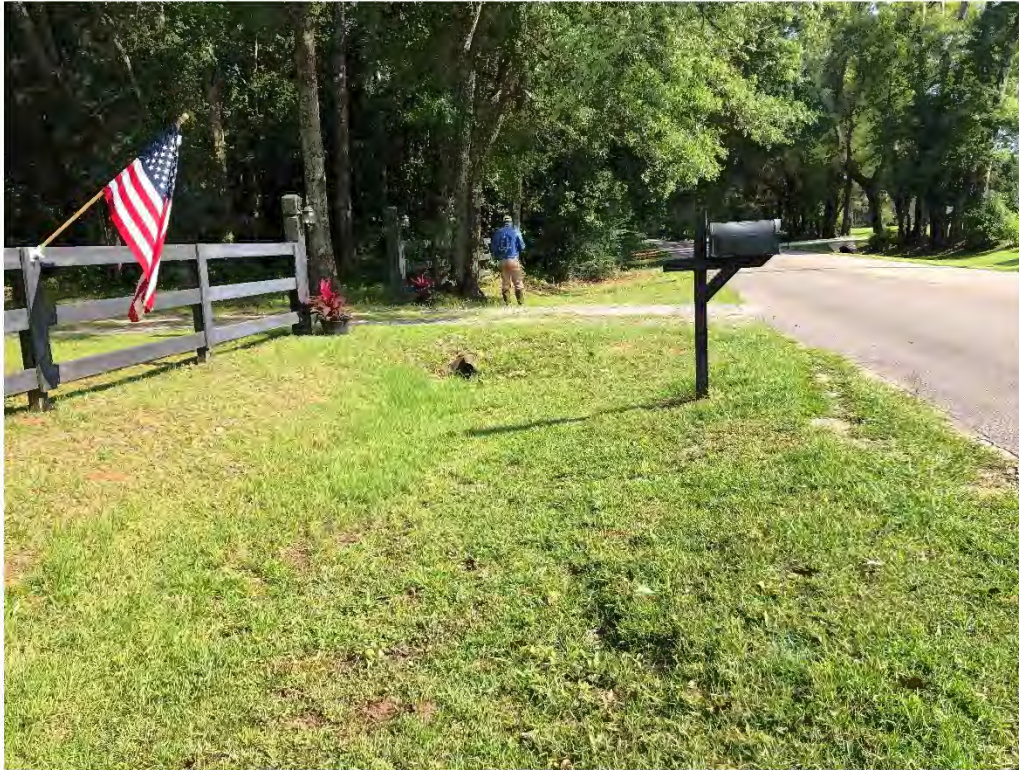
Figure 9290:
Photo taken facing South toward P-CH-4 along Pecan Grove St.

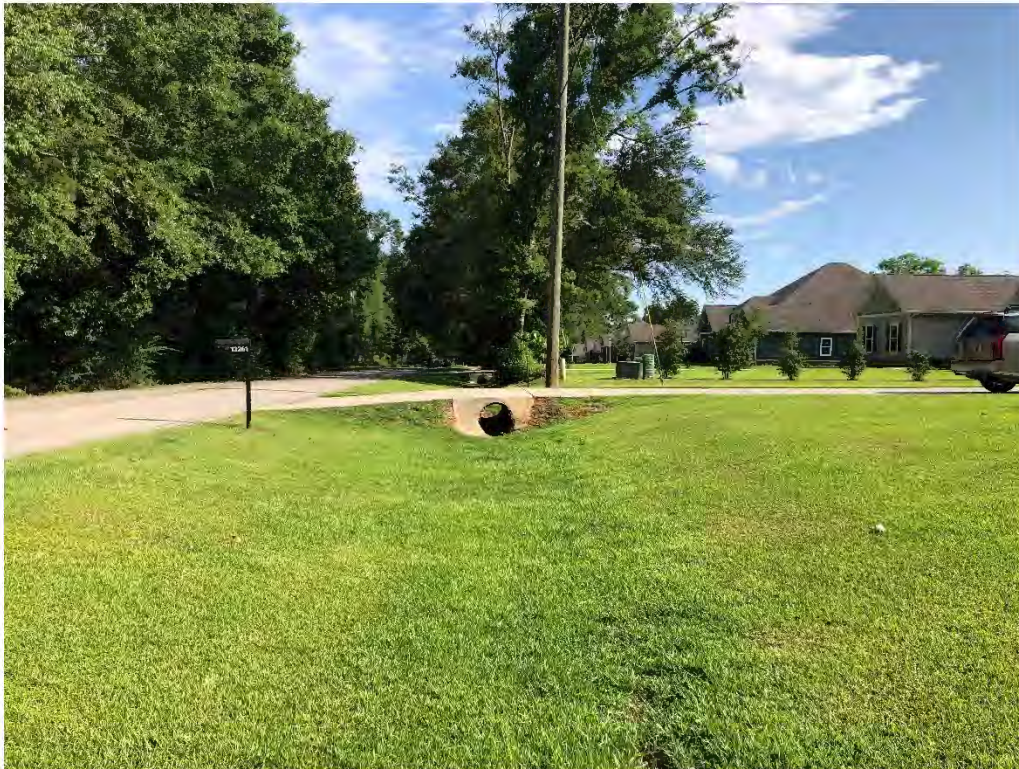
Figure 9292:

Photo taken facing South toward a crushed P-CO-4 at the intersection of Pecan Grove St and a residential driveway.

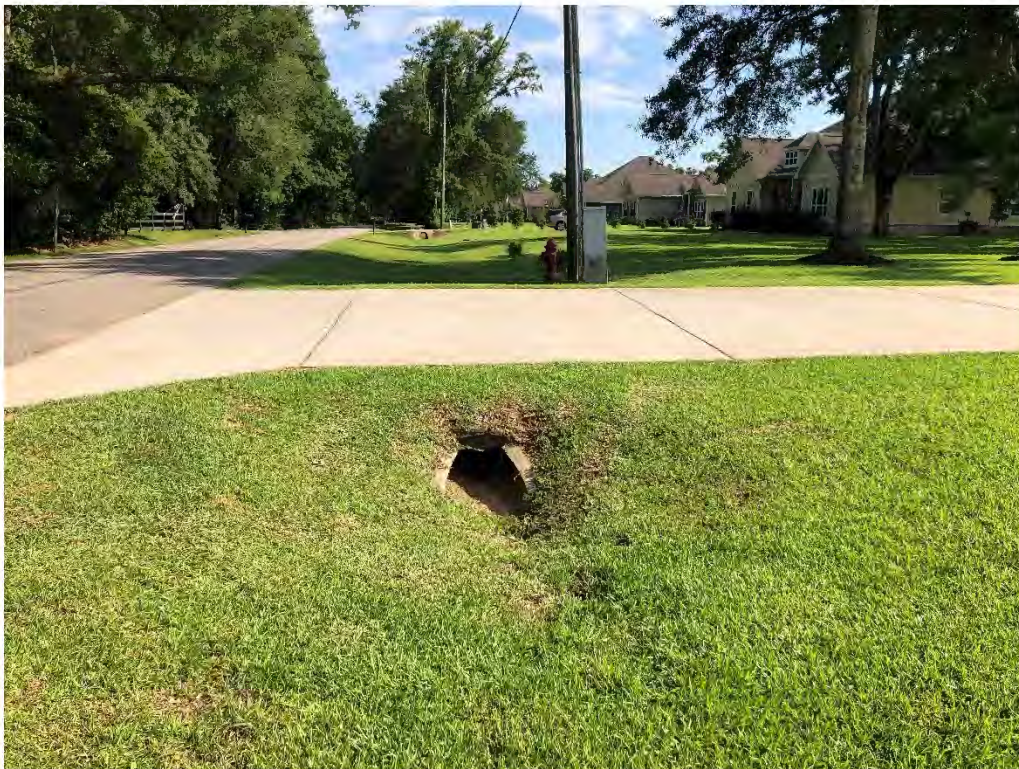
Figure 9296:

Photo taken facing South toward P-CO-2 at the intersection of Pecan Grove St and a residential driveway.

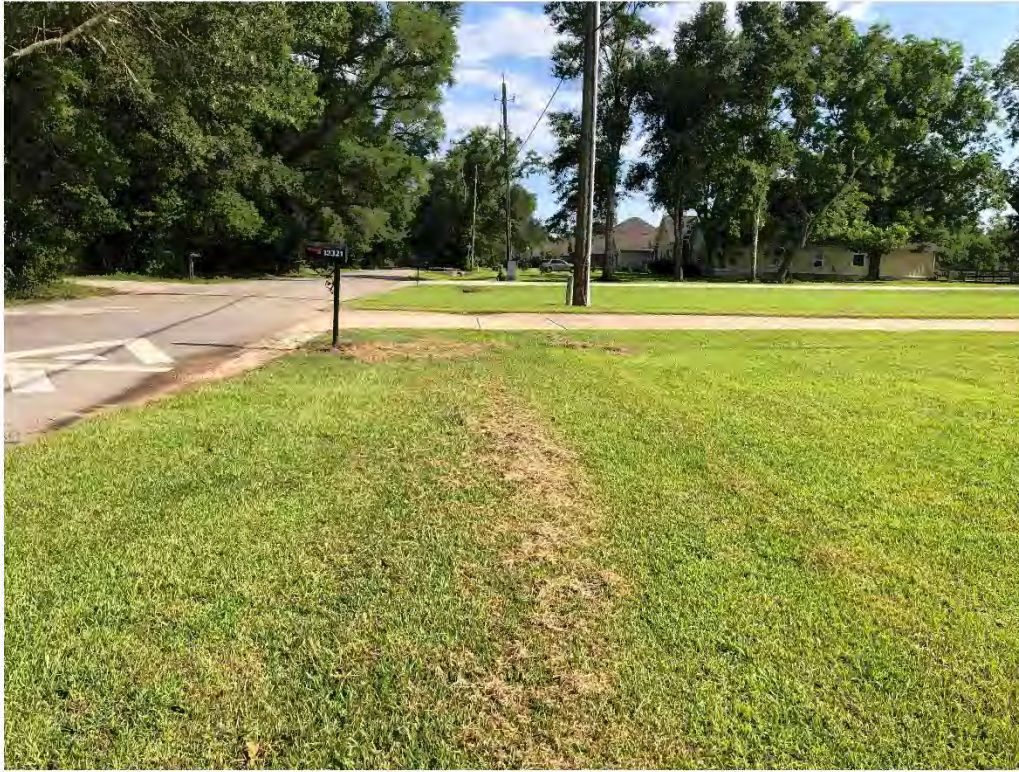
Figure 9297:
Photo taken facing South toward OAK-CH-17 along Pecan Grove St.

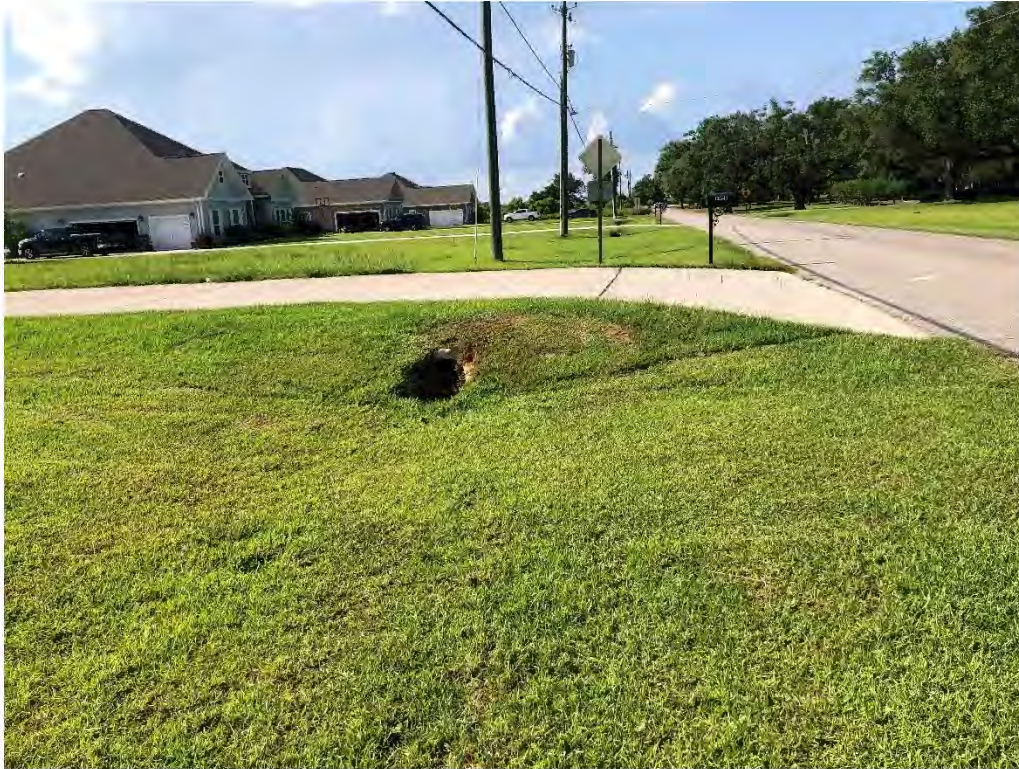
Figure 9298:
Photo taken facing North toward OAK-CO-15 at the intersection of Pecan Grove St and a residential driveway.
