Town of Magnolia Springs Comprehensive Drainage Masterplan

Town of Magnolia Springs
Magnolia Springs, Baldwin County, Alabama

VOLKERT

March 2023

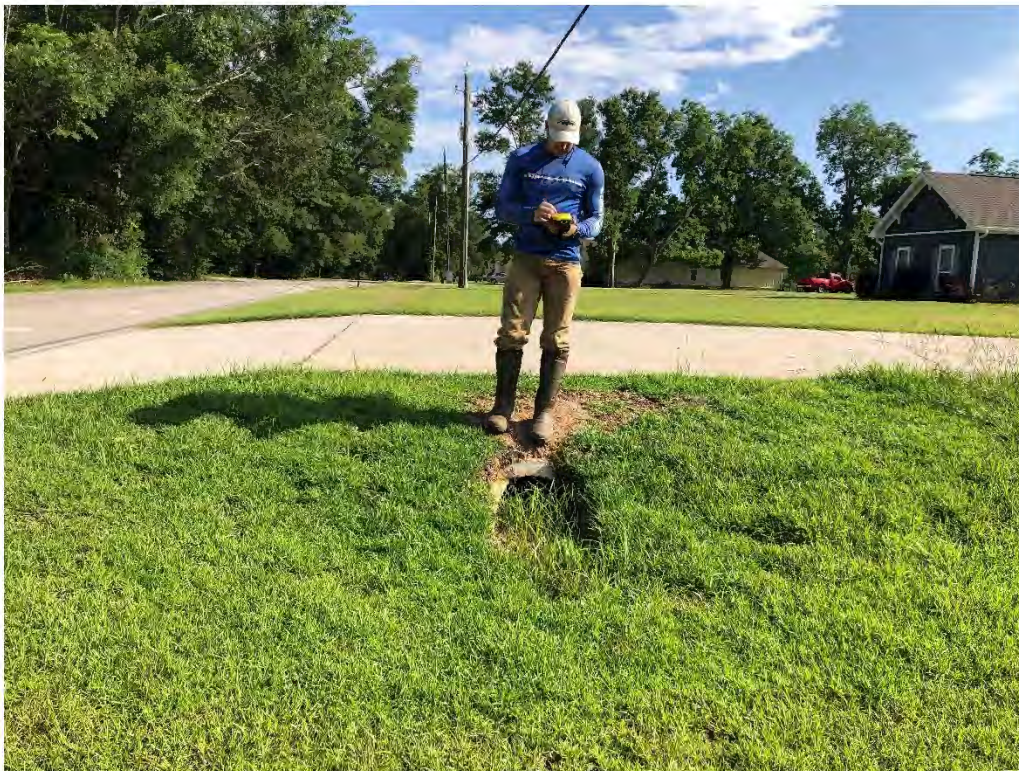
Figure 9299:

Photo taken facing South toward OAK-CO-14 at the intersection of Pecan Grove St and a residential driveway.

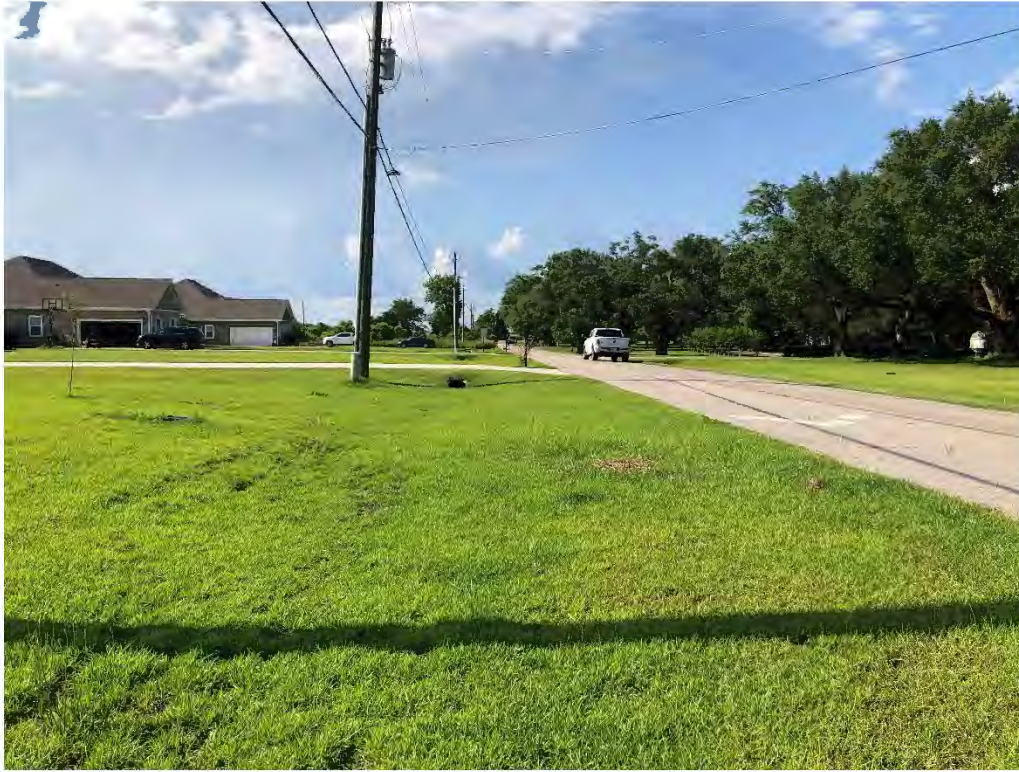
Figure 9300:
Photo taken facing North toward OAK-CH-19 along Pecan Grove St.

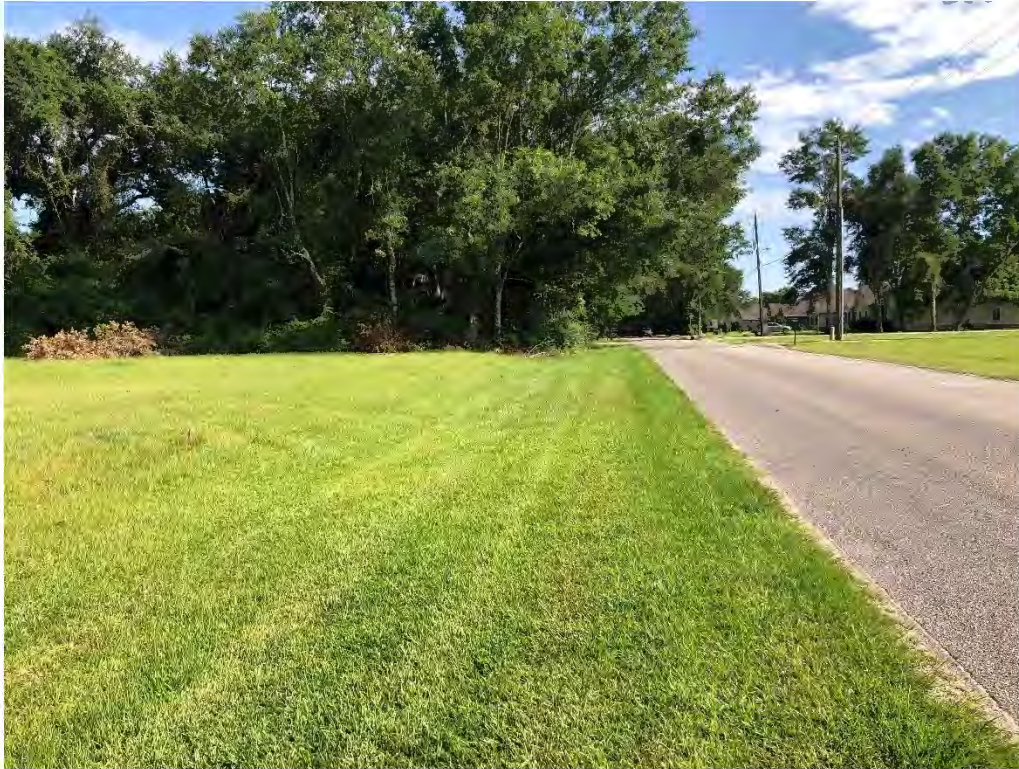
Figure 9302:
Photo taken facing South toward OAK-CH-22 along Pecan Grove St.

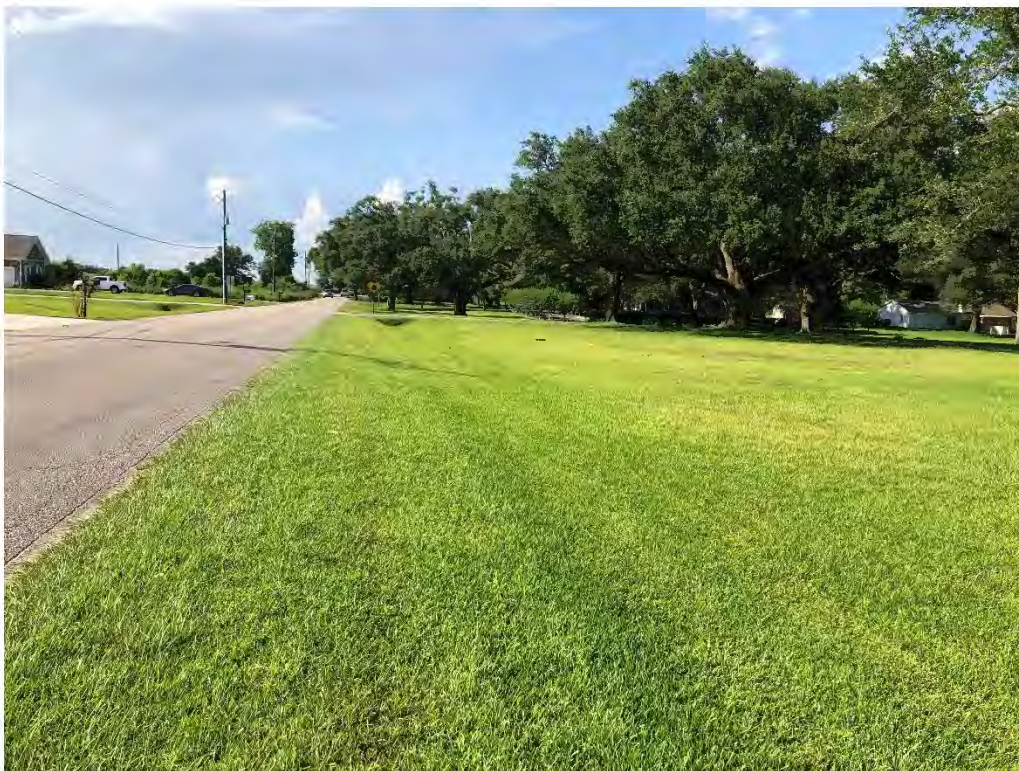
Figure 9303:
Photo taken facing North toward OAK-CH-22 along Pecan Grove St.

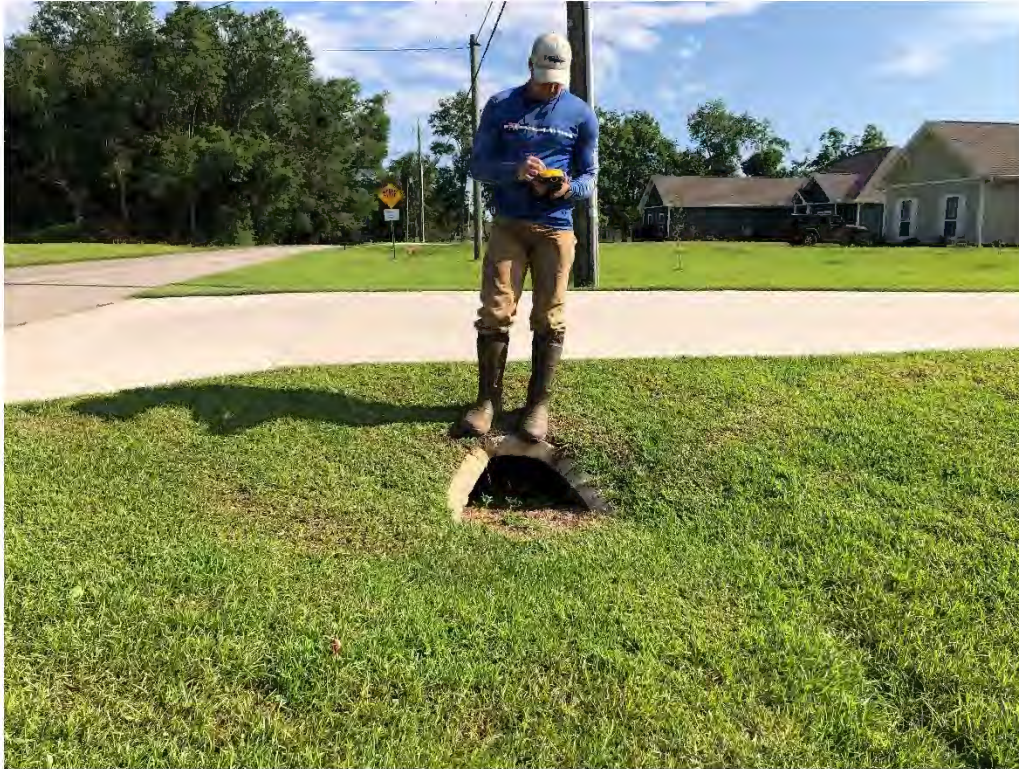
Figure 9304:
Photo taken facing South toward OAK-CO-14 along Pecan Grove St.

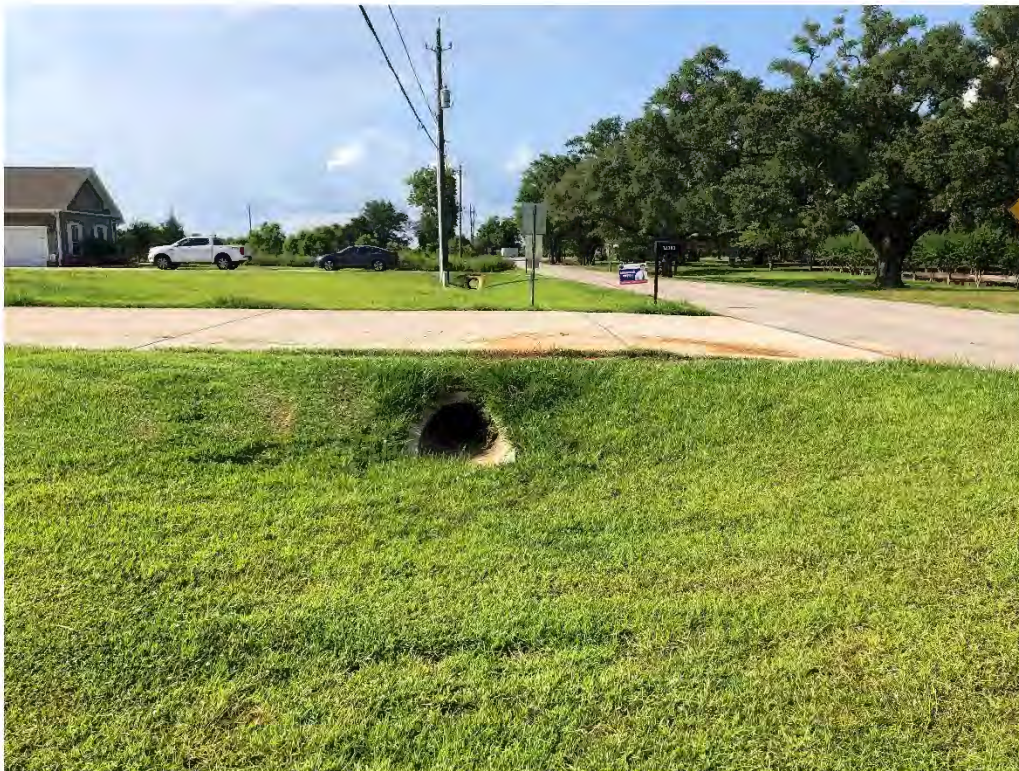
Figure 9305:

Photo taken facing North toward OAK-CO-16 at the intersection of Pecan Grove St and a residential driveway.

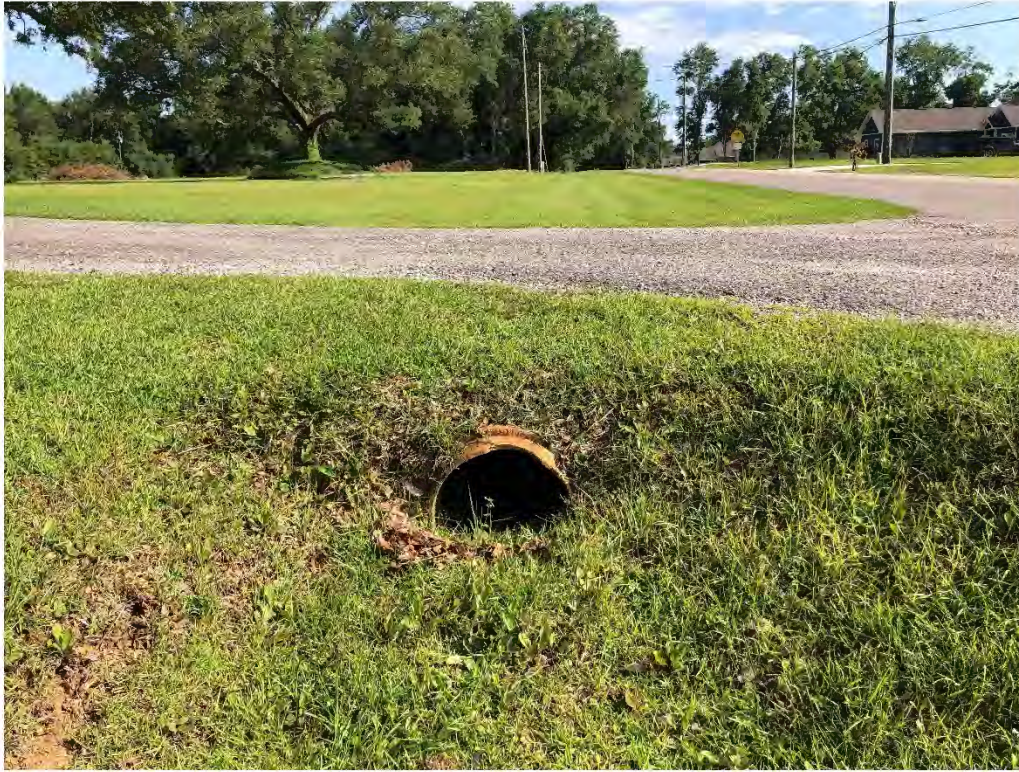
Figure 9306:

Photo taken facing South toward OAK-CO-18 at the intersection of Pecan Grove St and a residential driveway.

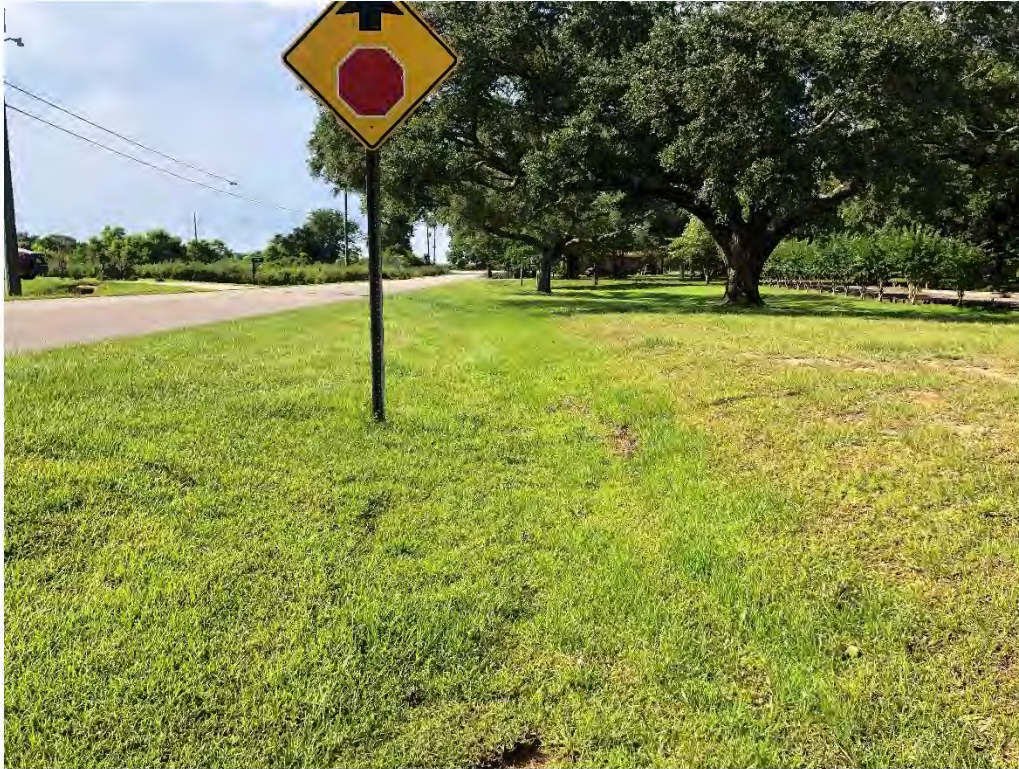
Figure 9307:
Photo taken facing North toward OAK-CH-22 along Pecan Grove St.

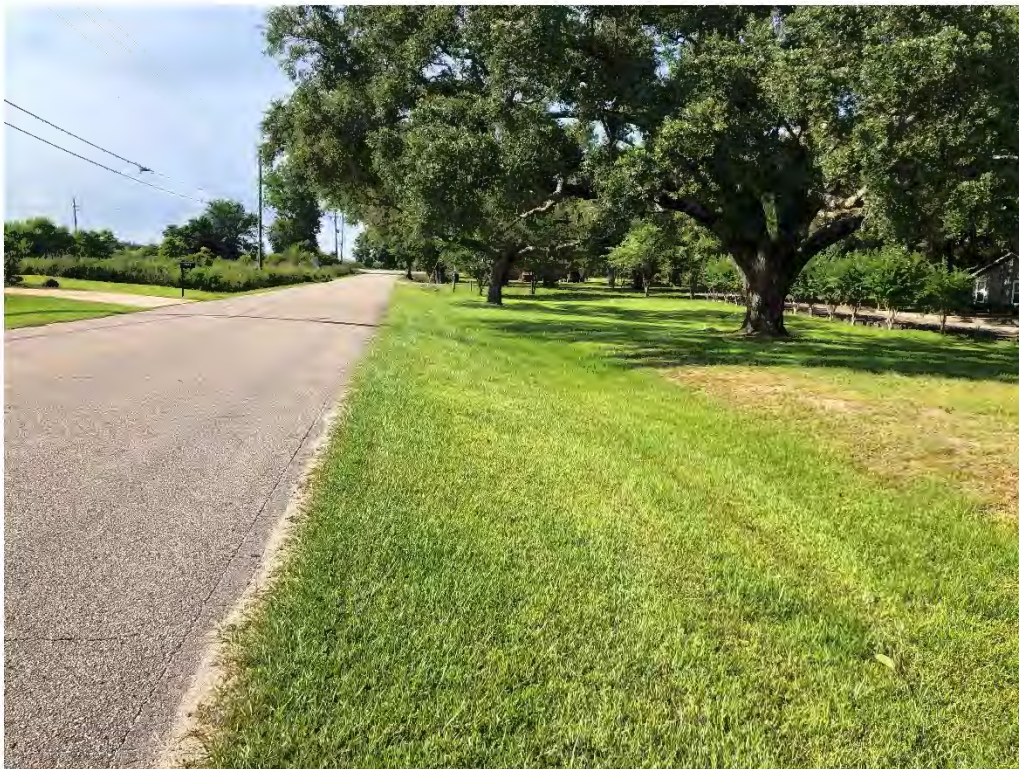
Figure 9308:
Photo taken facing North toward OAK-CH-22 along Pecan Grove St.

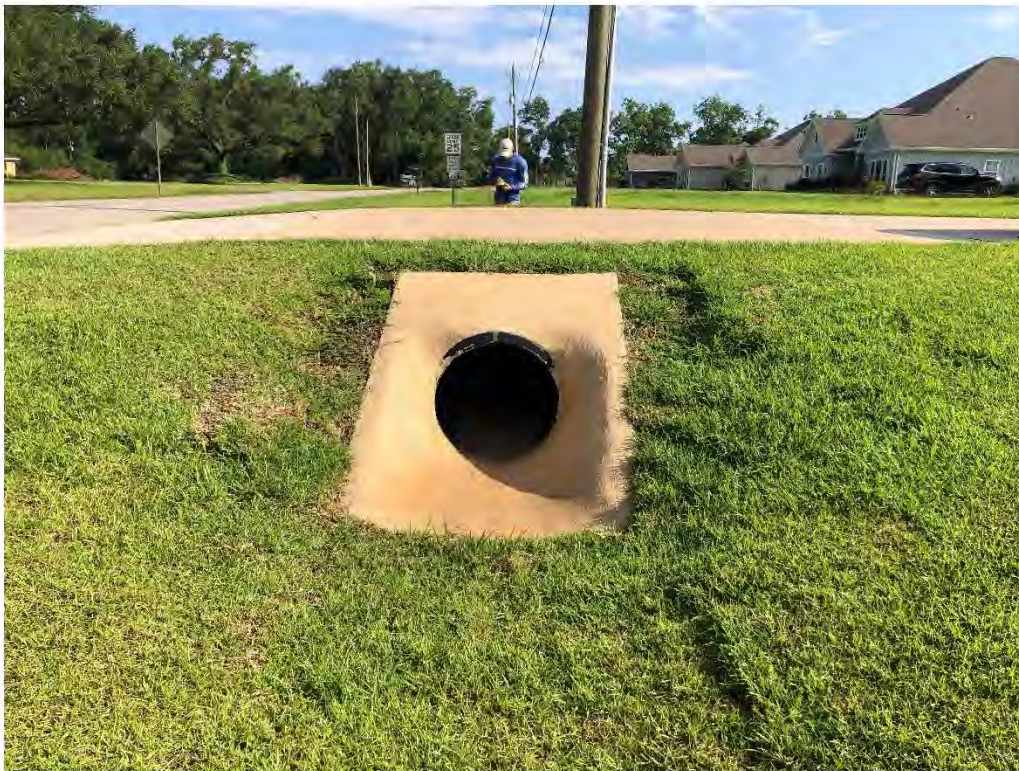
Figure 9310:

Photo taken facing South toward OAK-CO-17 at the intersection of Pecan Grove St and a residential driveway.

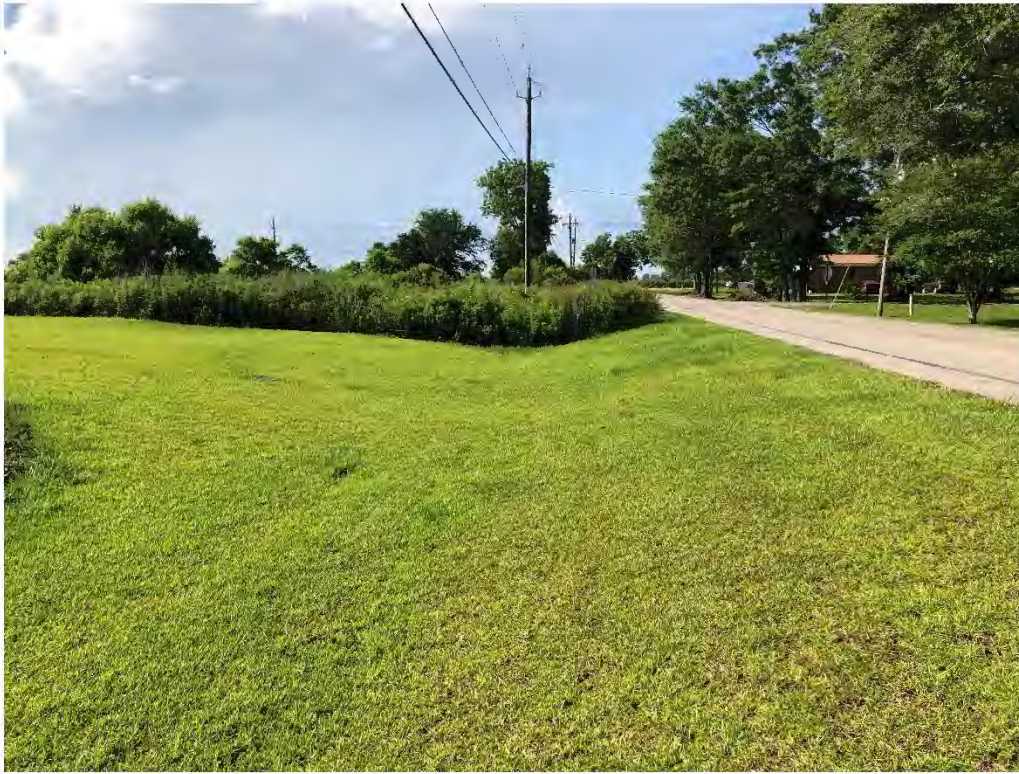
Figure 9311:
Photo taken facing North toward OAK-CH-21 along Pecan Grove St.

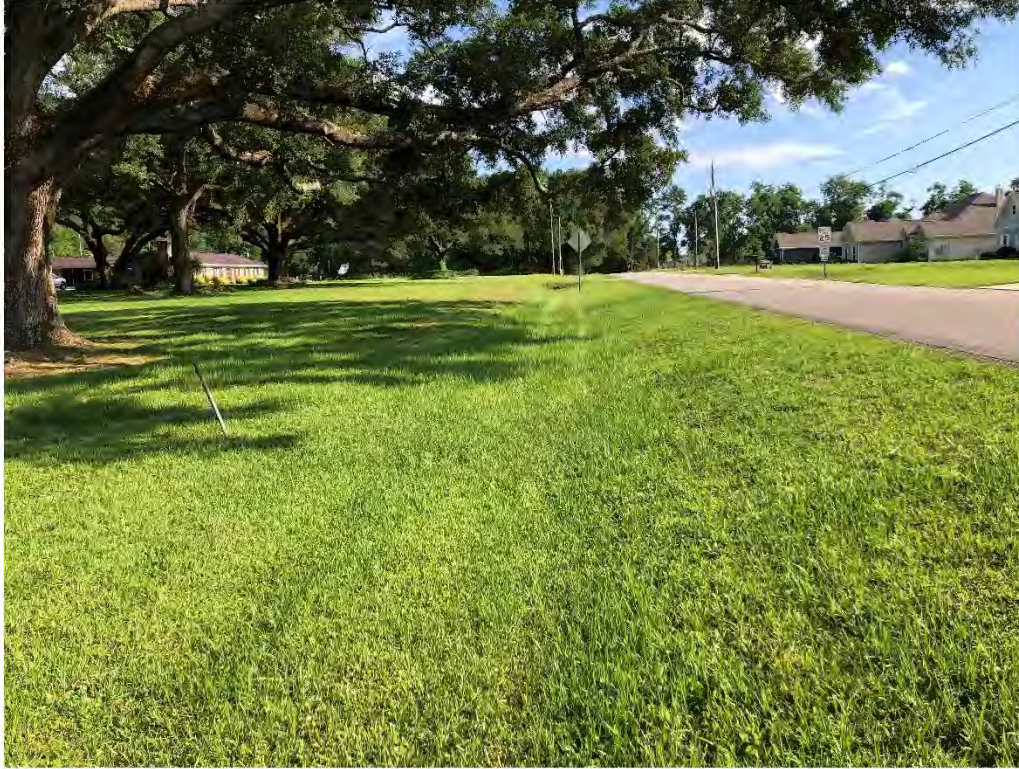
Figure 9312:
Photo taken facing South toward OAK-CH-22 along Pecan Grove St.

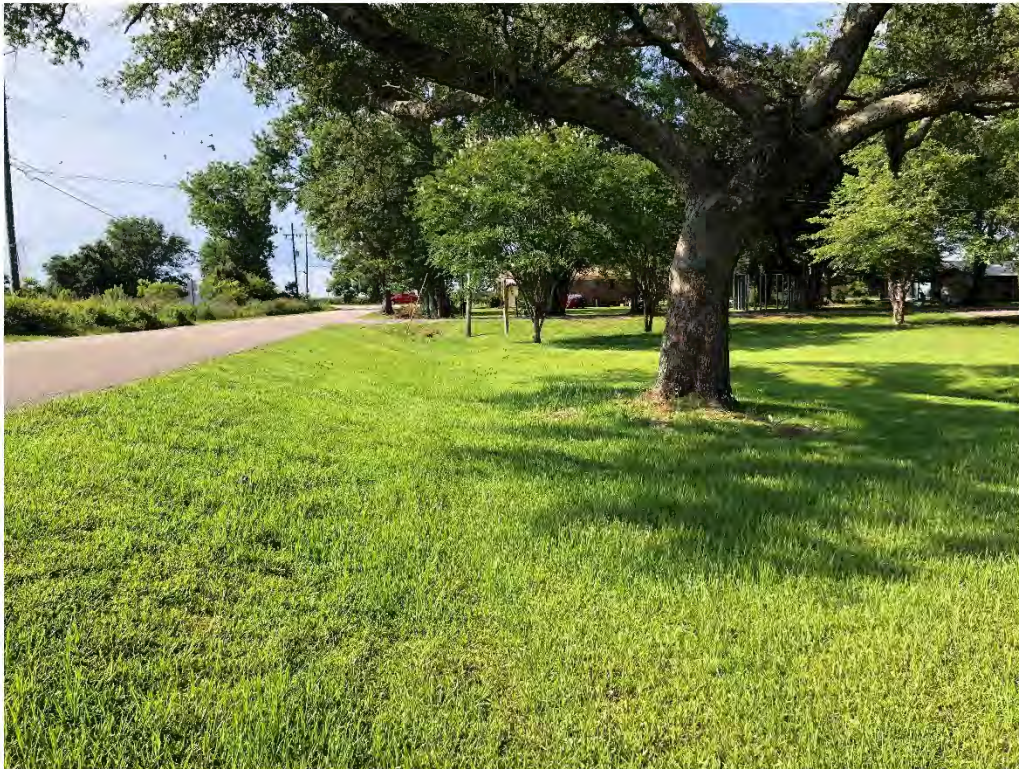
Figure 9313:
Photo taken facing North toward OAK-CH-26 along Pecan Grove St.

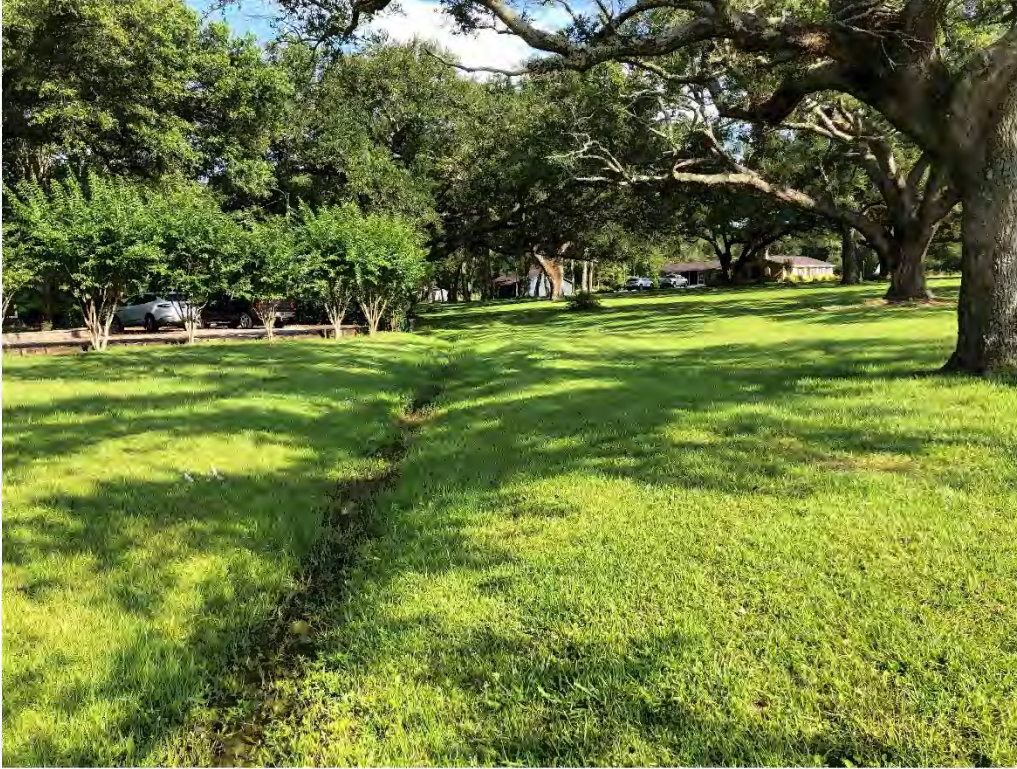
Figure 9314:
Photo taken facing East toward OAK-CH-27a along Pecan Grove St.

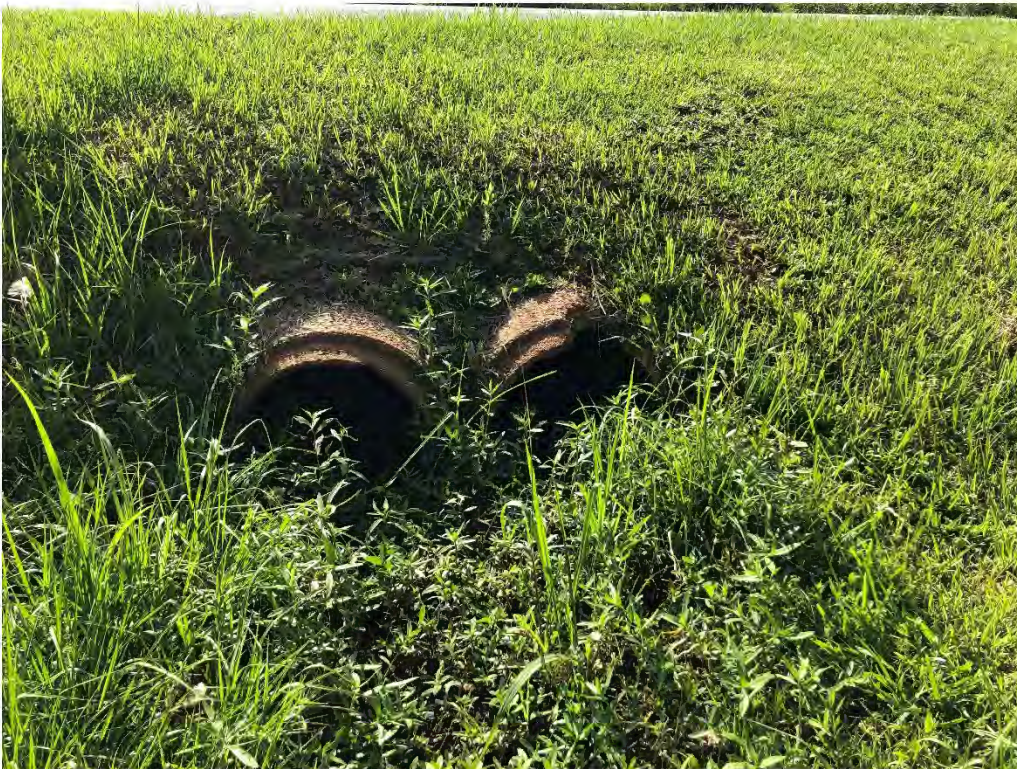
Figure 9315:
Photo taken facing West toward OAK-CO-19 along Pecan Grove St.

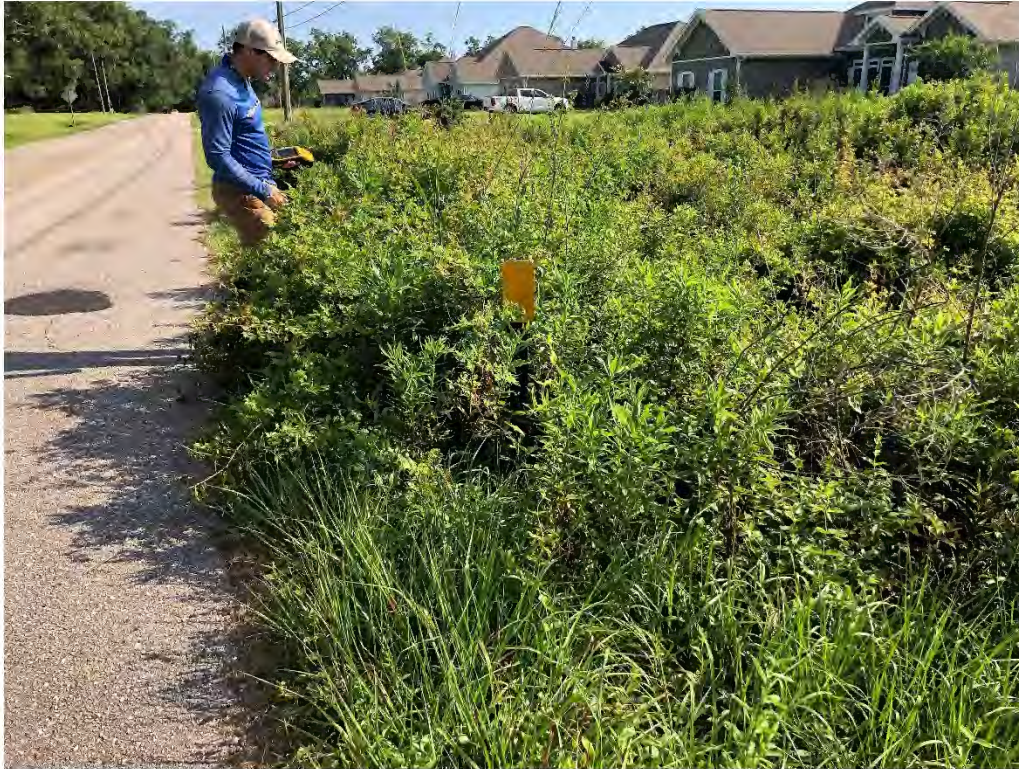
Figure 9316:
Photo taken facing East toward OAK-CO-19 along Pecan Grove St.

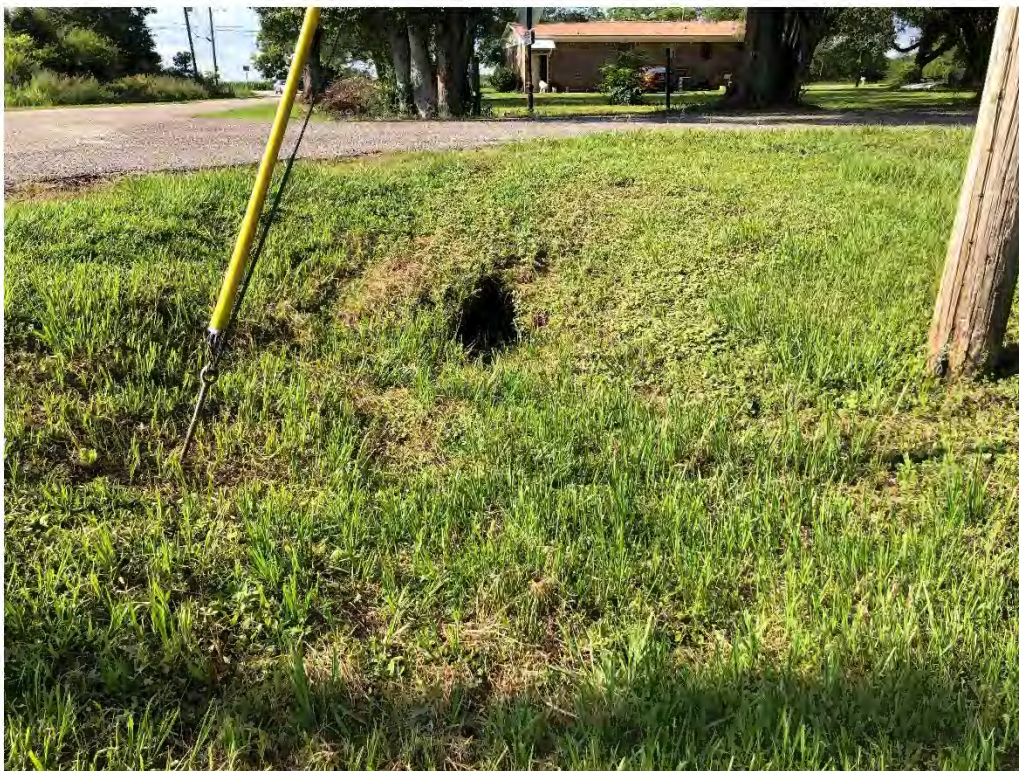
Figure 9317:
Photo taken facing North toward OAK-CO-21 along Pecan Grove St.

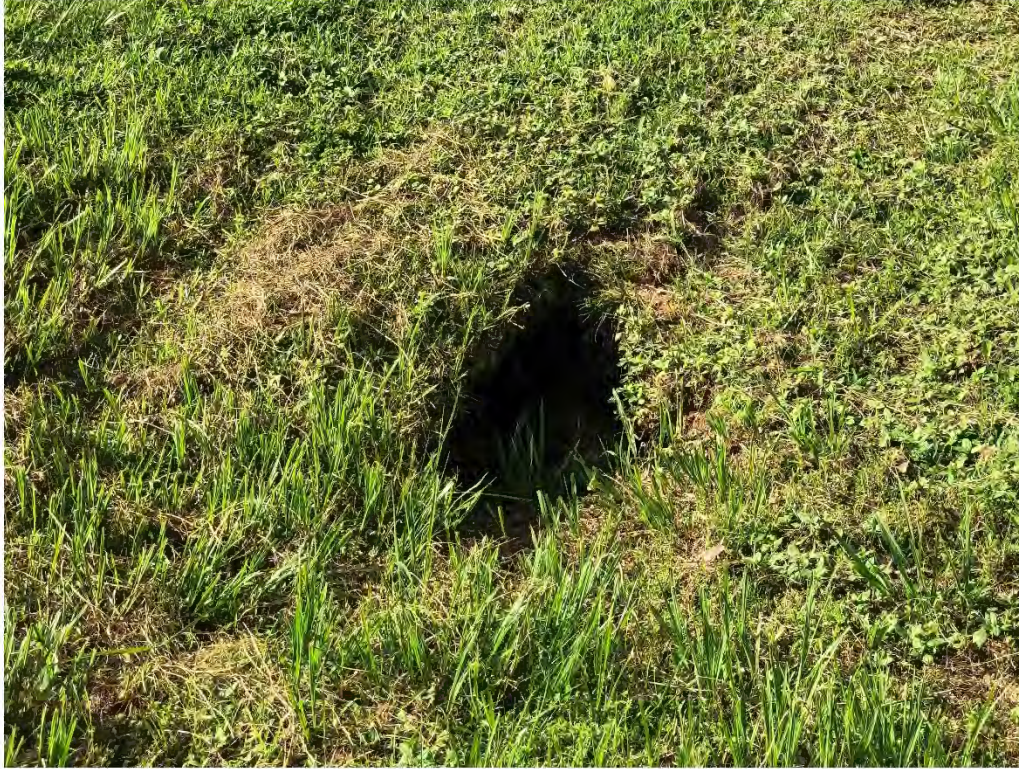
Figure 9318:
Photo taken facing North toward OAK-CO-21 along Pecan Grove St.

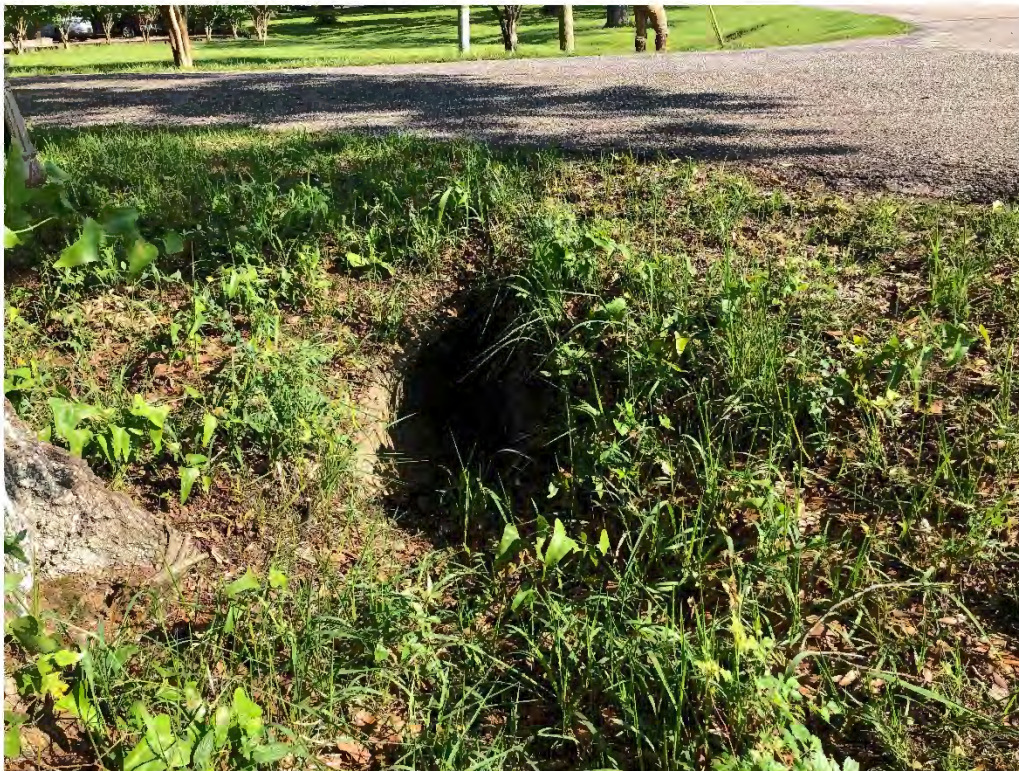
Figure 9319:
Photo taken facing South toward OAK-CO-21 along Pecan Grove St.

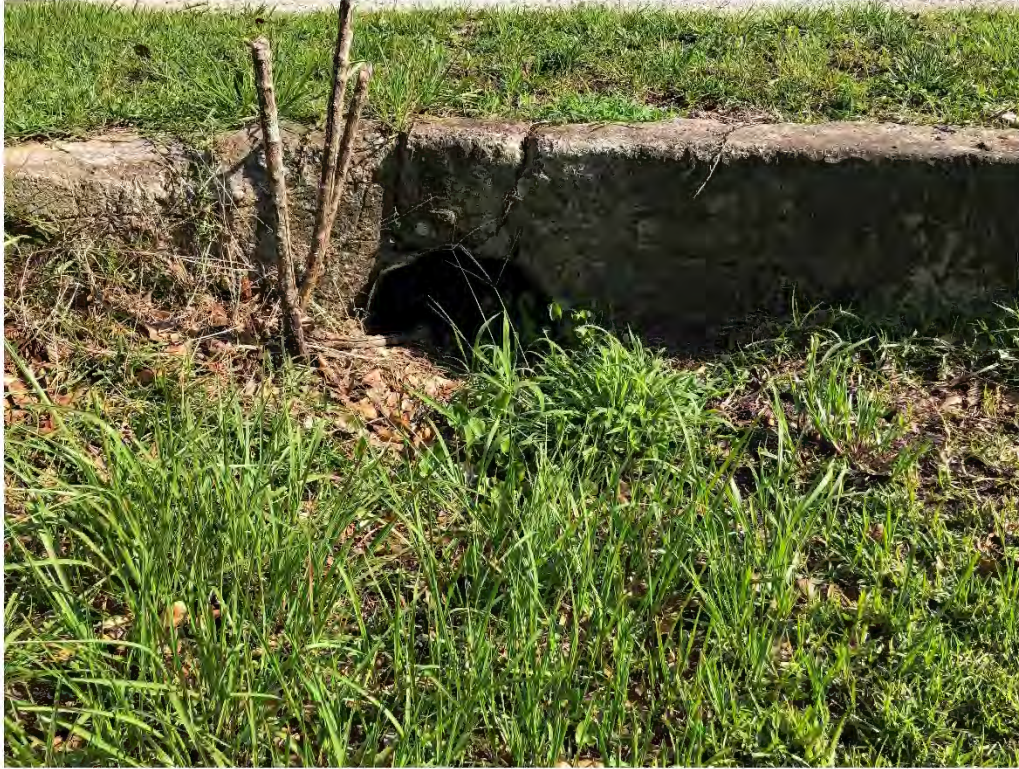
Figure 9321:
Photo taken facing North toward OAK-CO-20 along Pecan Grove St.

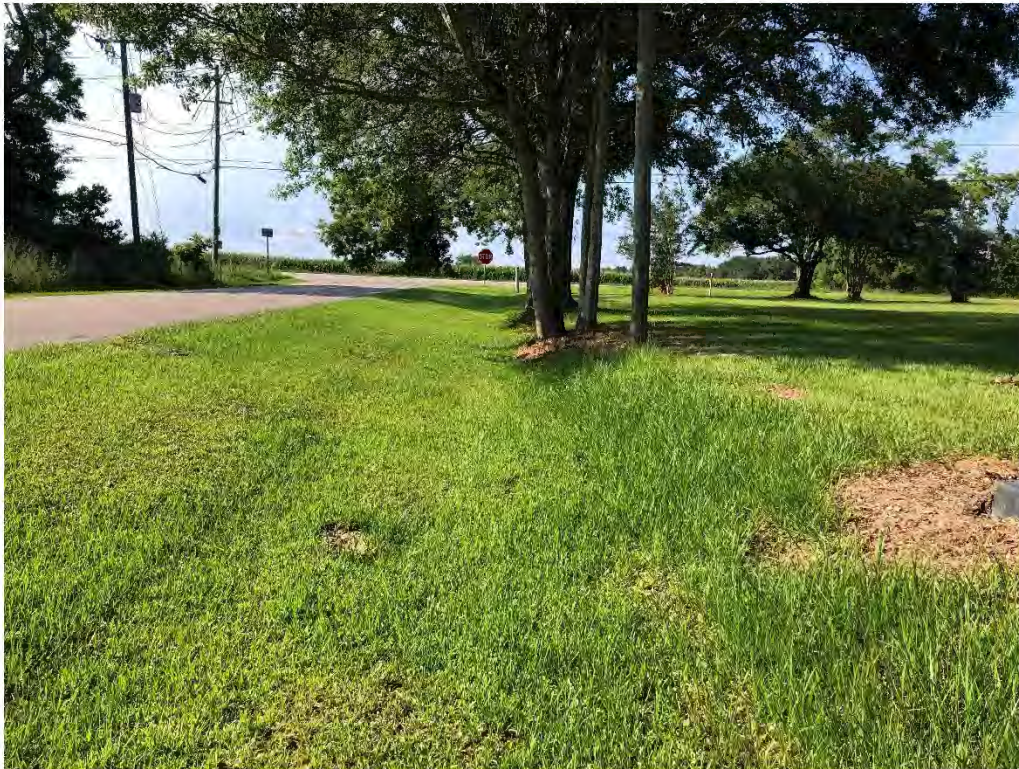
Figure 9322:
Photo taken facing North toward OAK-CH-24 along Pecan Grove St.

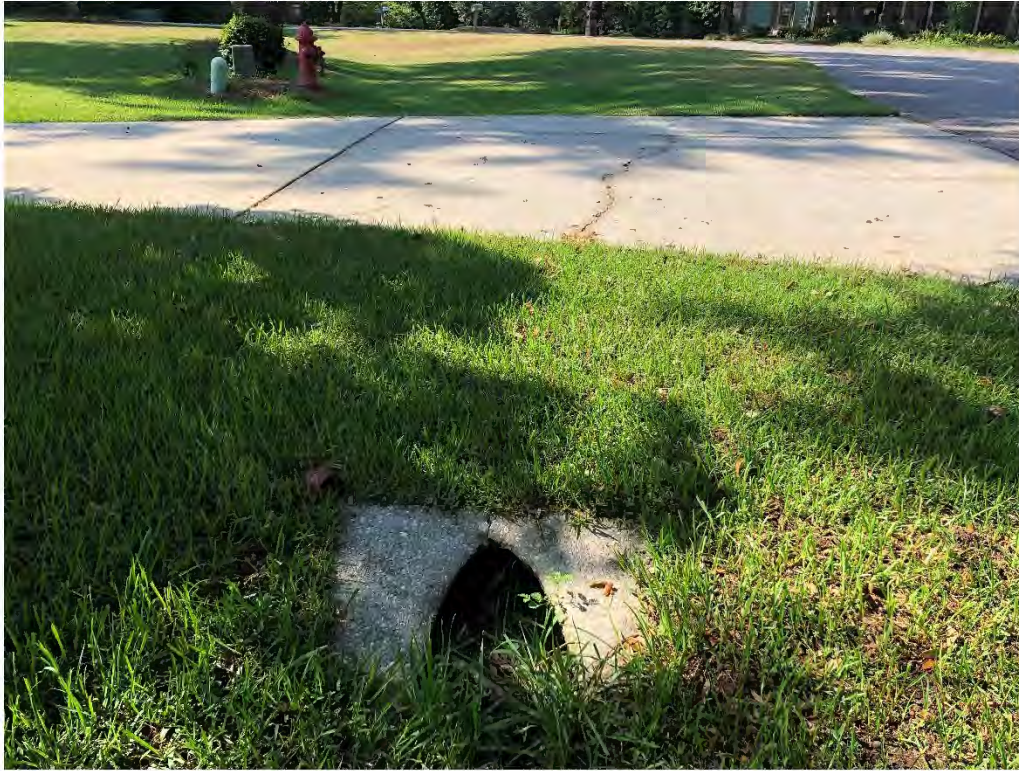
Figure 9486:
Photo taken facing South toward VG-CO-2 at the intersection of Village Green Drive and a residential driveway.

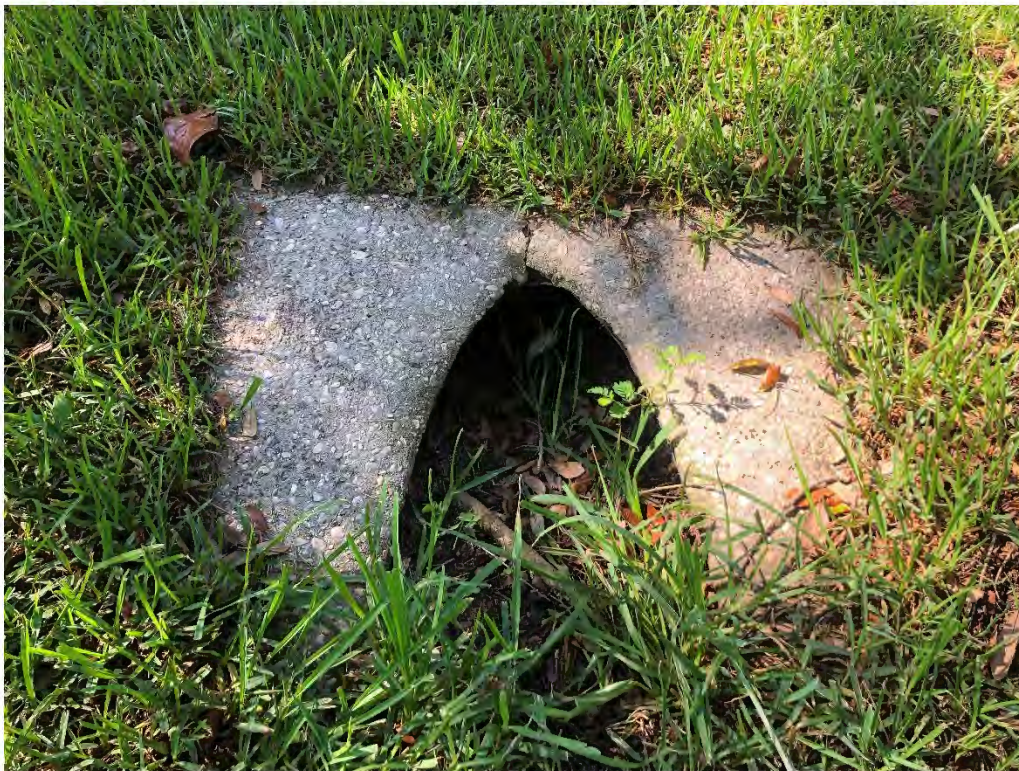
Figure 9487:

Photo taken facing South toward VG-CO-2 at the intersection of Village Green Drive and a residential driveway.

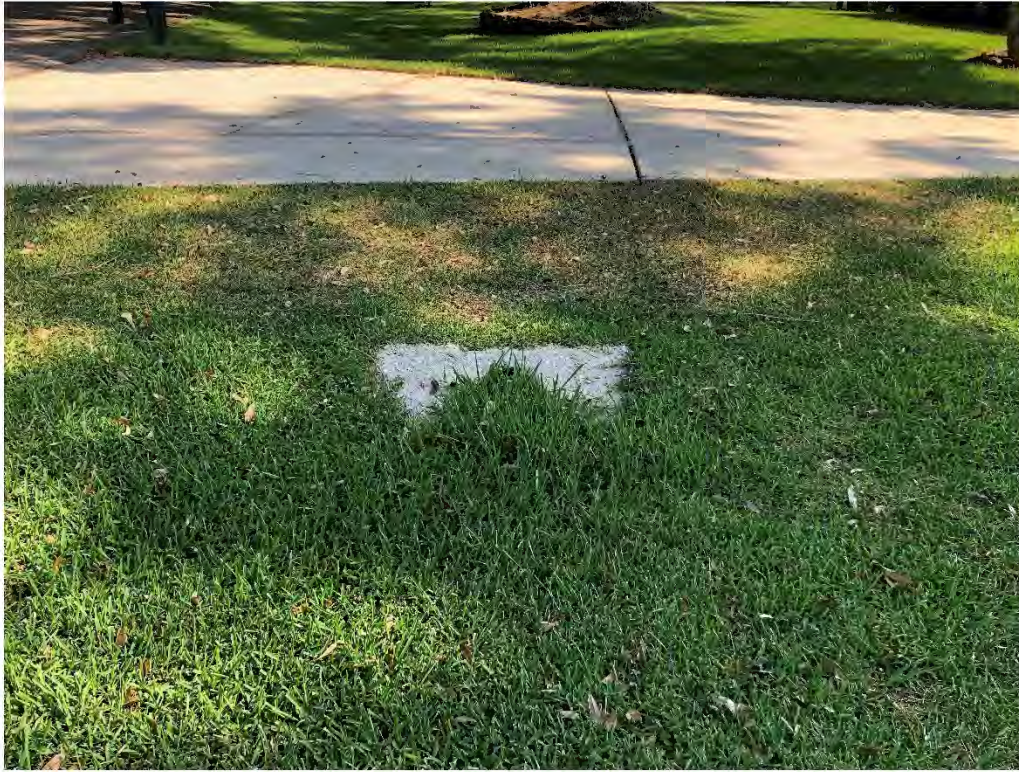
Figure 9488:

Photo taken facing North toward VG-CO-2 at the intersection of Village Green Drive and a residential driveway.

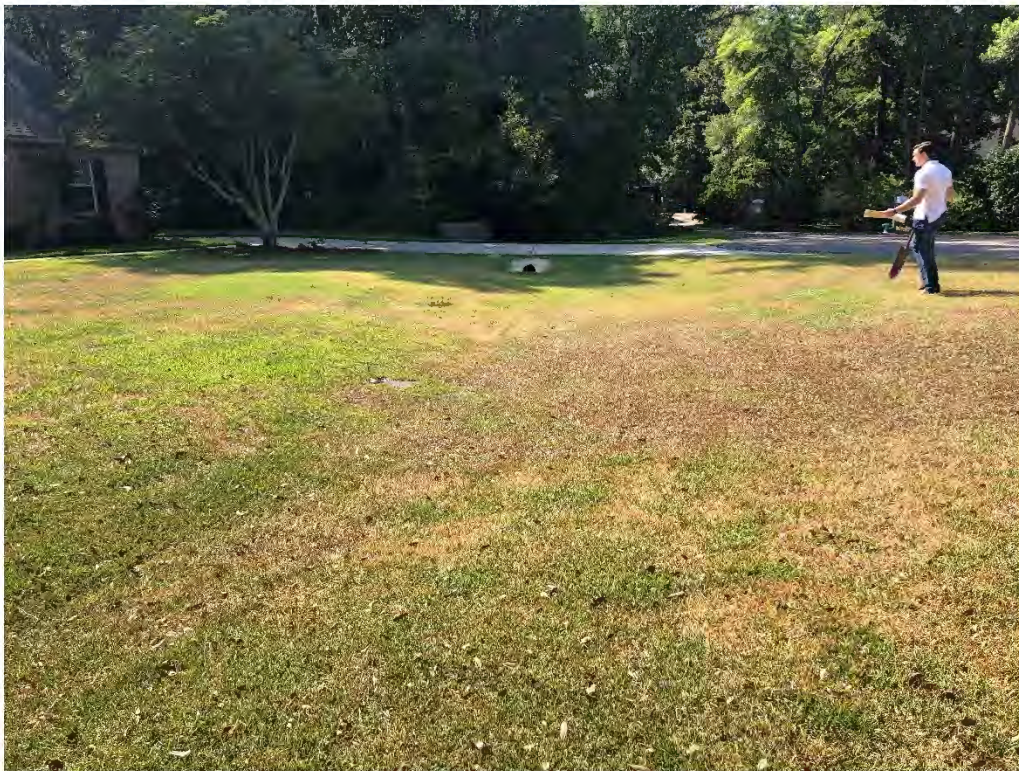
Figure 9490:

Photo taken facing SE toward VG-CH-2 at the intersection of Village Green Drive and a residential cul-de-sac.

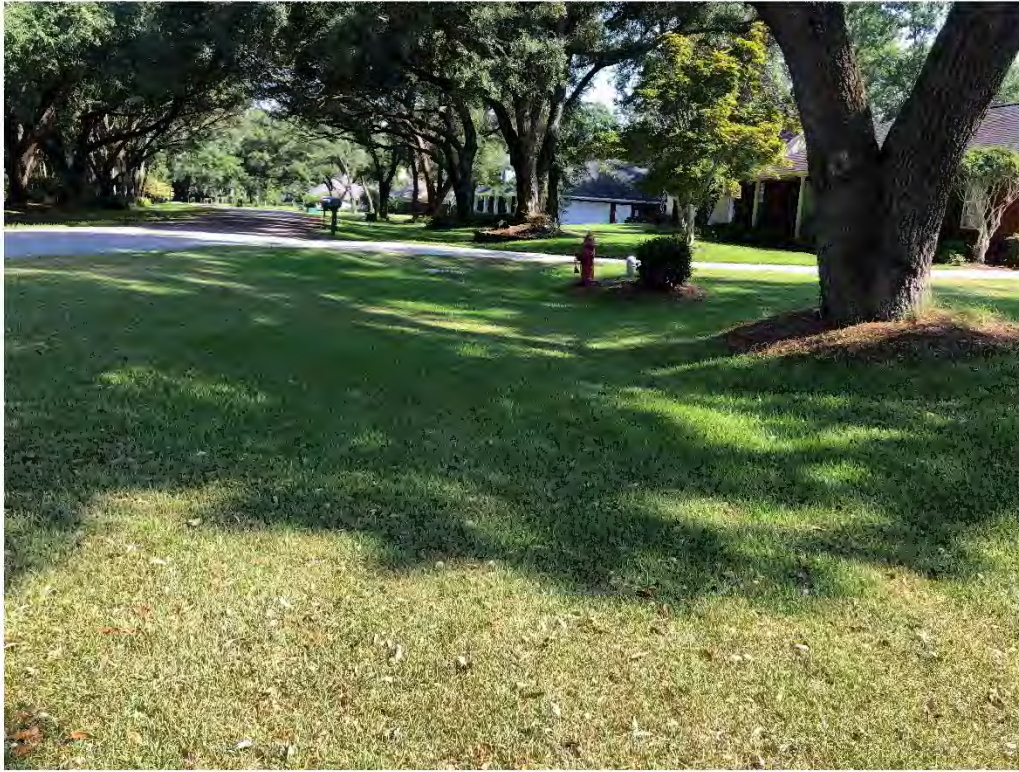
Figure 9491:

Photo taken facing North toward VG-CH-1 at the intersection of Village Green Drive and a residential driveway.

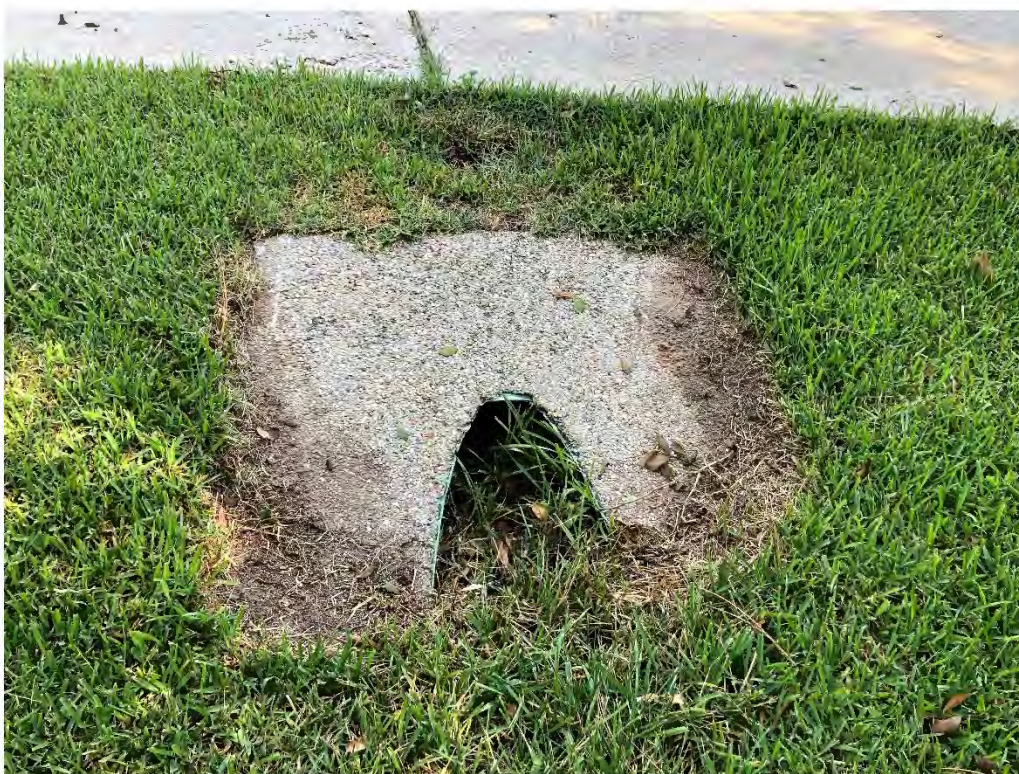
Figure 9493:

Photo taken facing NE toward VG-CH-2 at the intersection of Village Green Drive and a residential driveway.

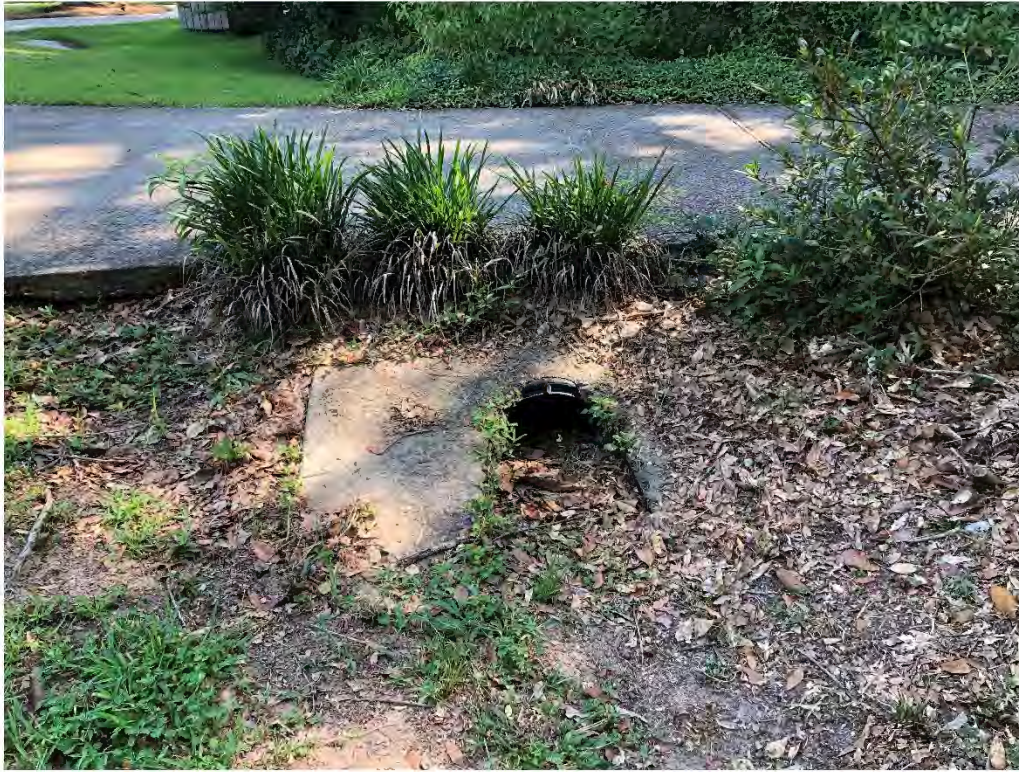
Figure 9494:

Photo taken facing NE toward VG-CO-3 at the intersection of Village Green Drive and a residential driveway.
