Town of Magnolia Springs Comprehensive Drainage Masterplan

Town of Magnolia Springs
Magnolia Springs, Baldwin County, Alabama

VOLKERT

March 2023

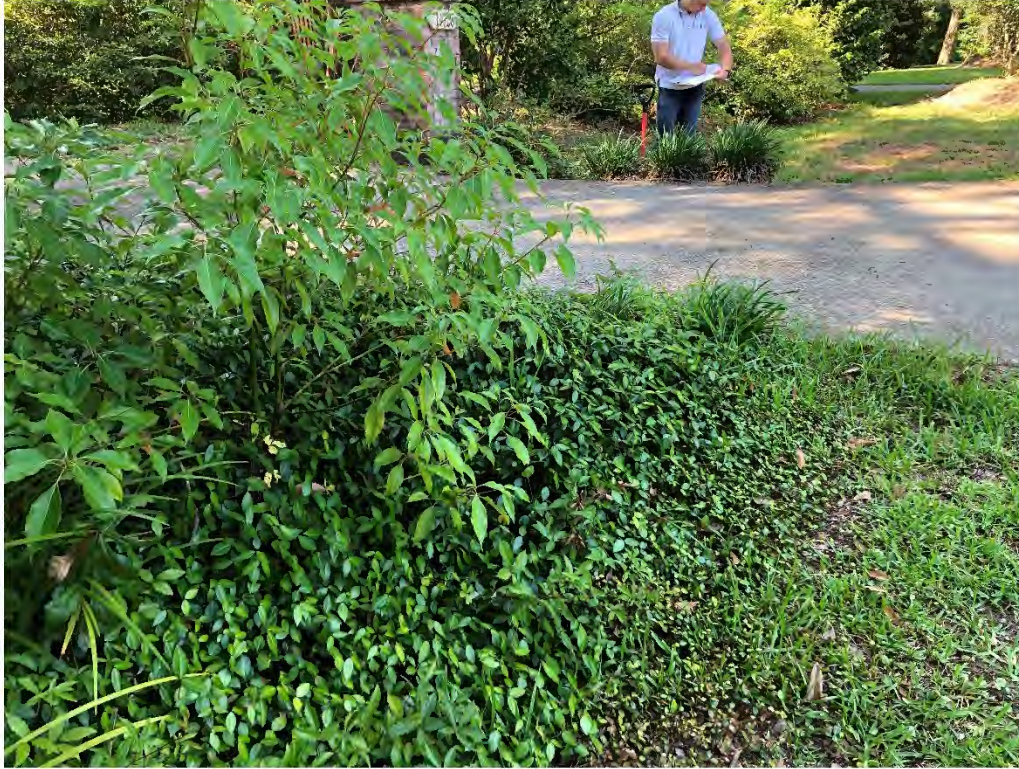
Figure 9495:
Photo taken facing West toward VG-CO-3 at the intersection of Village Green Drive and a residential driveway.

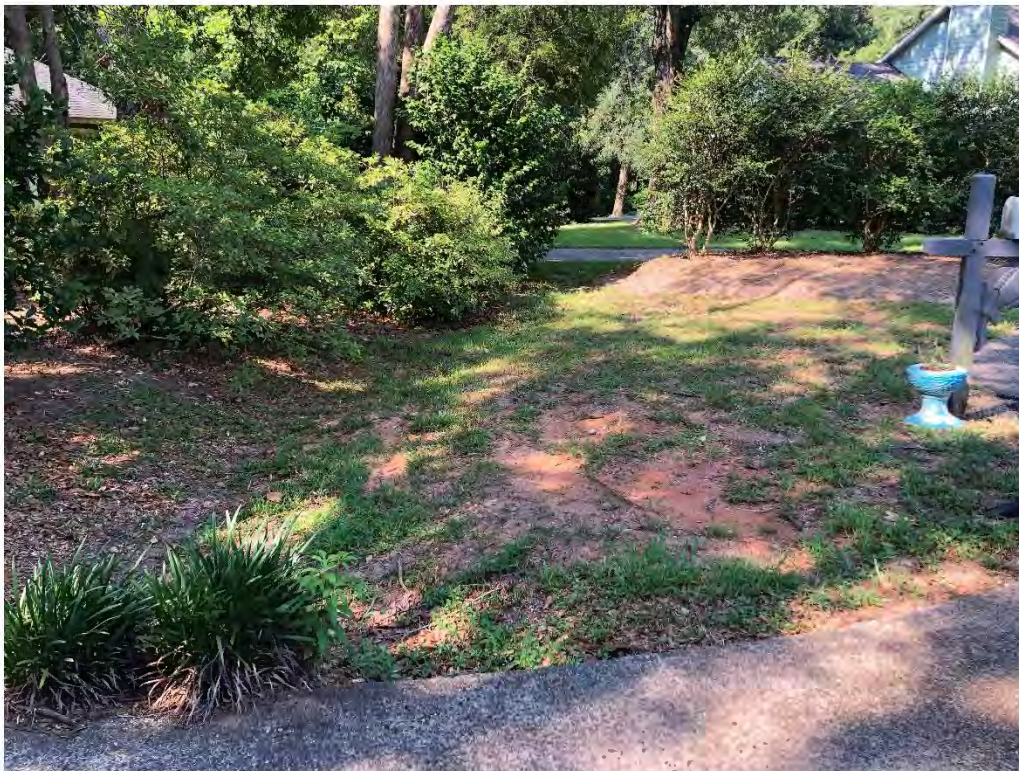
Figure 9496:

Photo taken facing East toward VG-CH-3 at the intersection of Village Green Drive and a residential driveway.

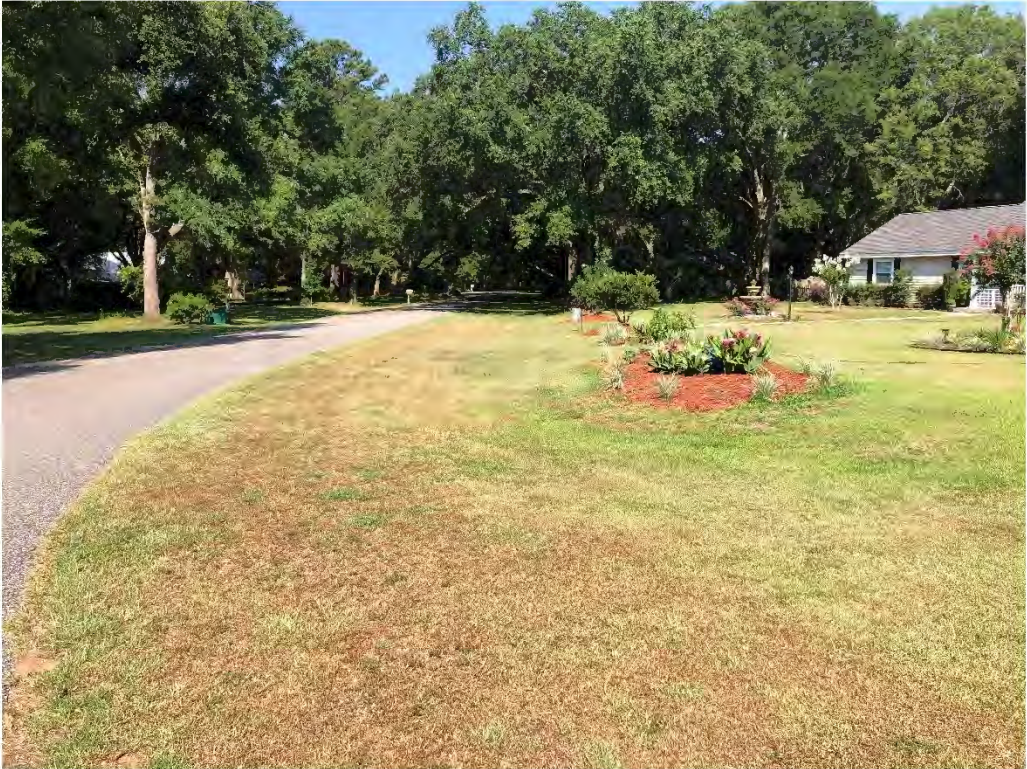
Figure 9499:

Photo taken facing West toward VG-CH-11 at the intersection of Village Green Drive and a residential driveway.

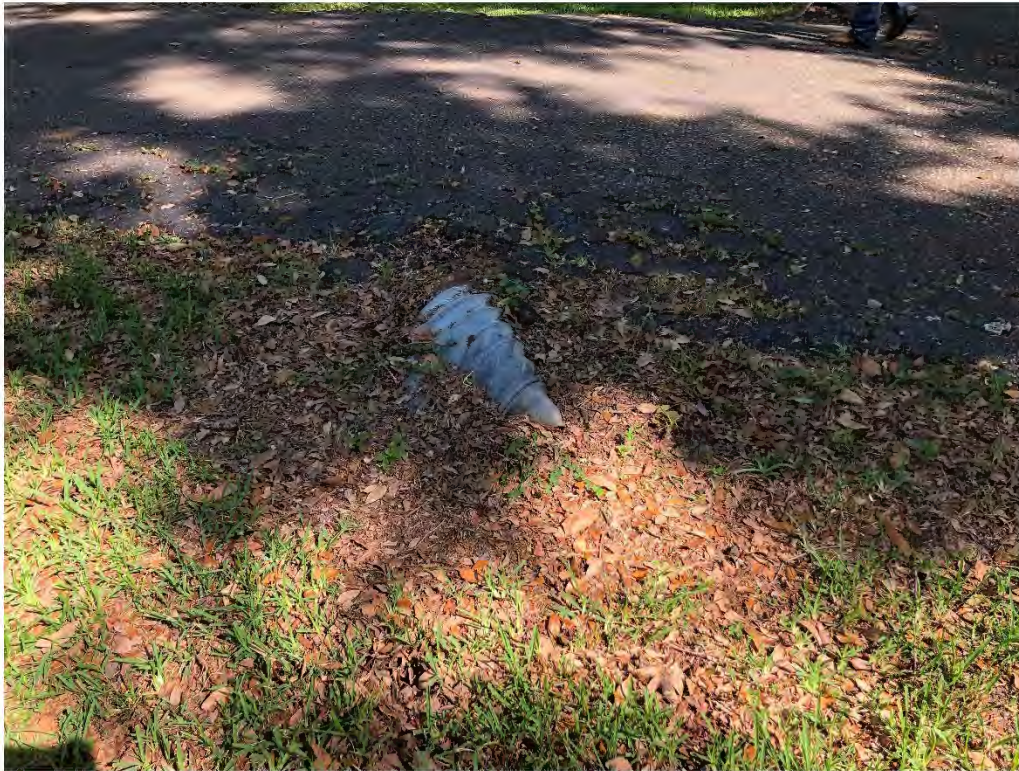
Figure 9500:

Photo taken facing West toward VG-CO-1 at the intersection of Village Green Drive and a residential driveway.

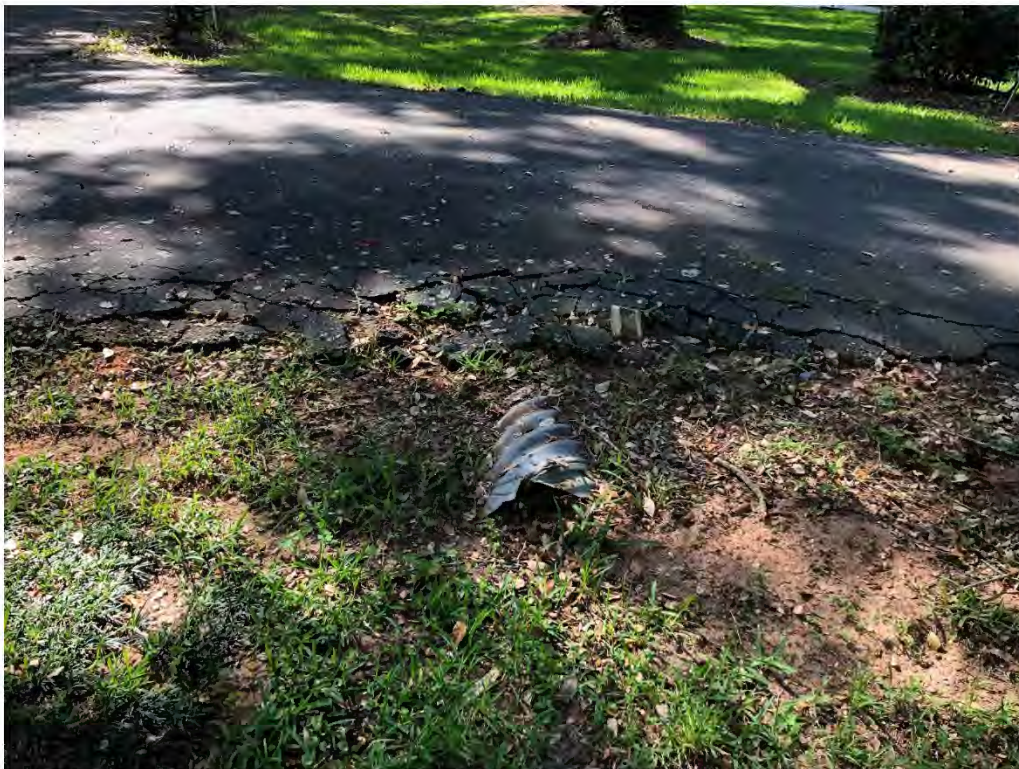
Figure 9502:

Photo taken facing East toward VG-CO-1 at the intersection of Village Green Drive and a residential driveway.

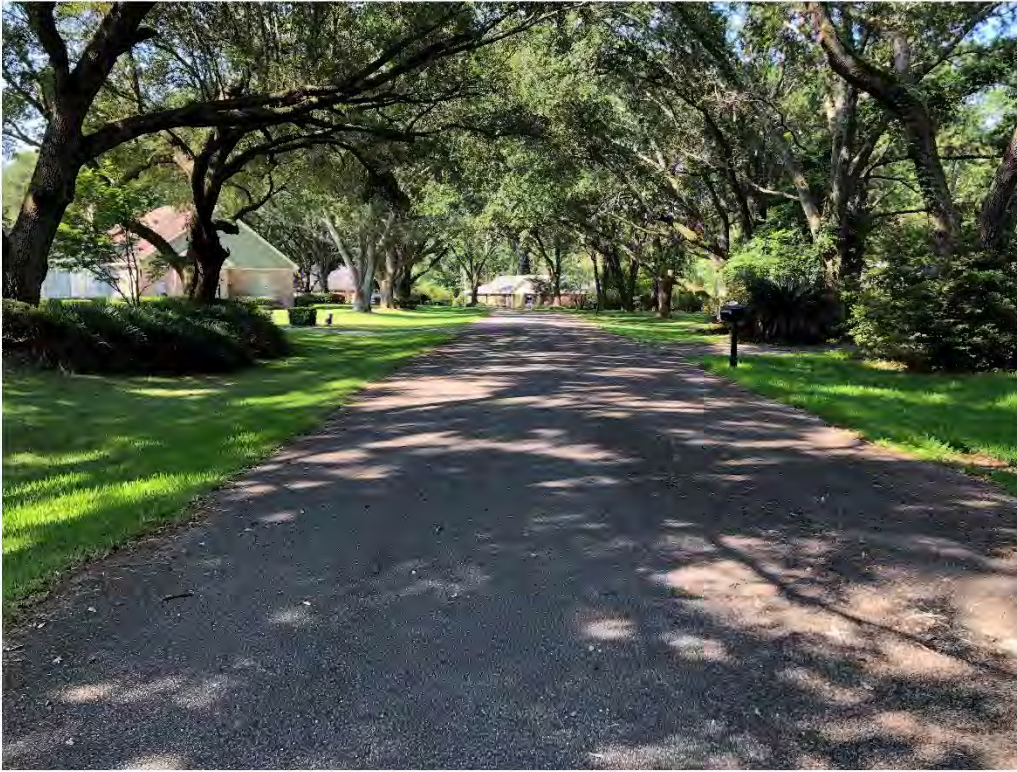
Figure 9505:

Photo taken facing South toward the intersection of Village Green Drive and a residential driveway.

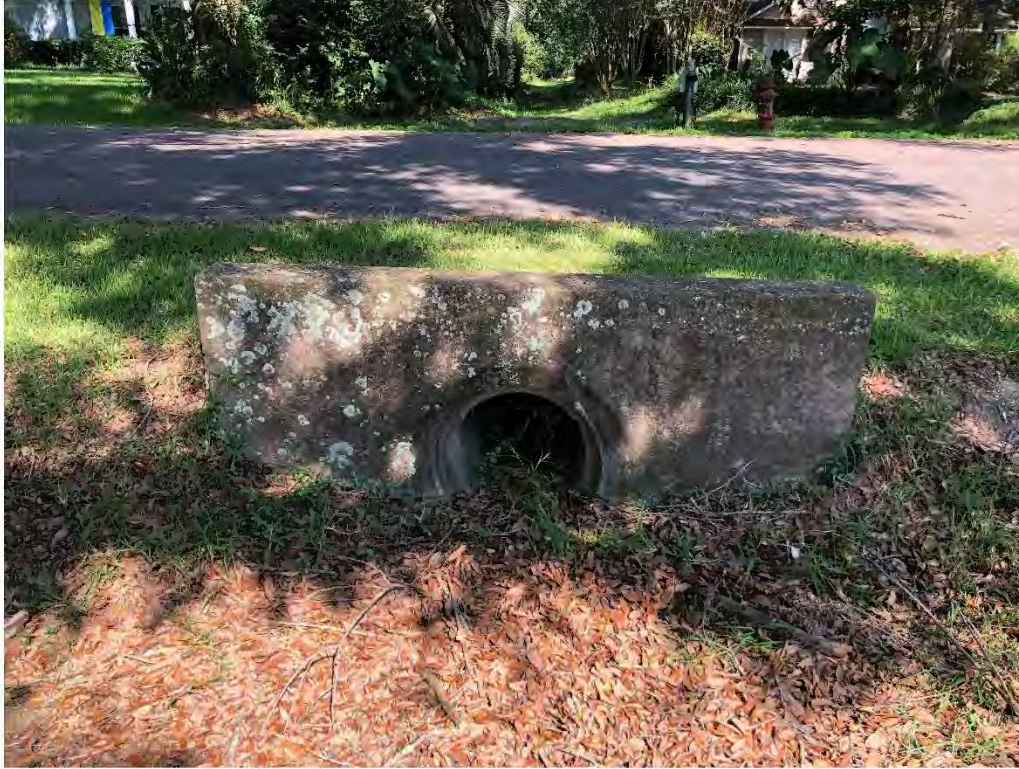
Figure 9506:
Photo taken facing West toward VG-CO-7 that crosses Village Green Drive.

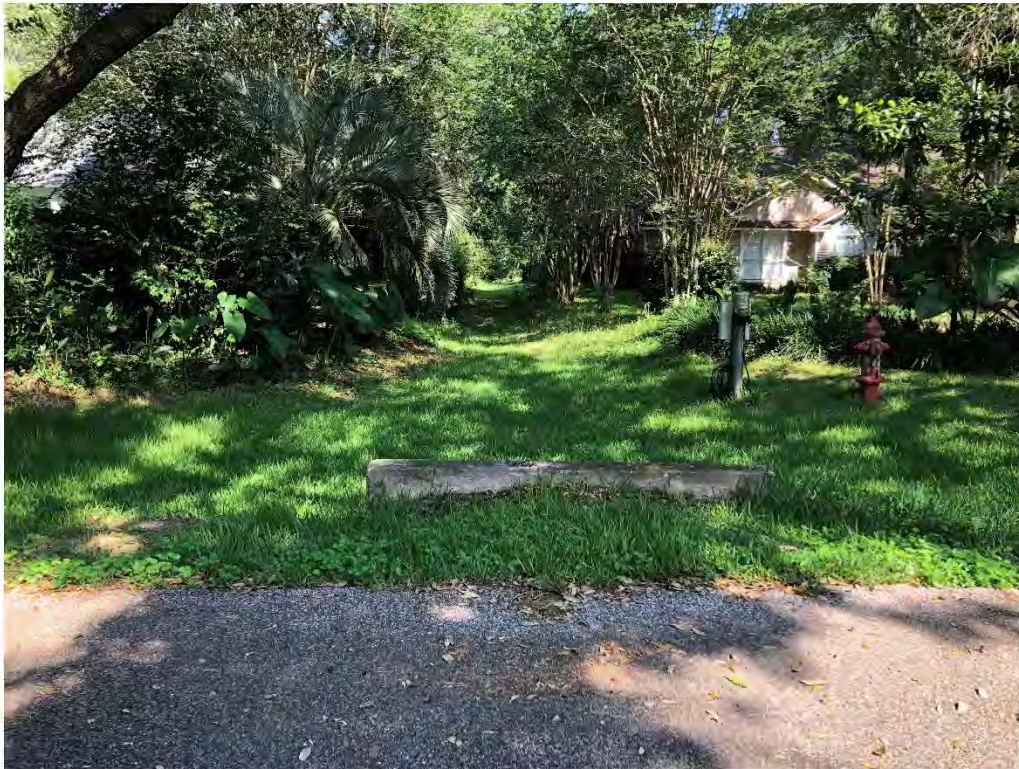
Figure 9507:
Photo taken facing West toward VG-CH-6 along Village Green Drive.

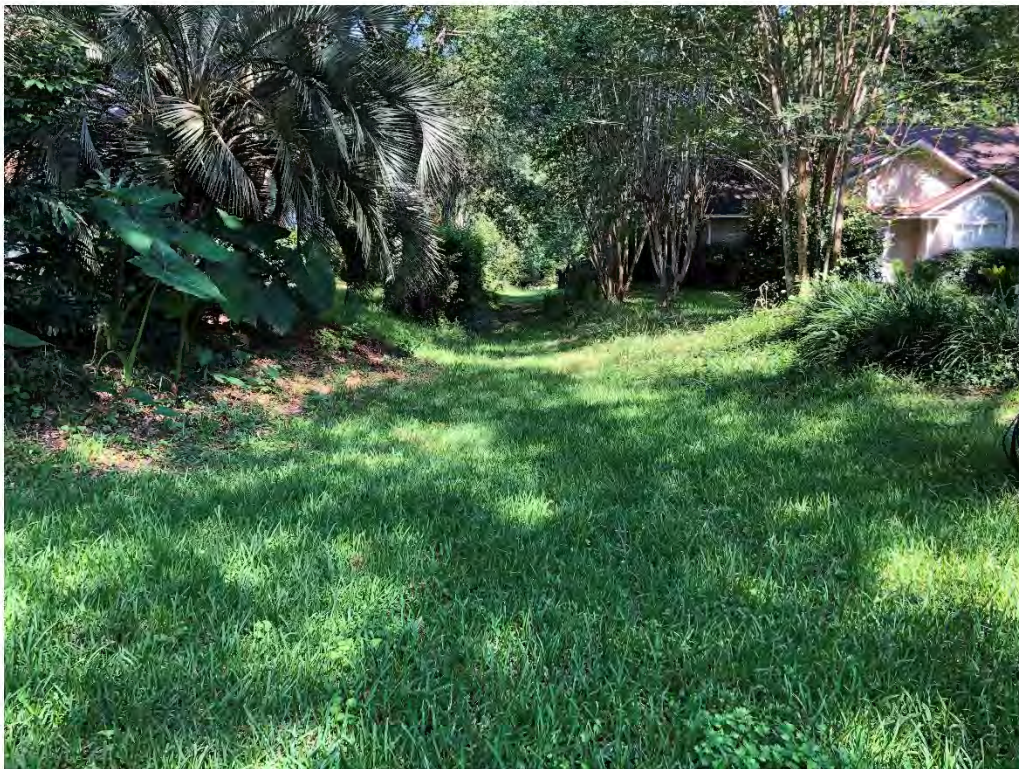
Figure 9509:
Photo taken facing West toward VG-CH-7 along Village Green Drive.

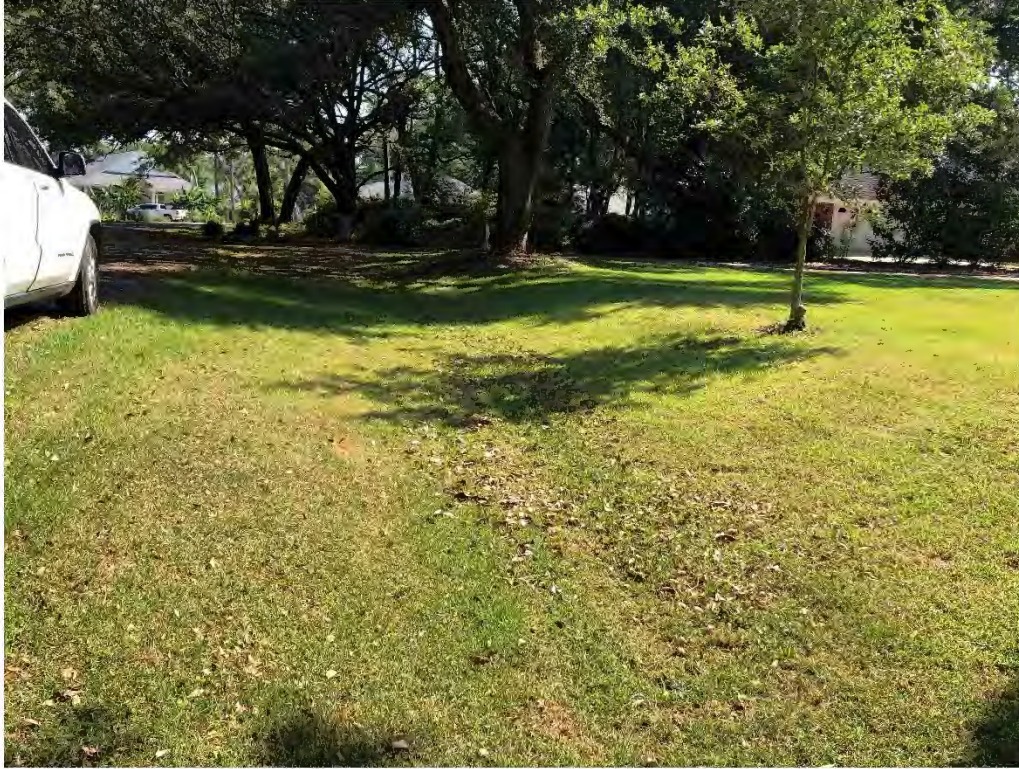
Figure 9510:
Photo taken facing North of Village Green Drive.

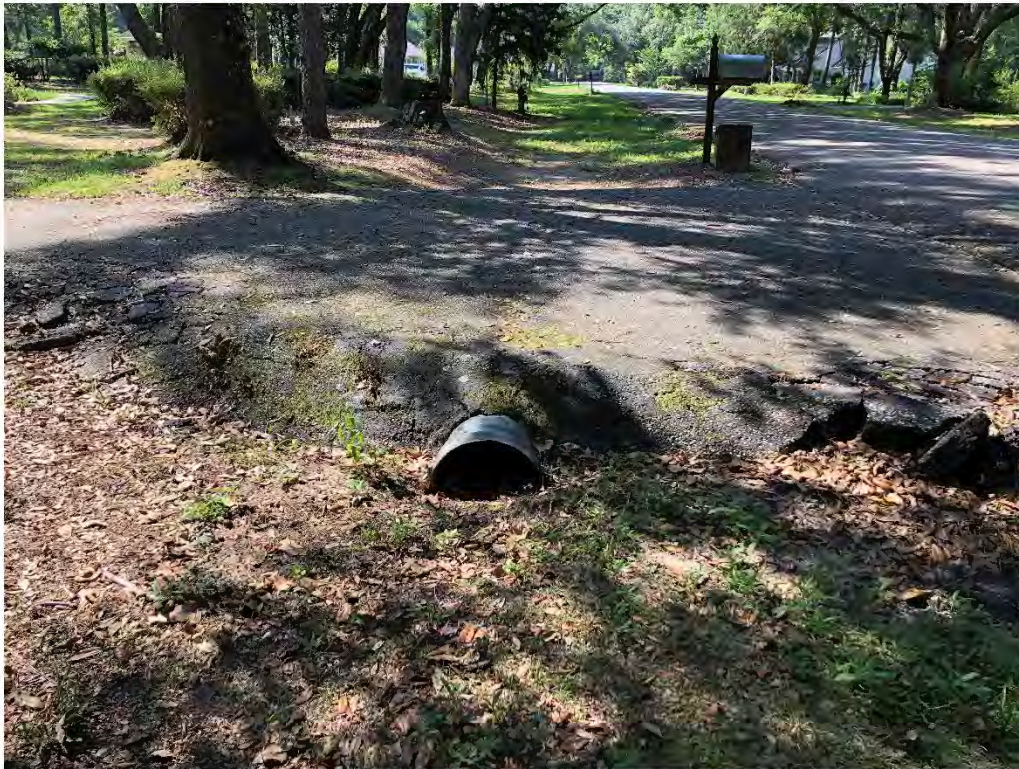
Figure 9511:

Photo taken facing SE toward a pipe at the intersection of Village Green Drive and a residential driveway.

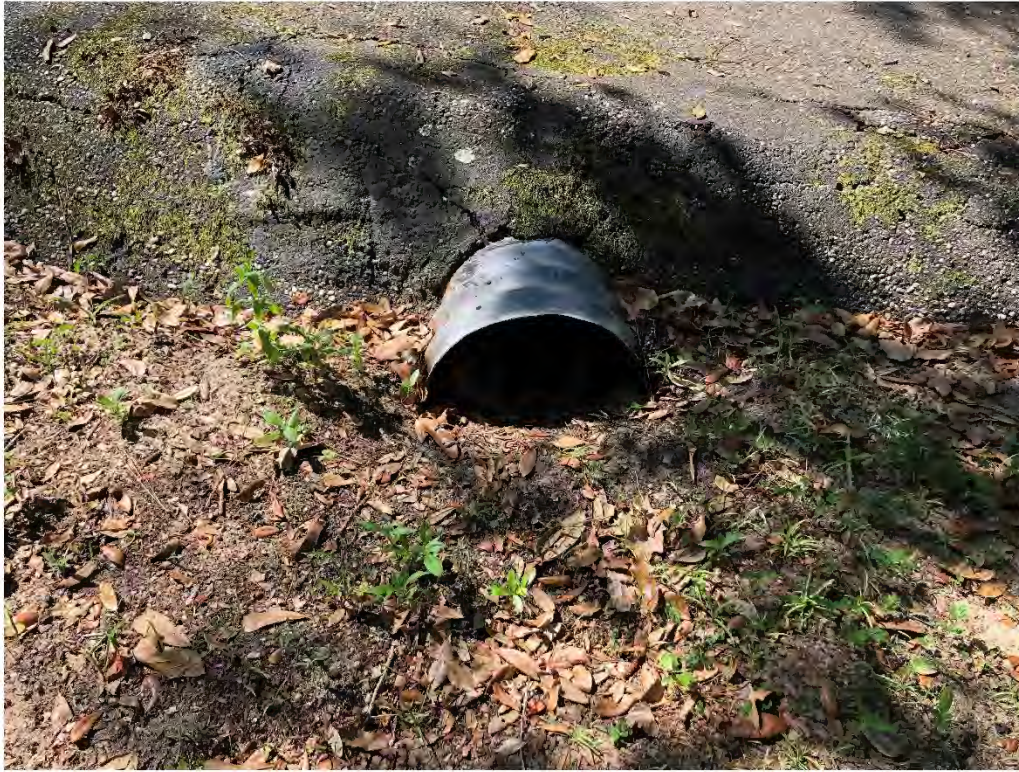
Figure 9512:

Photo taken facing NW toward a pipe at the intersection of Village Green Drive and a residential driveway.

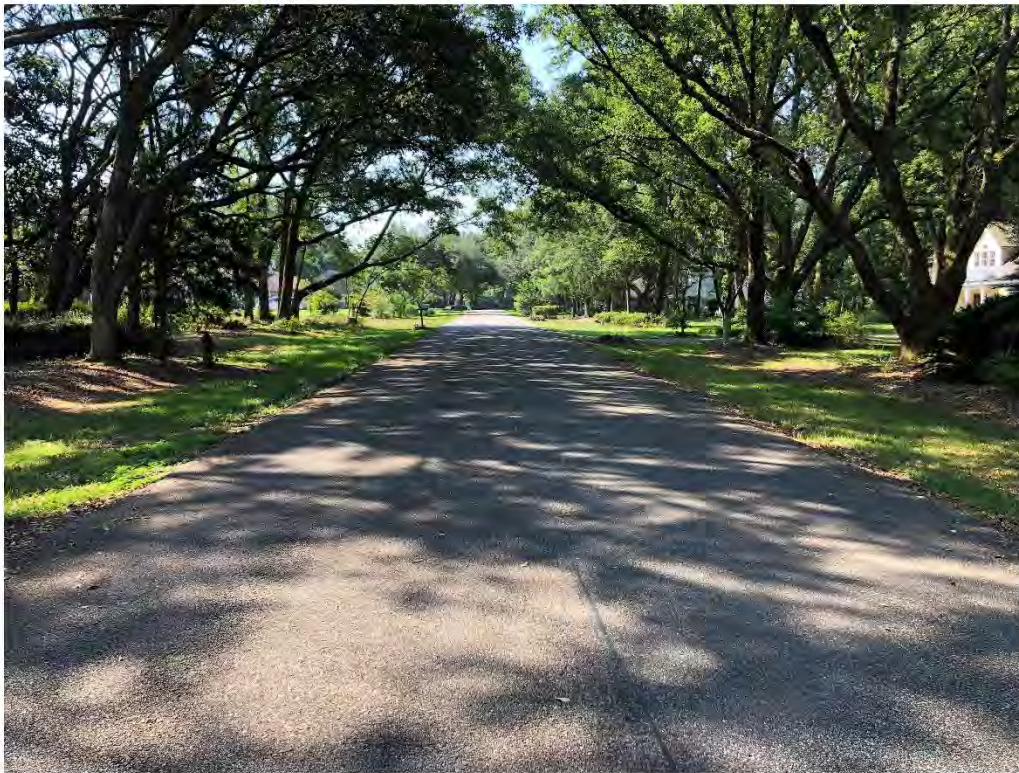
Figure 9514:
Photo taken facing SE of a ditch along Village Green Drive.

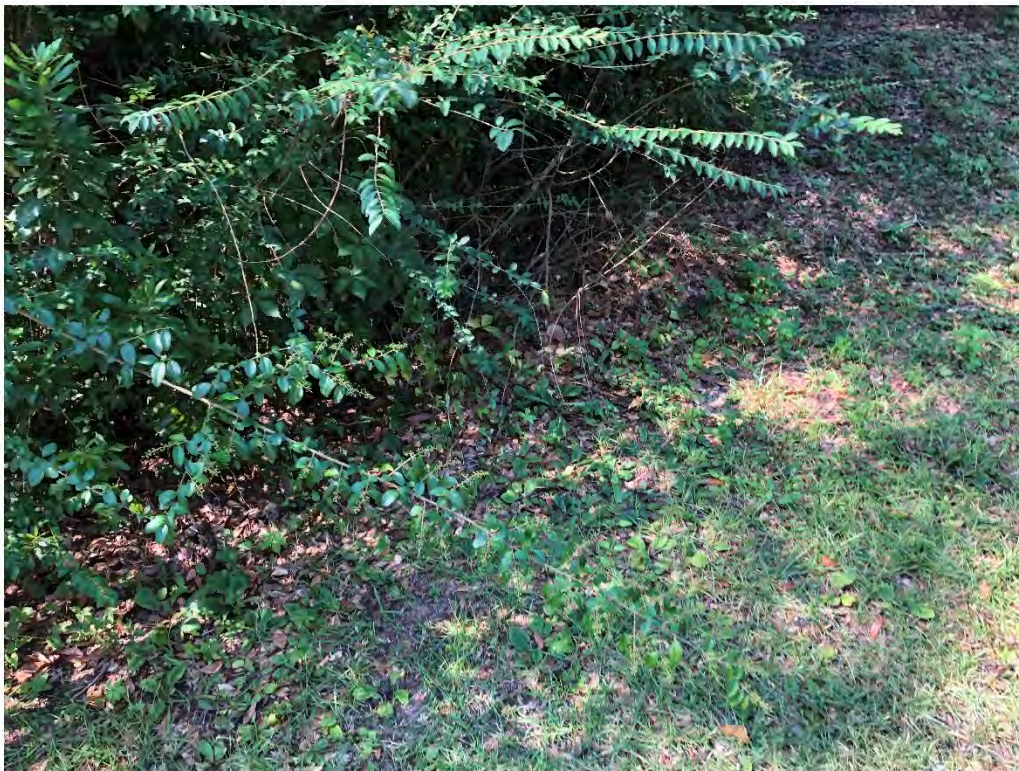
Figure 9516:
Photo taken along Cotton Stocking Lane.

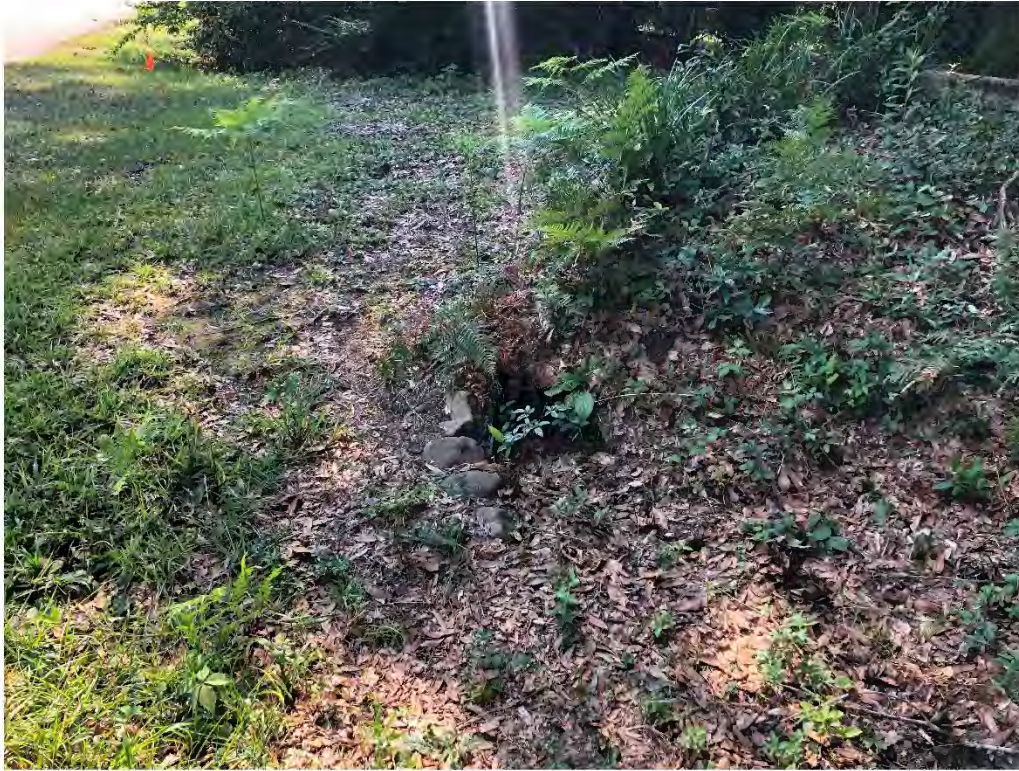
Figure 9517:
Photo taken of VG-CO-5 across Cotton Stocking Lane.

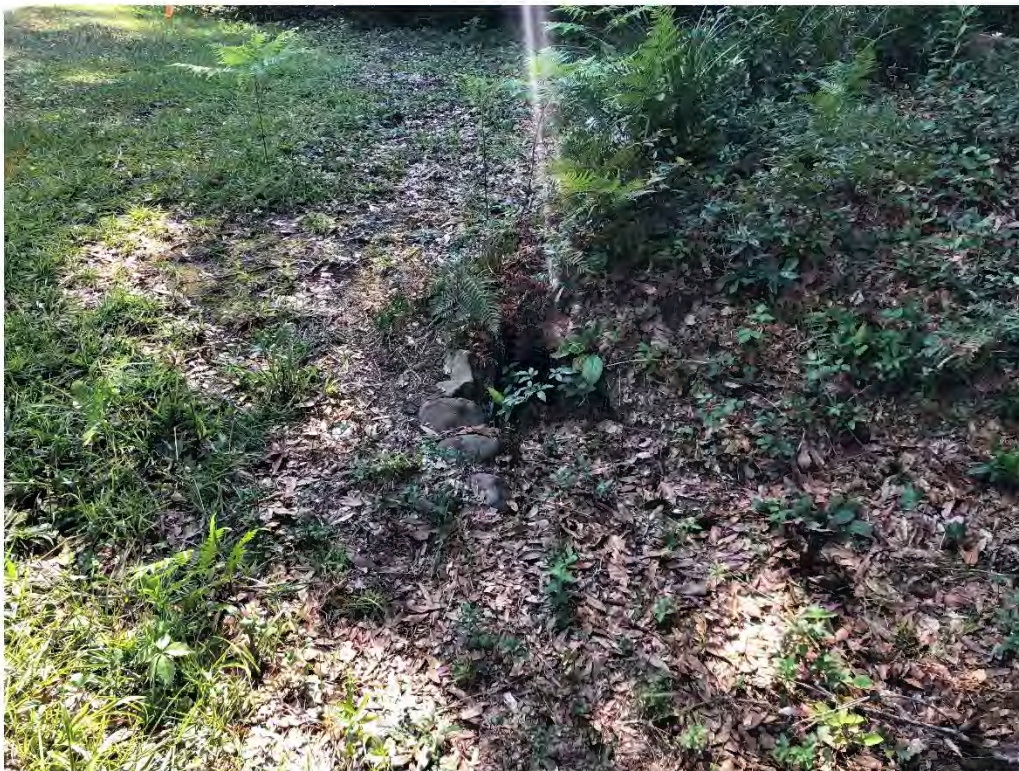
Figure 9518:
Photo taken of VG-CO-5 across Cotton Stocking Lane.

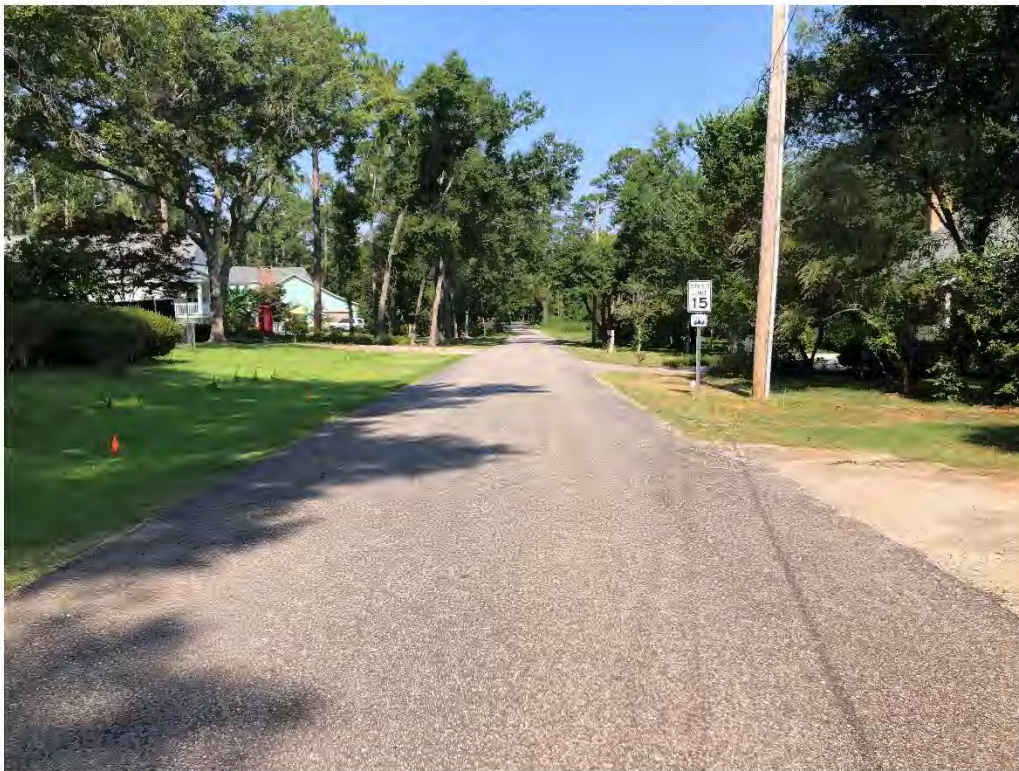
Figure 9520:
Photo taken facing West toward a ditch along Cotton Stocking Lane.

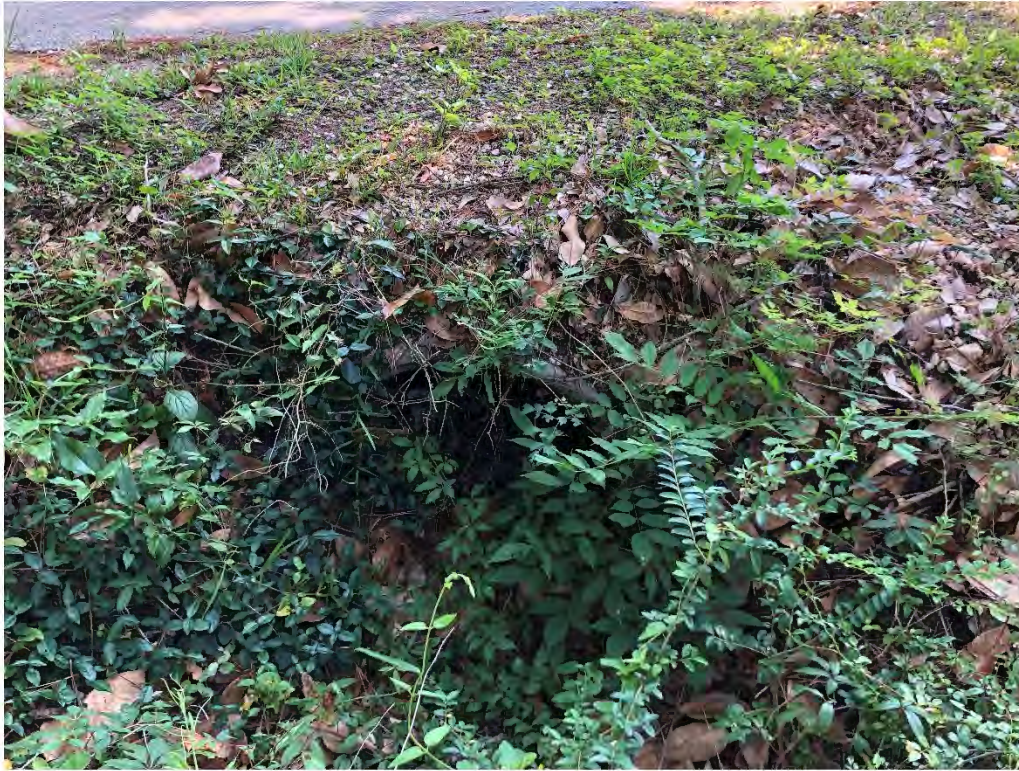
Figure 9521:
Photo taken of a pipe across Cotton Stocking Lane.

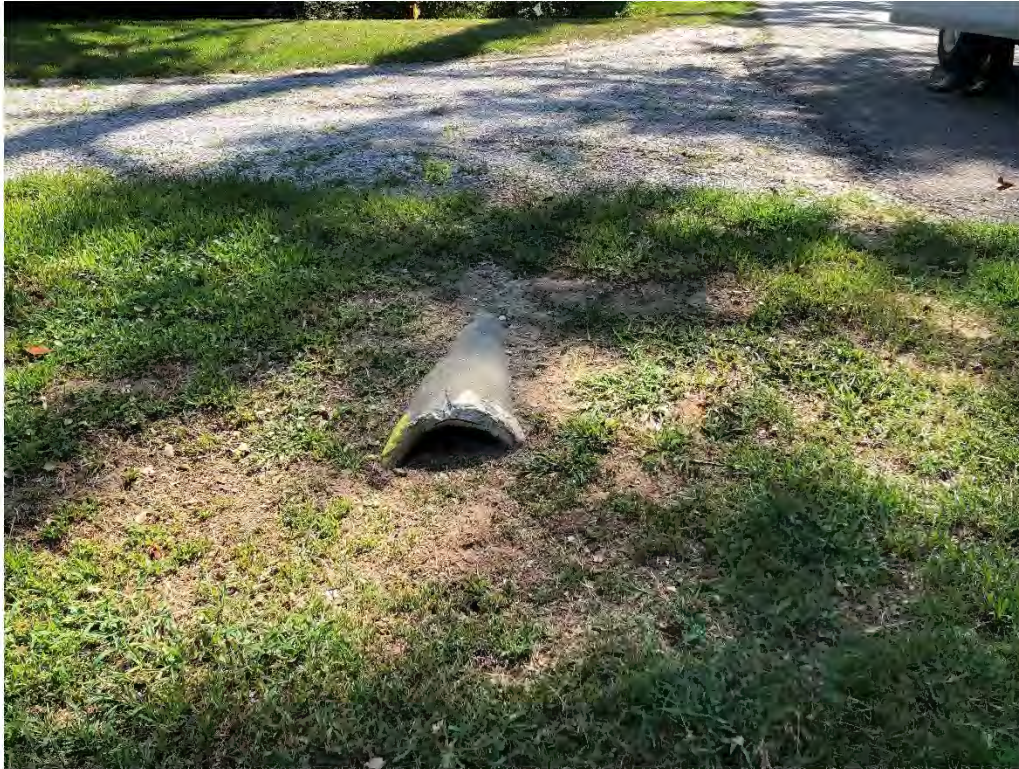
Figure 9523:
Photo taken of a pipe across a residential driveway along Cotton Stocking Lane.

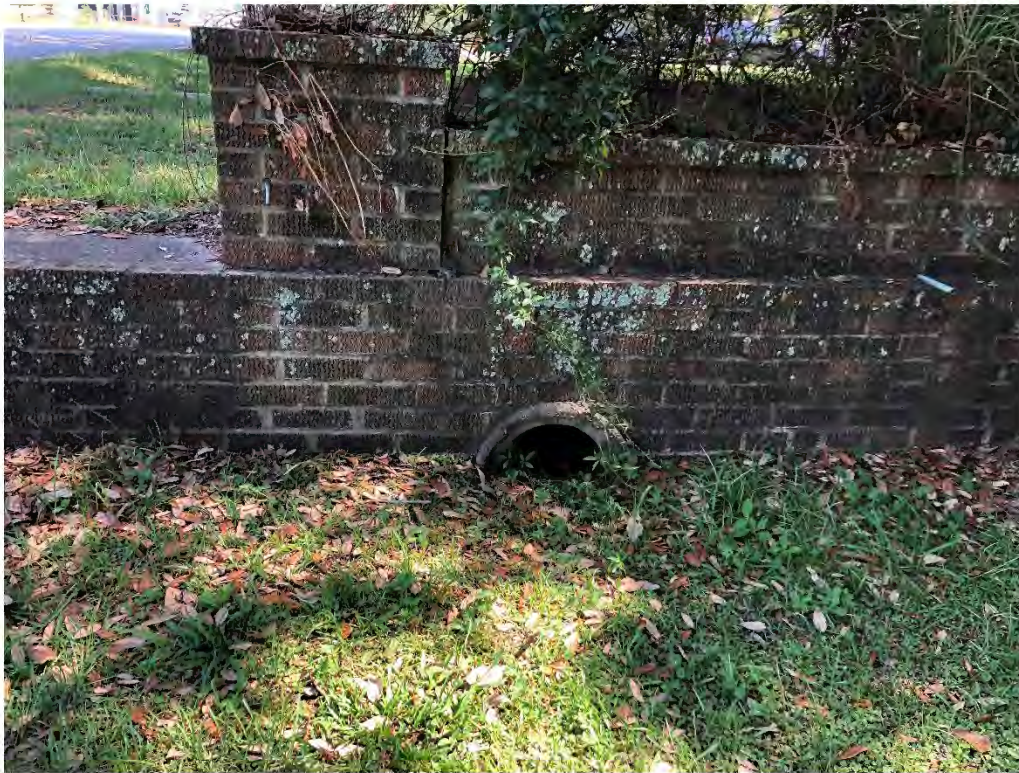
Figure 9527:

Photo taken facing North toward MN-CO-1 at the intersection of Magnolia Springs HWY and driveway.

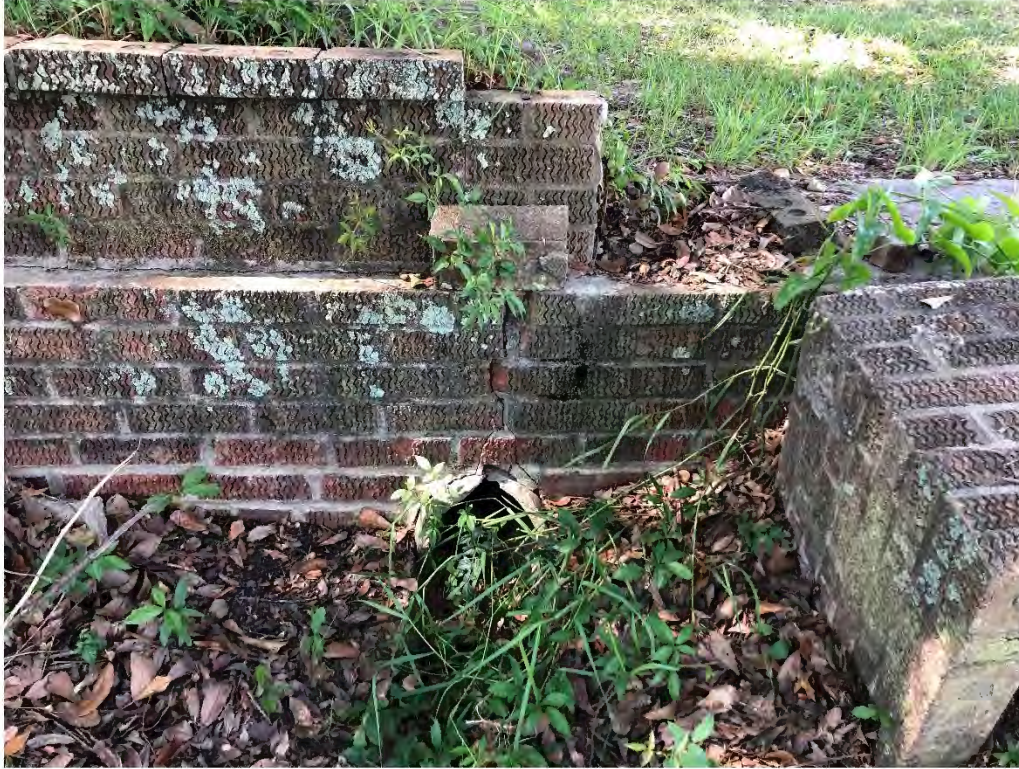
Figure 9528:

Photo taken facing South toward MN-CO-1 at the intersection of Magnolia Springs HWY and driveway.

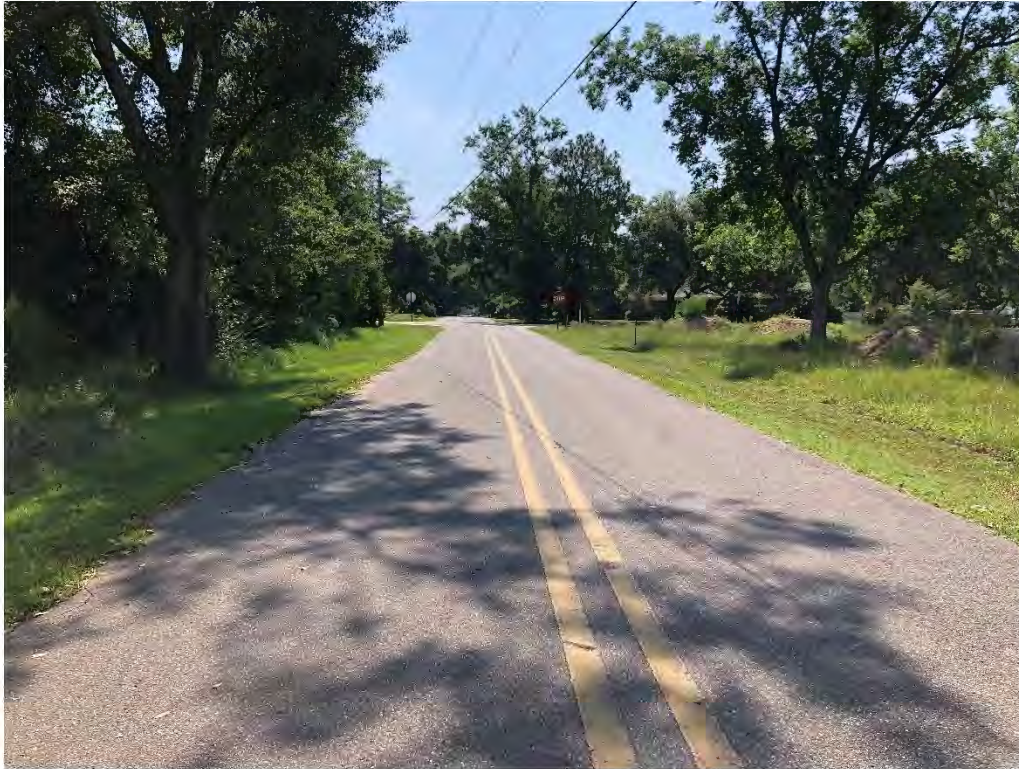
Figure 9535:
Photo taken facing West toward OAK-CO-29 at the intersection of Camelia Ave and a driveway.

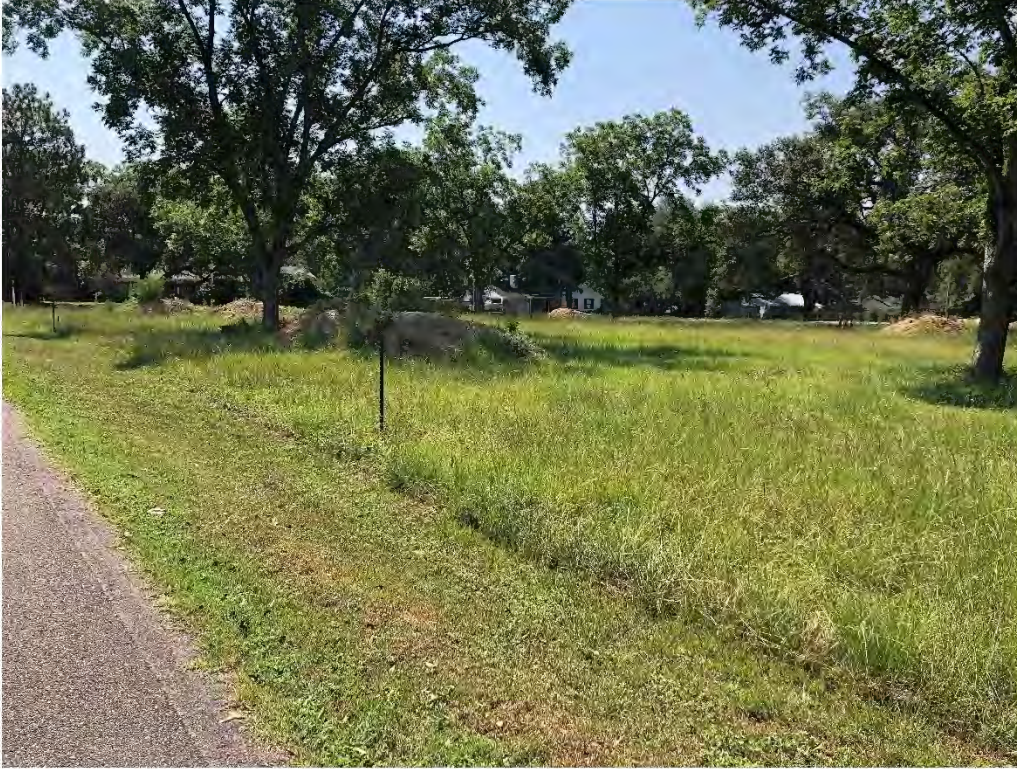
Figure 9539:
Photo taken facing West toward the open field along the northern side of Camelia Ave.

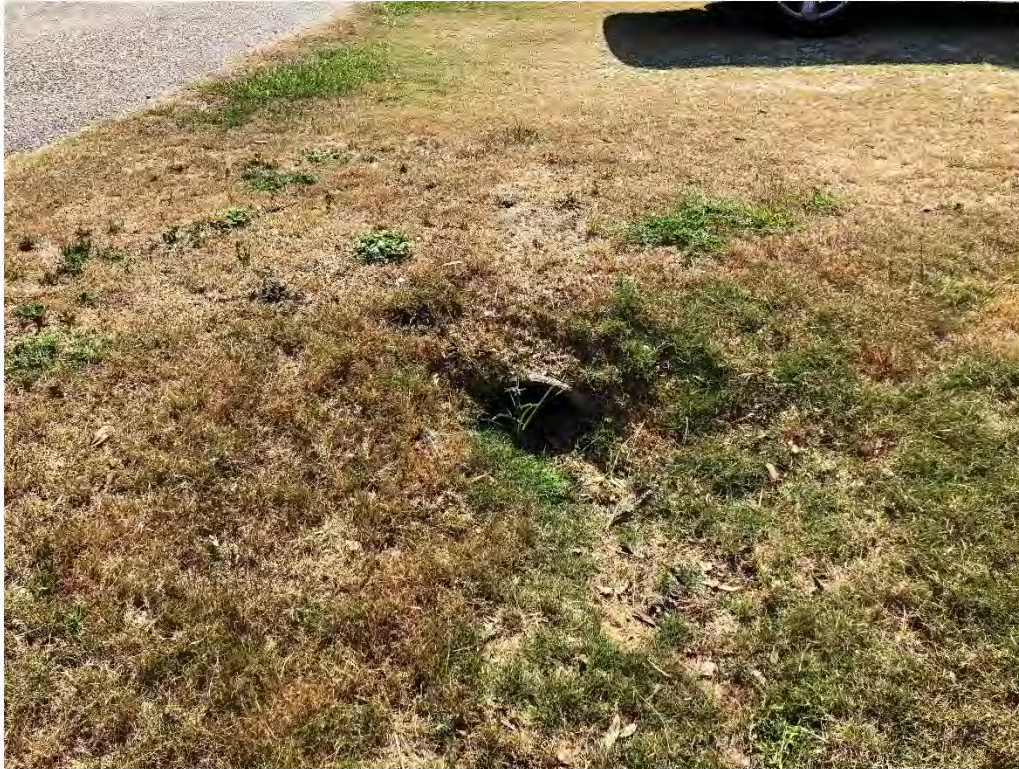
Figure 9541:
Photo taken facing West toward OAK-CH-7 at the intersection of Camelia Ave and a driveway.

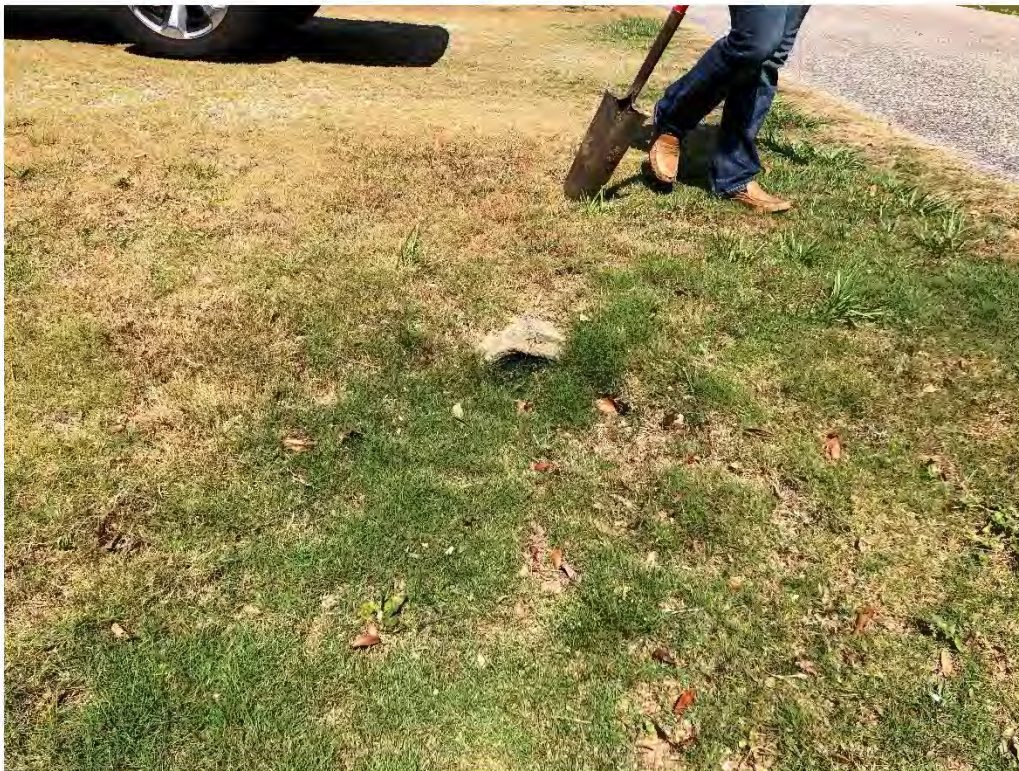
Figure 9544:
Photo taken facing East toward a ditch at the intersection of Camelia Ave and a driveway.

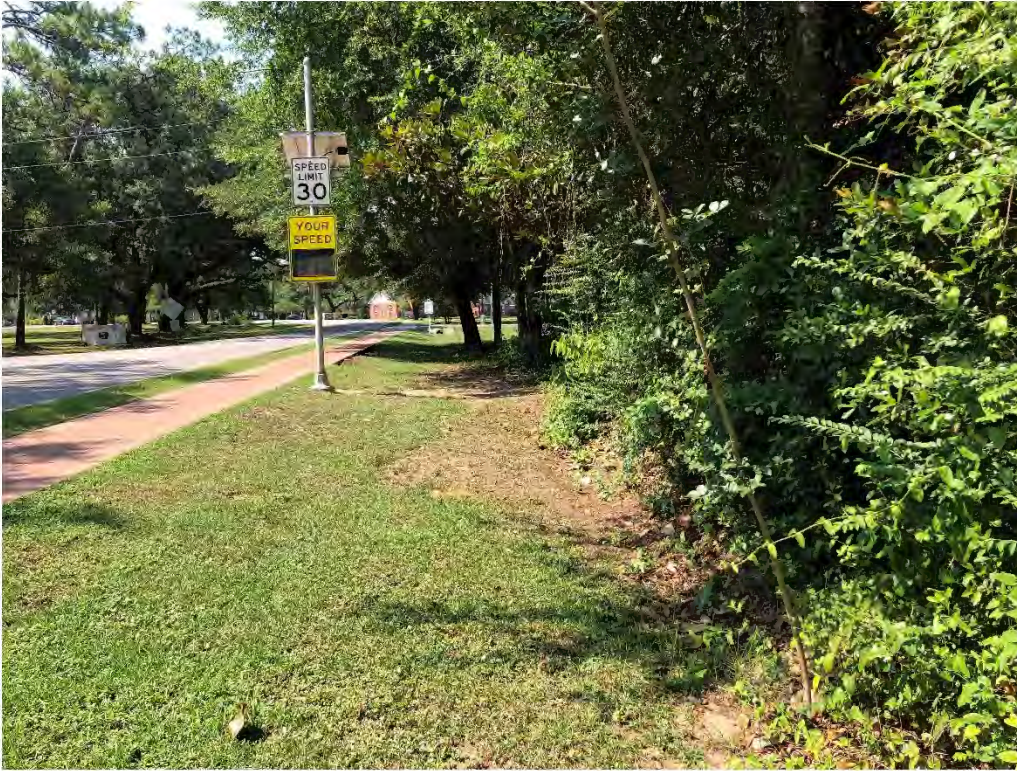
Figure 9547:
Photo taken of OAK-CO-31 at the intersection of HWY 49 and School Street.

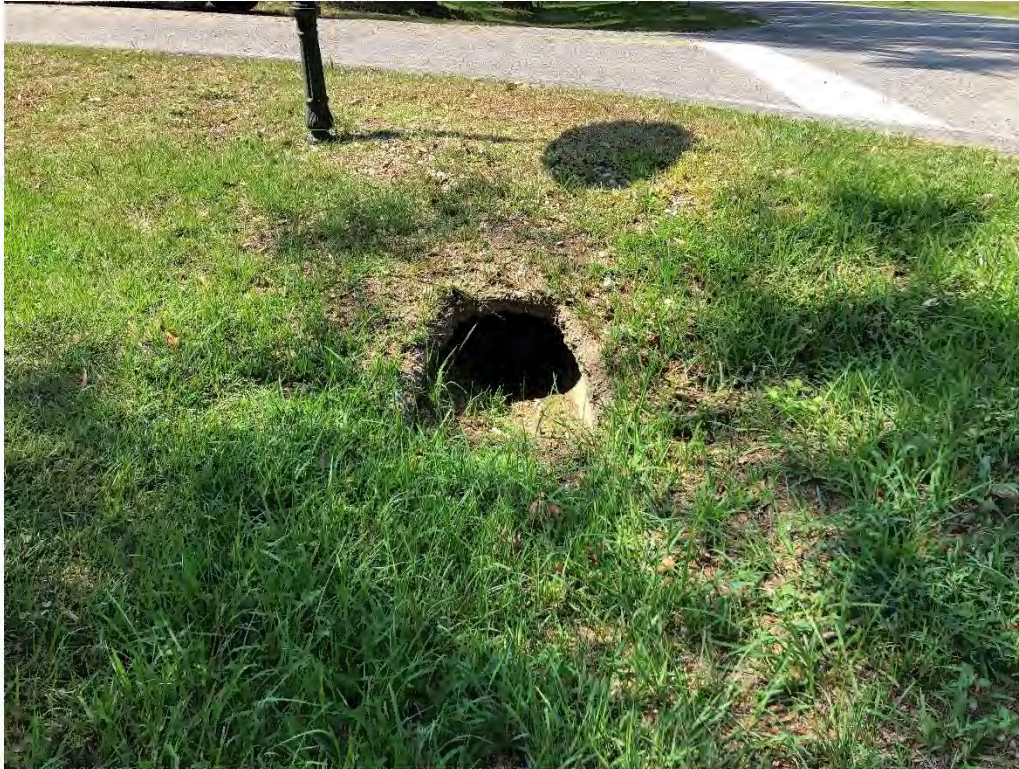
Figure 9551:
Photo taken facing North toward MN-CH-2 at the intersection of HWY 49 and Camelia Ave.

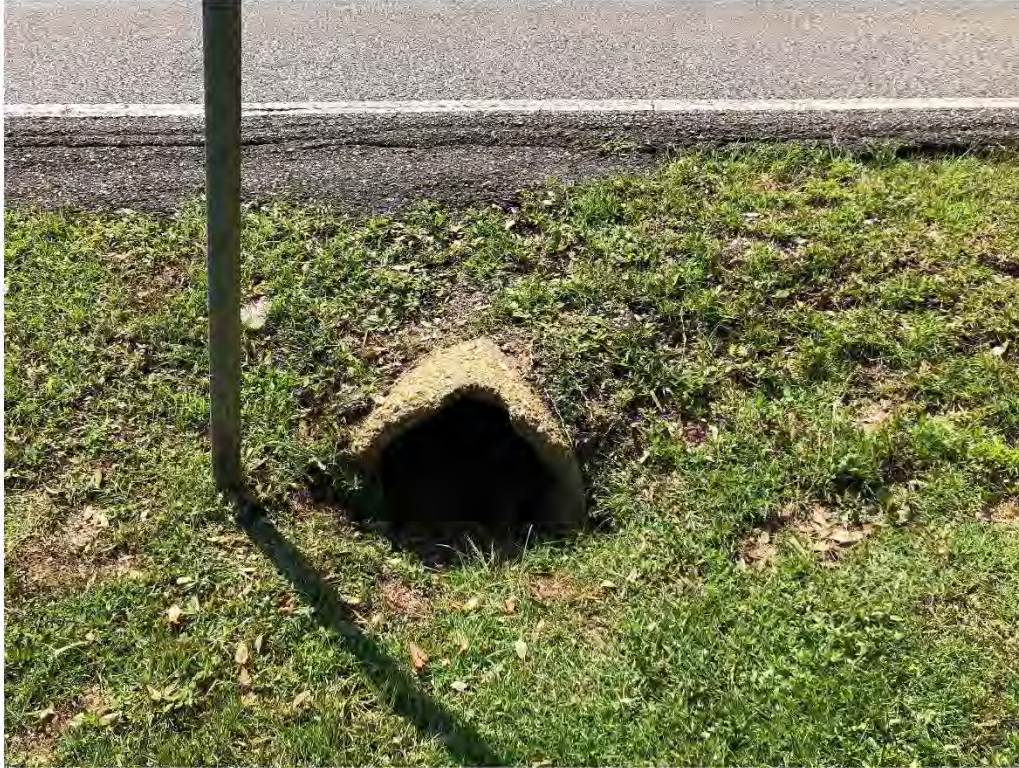
Figure 9555:

Photo taken facing East toward MN-CH-3 at the intersection of HWY 49 and Camelia Ave.
