Town of Magnolia Springs Comprehensive Drainage Masterplan

Town of Magnolia Springs
Magnolia Springs, Baldwin County, Alabama

VOLKERT

March 2023

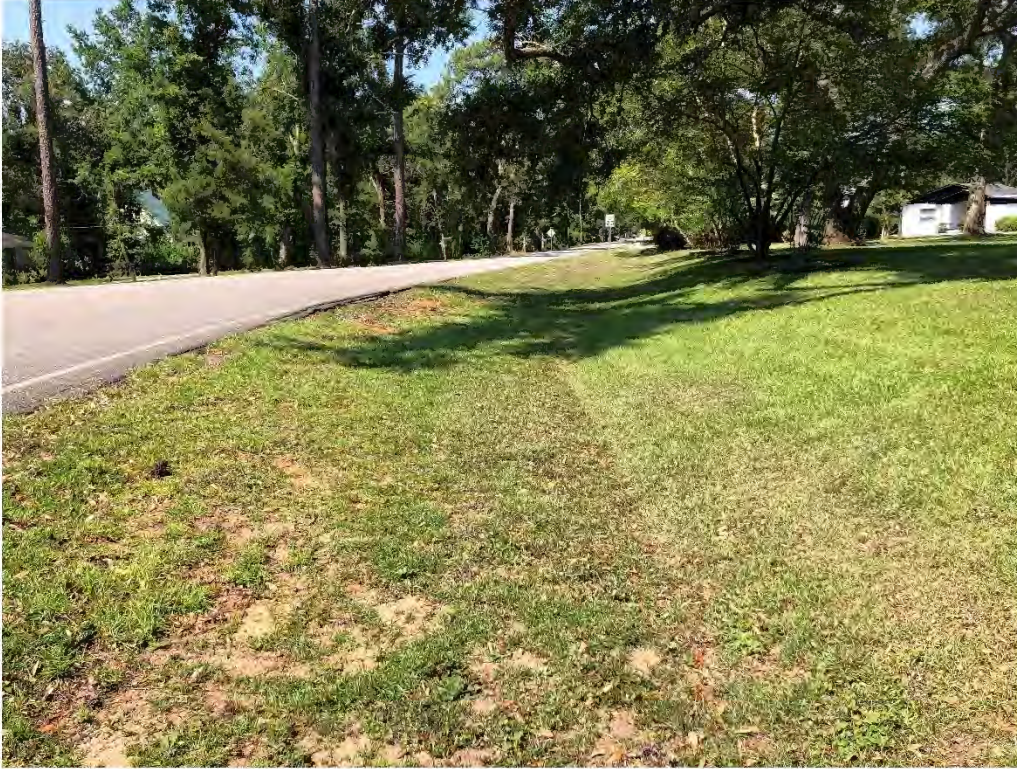
Figure 9556:

Photo taken of G-CO-1 at the intersection of Old Marlow Road and Gates Ave.

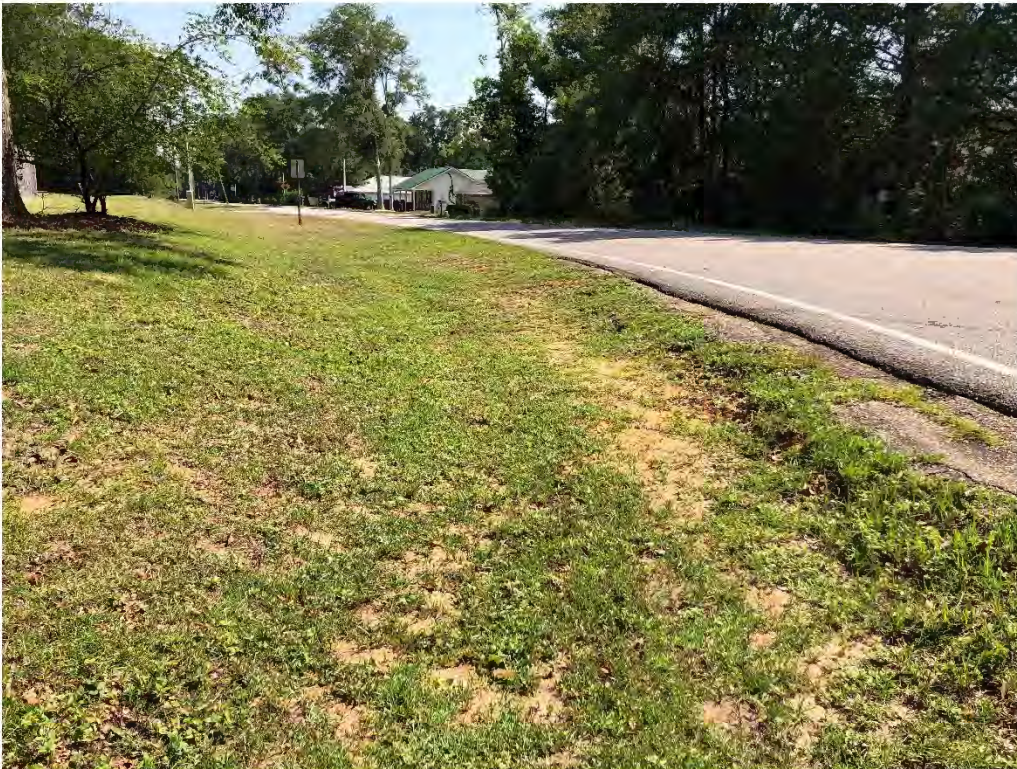
Figure 9557:
Photo taken facing SW of MN-CH-12 at the intersection of Old Marlow Road and Gates Ave.

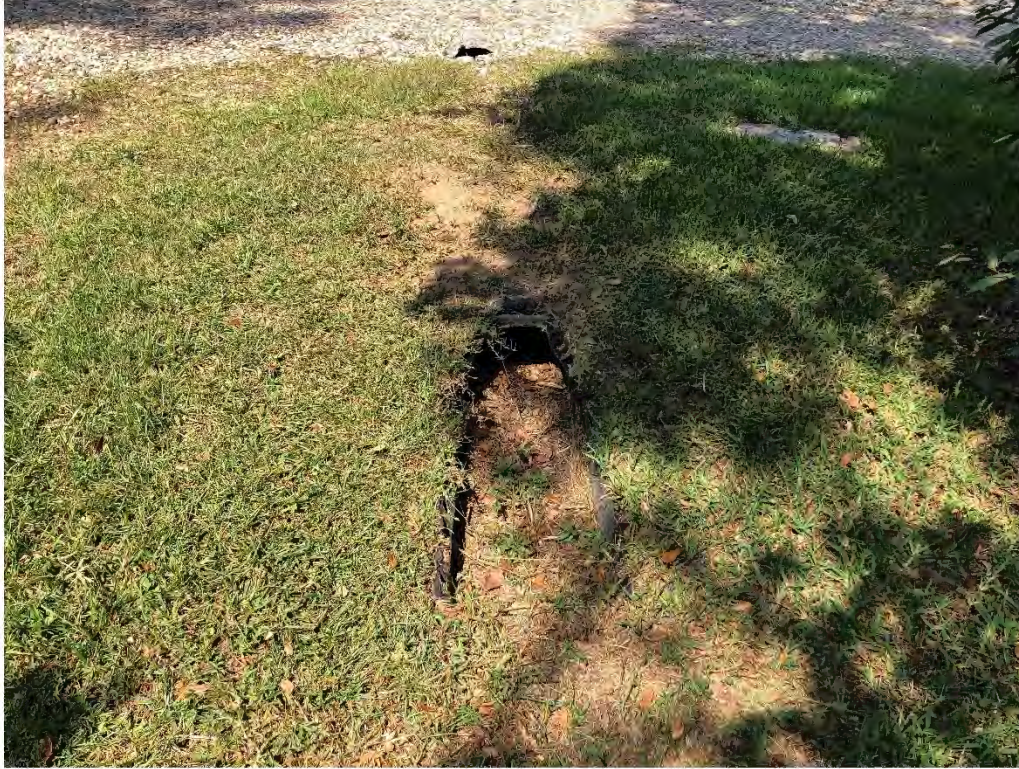
Figure 9562:
Photo taken facing West of MN-CO-10 at the intersection of Gates Ave and a driveway.

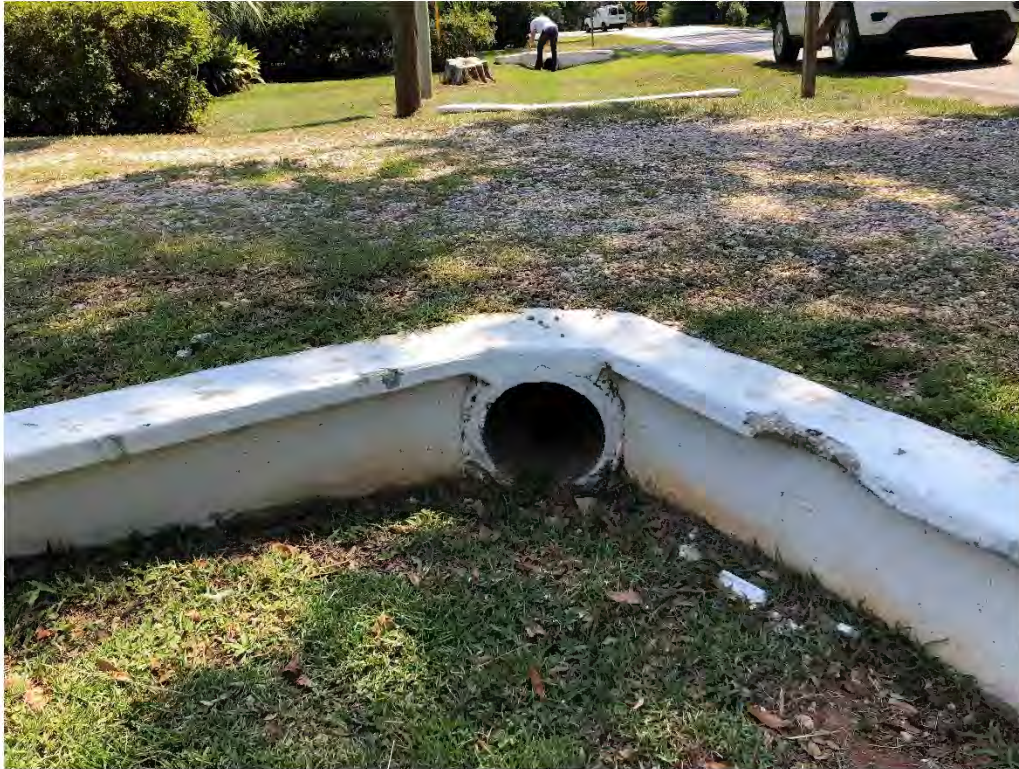
Figure 9564:

Photo taken facing East of MN-CO-10 at the intersection of Gates Ave and a driveway.

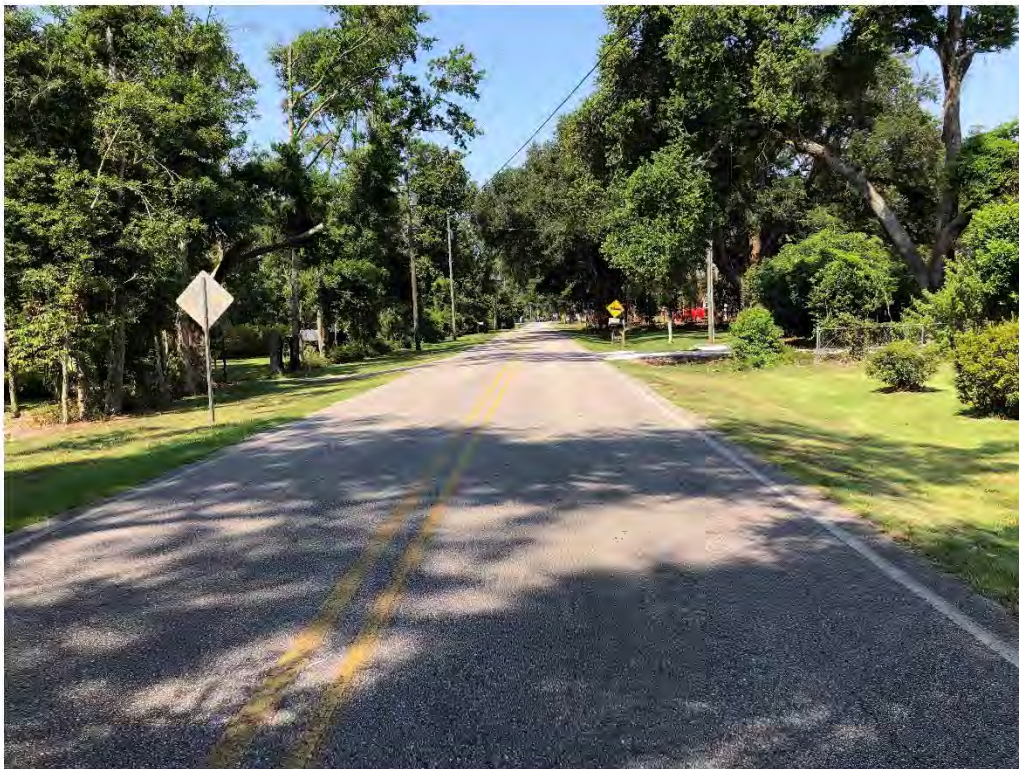
Figure 9565:
Photo taken facing West of MN-CO-11 at the intersection of Gates Ave and a driveway.

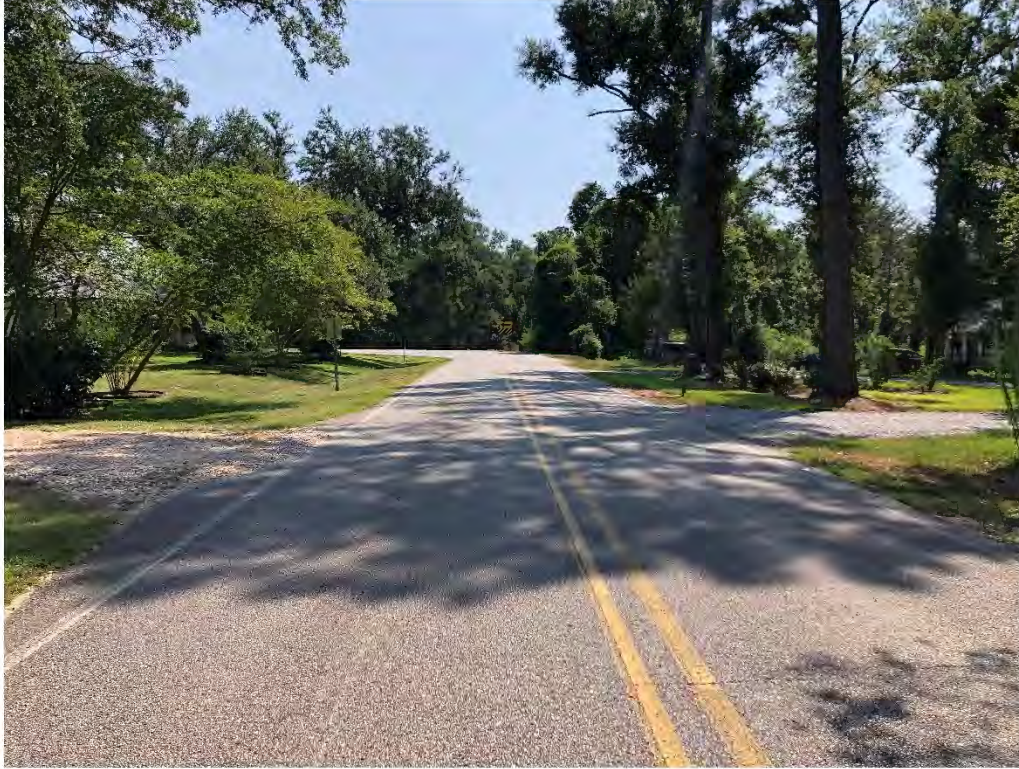
Figure 9566:
Photo taken facing West of MN-CH-14 along Gates Ave.

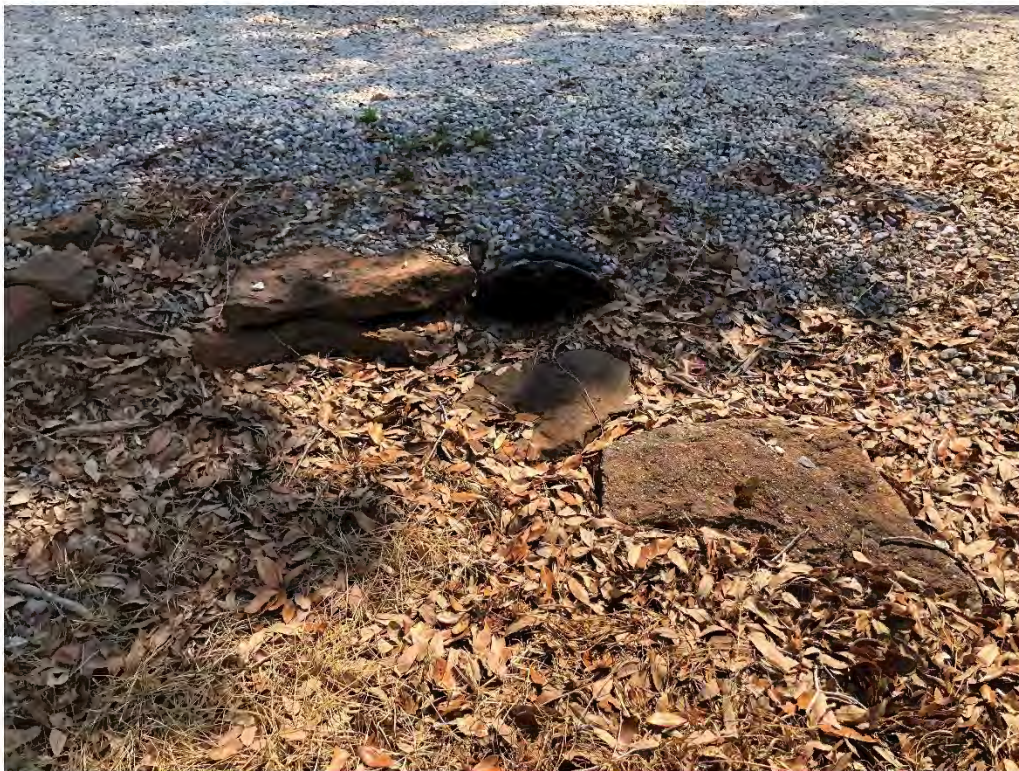
Figure 9567:
Photo taken facing West of MN-CH-12 along Gates Ave.

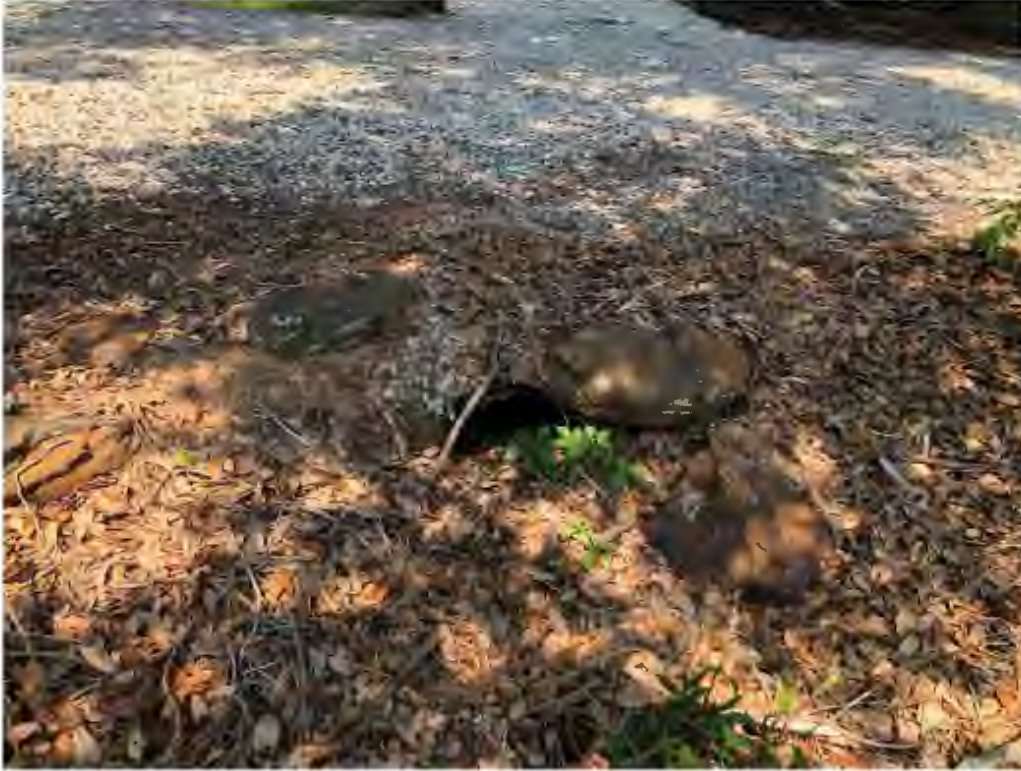
Figure 9568:
Photo taken facing East of MN-CO-12 at the intersection of Gates Ave and a driveway.

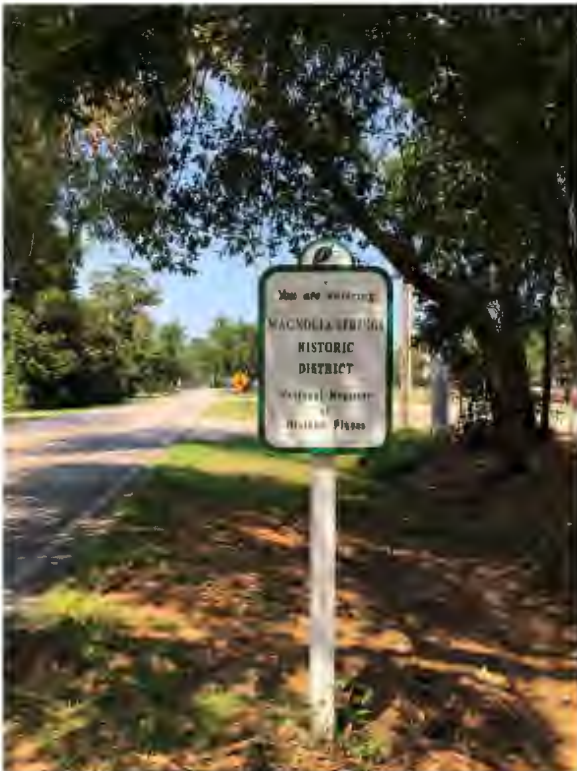
Figure 9569:
Photo taken facing West of MN-CO-12 at the intersection of Gates Ave and a driveway.

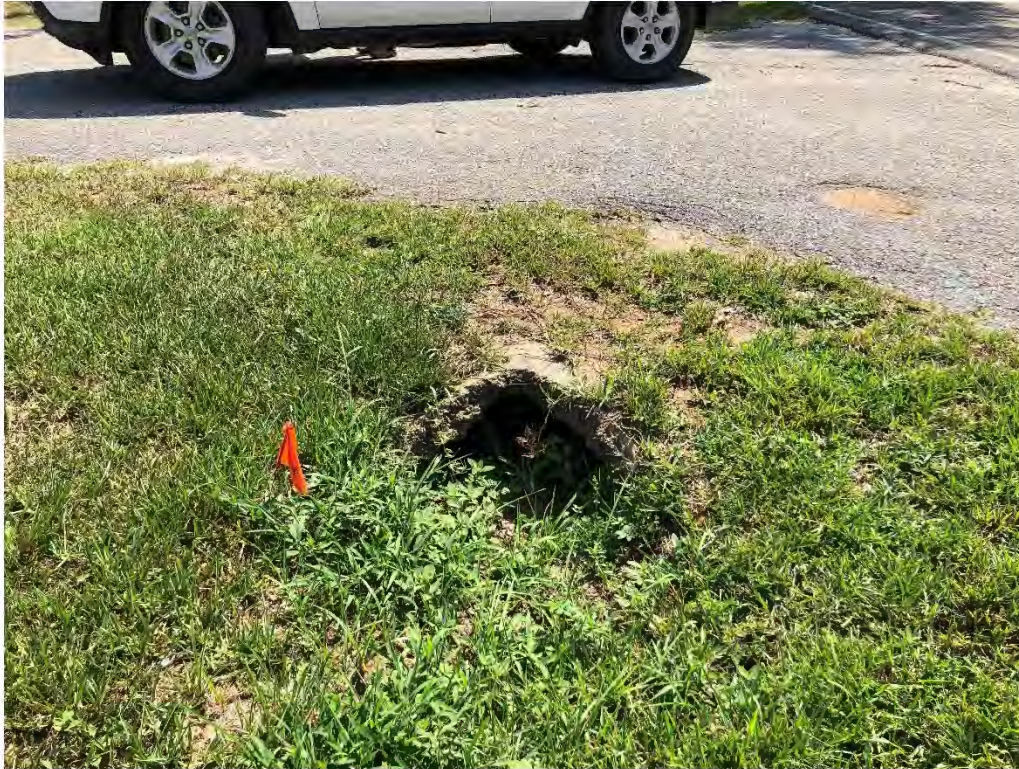
Figure 9572:
Photo taken facing East of MN-CO-14 at the intersection of Gates Ave and a driveway.

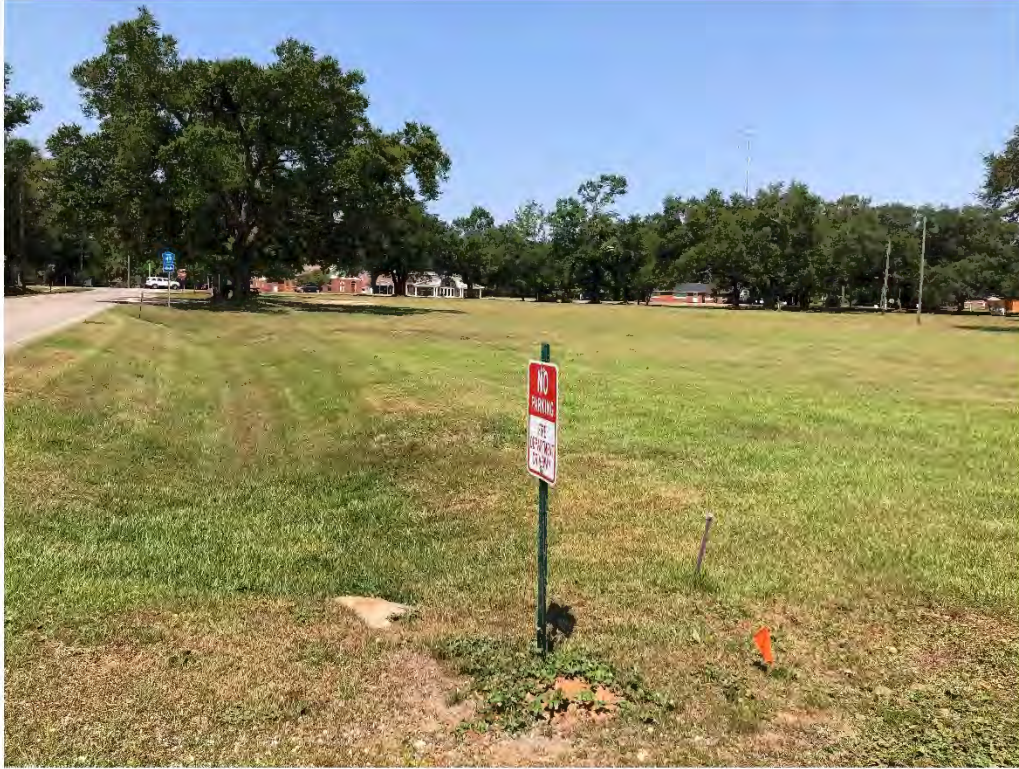
Figure 9578:
Photo taken facing West of MN-CH-18 along Gates Ave.

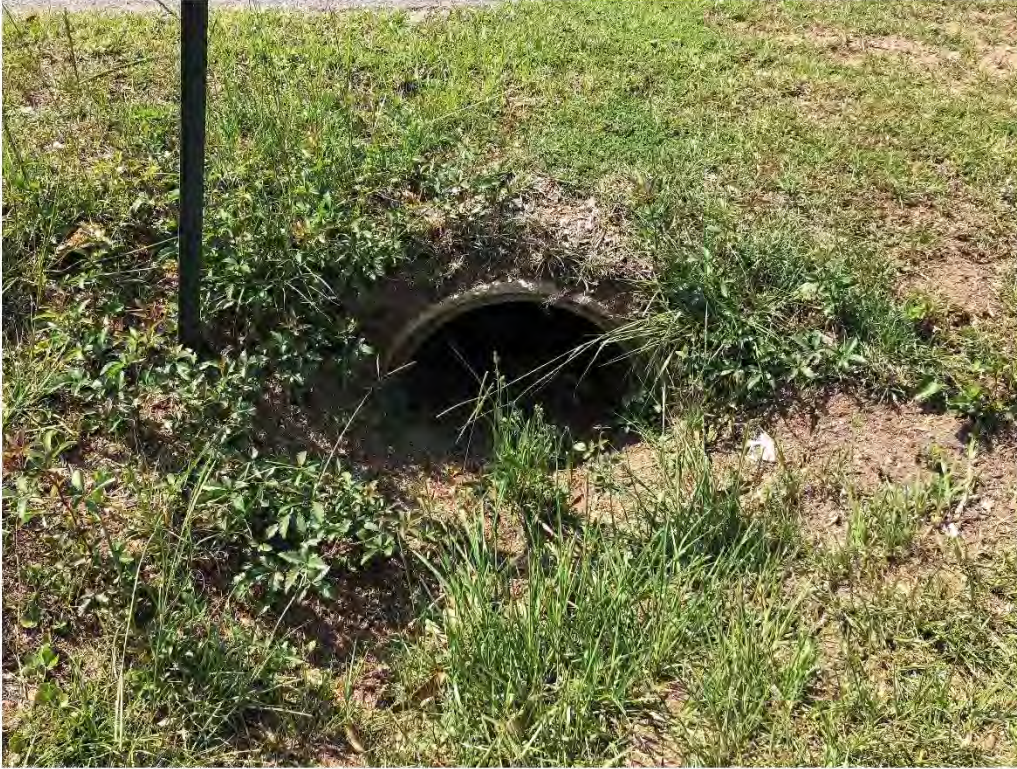
Figure 9580:
Photo taken facing South of MN-CO-16 across Gates Ave.

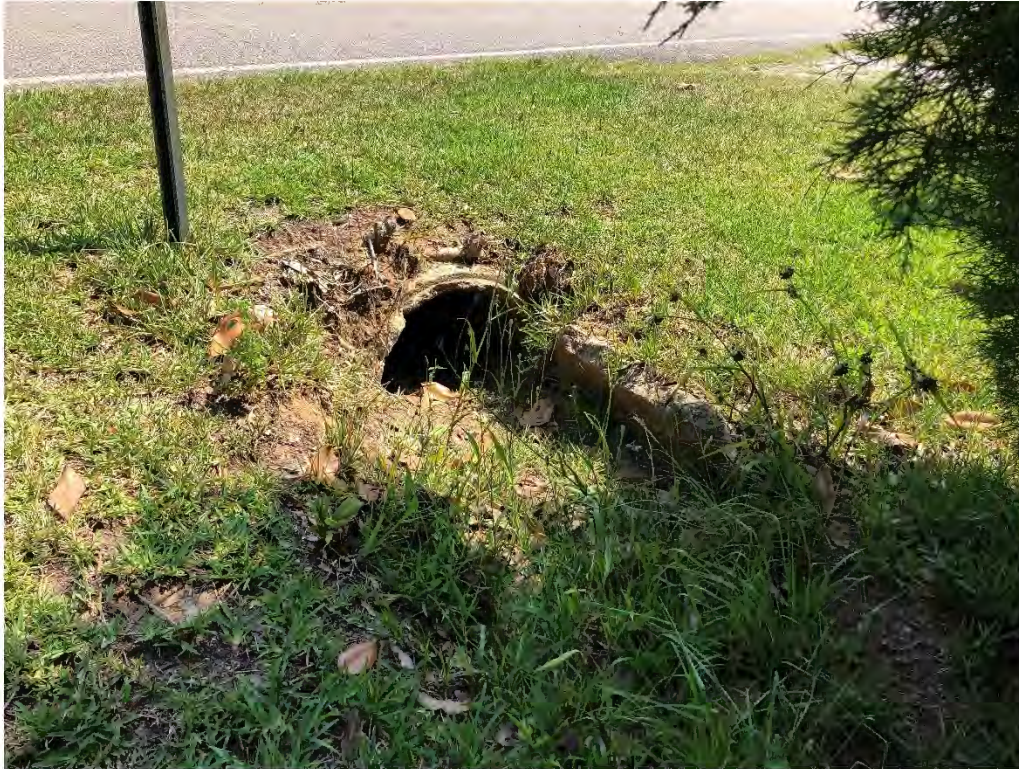
Figure 9583:
Photo taken facing North of MN-CO-16 across Gates Ave.

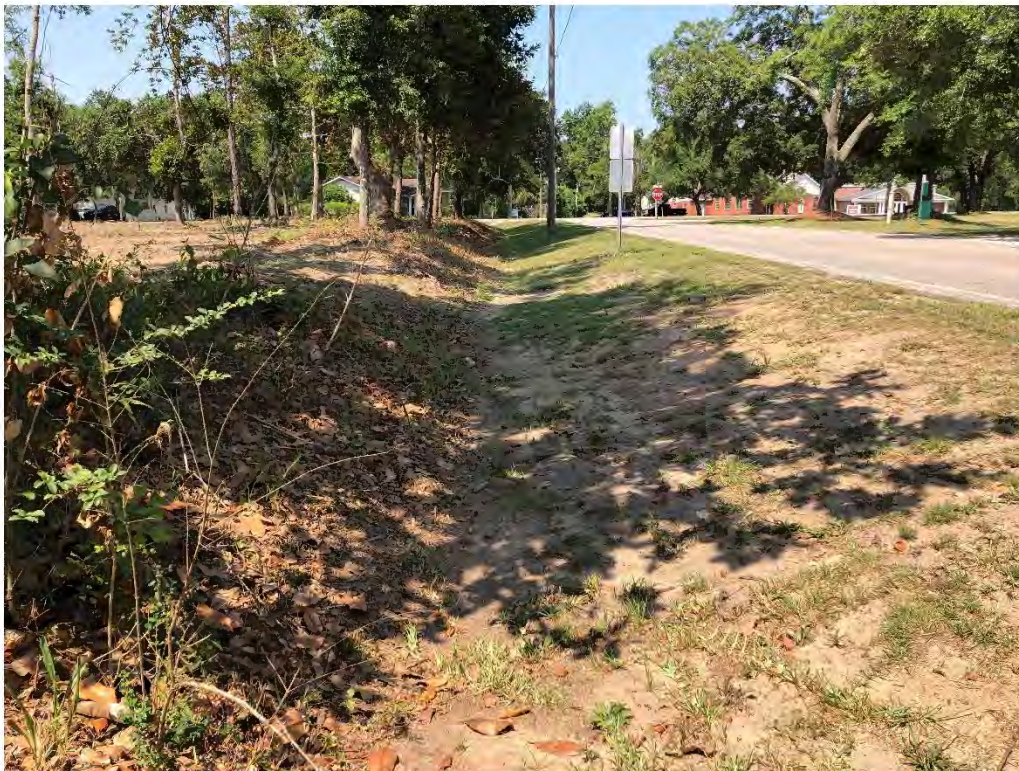
Figure 9584:
Photo taken facing West of MN-CH-19 along Gates Ave.

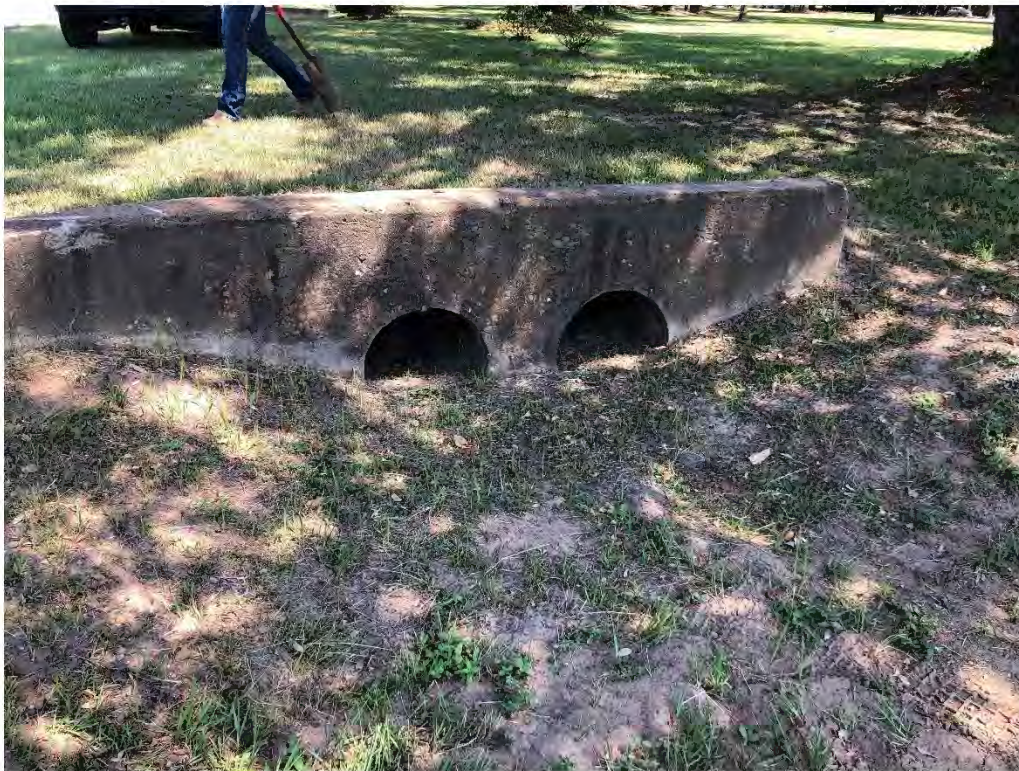
Figure 9586:
Photo taken of MN-CO-8 across HWY 49.

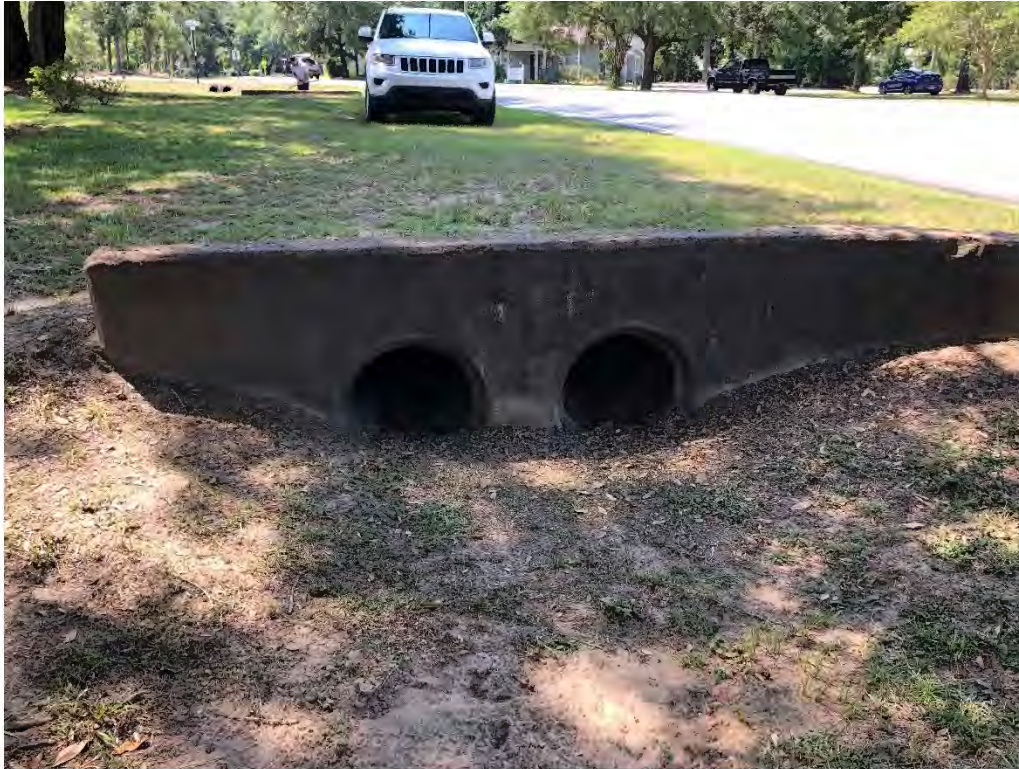
Figure 9587:
Photo taken facing South toward MN-CO-8 across HWY 49.

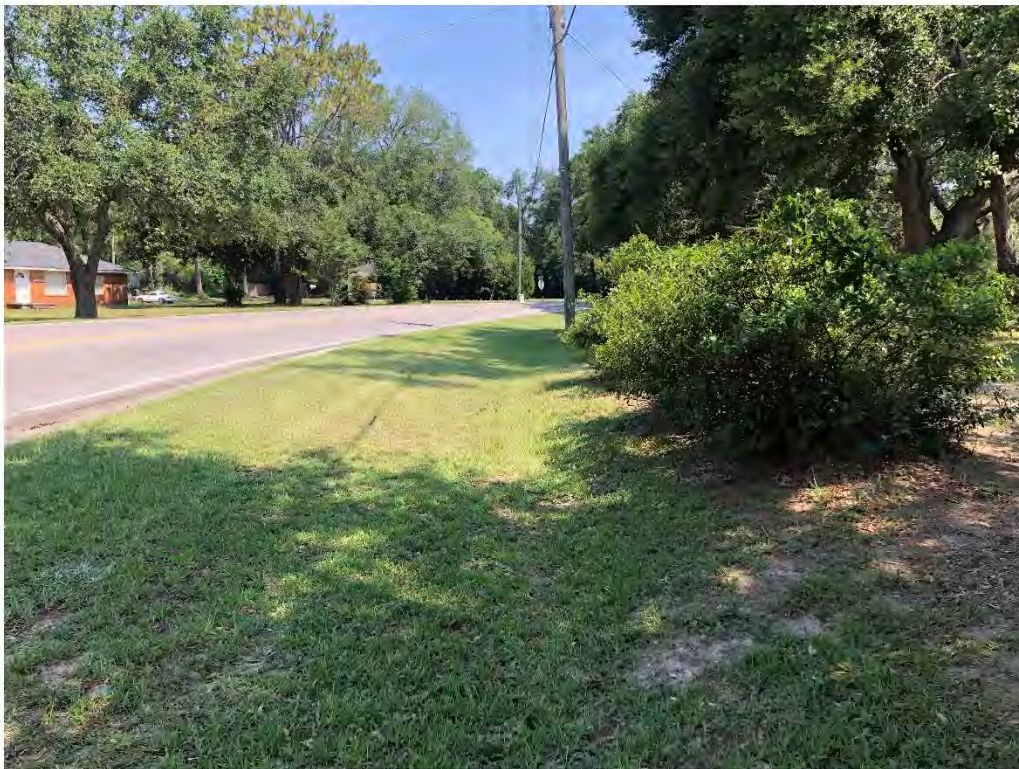
Figure 9588:
Photo taken facing North toward MN-CH-10 along HWY 49.

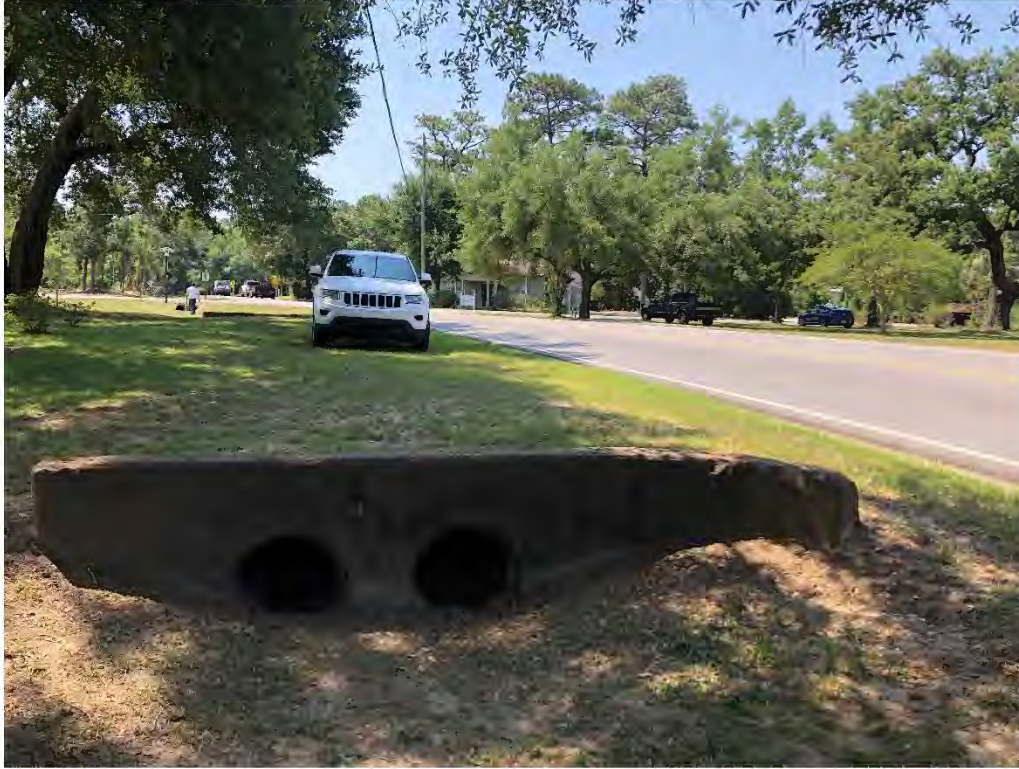
Figure 9589:
Photo taken facing South toward MN-CO-8 across HWY 49.

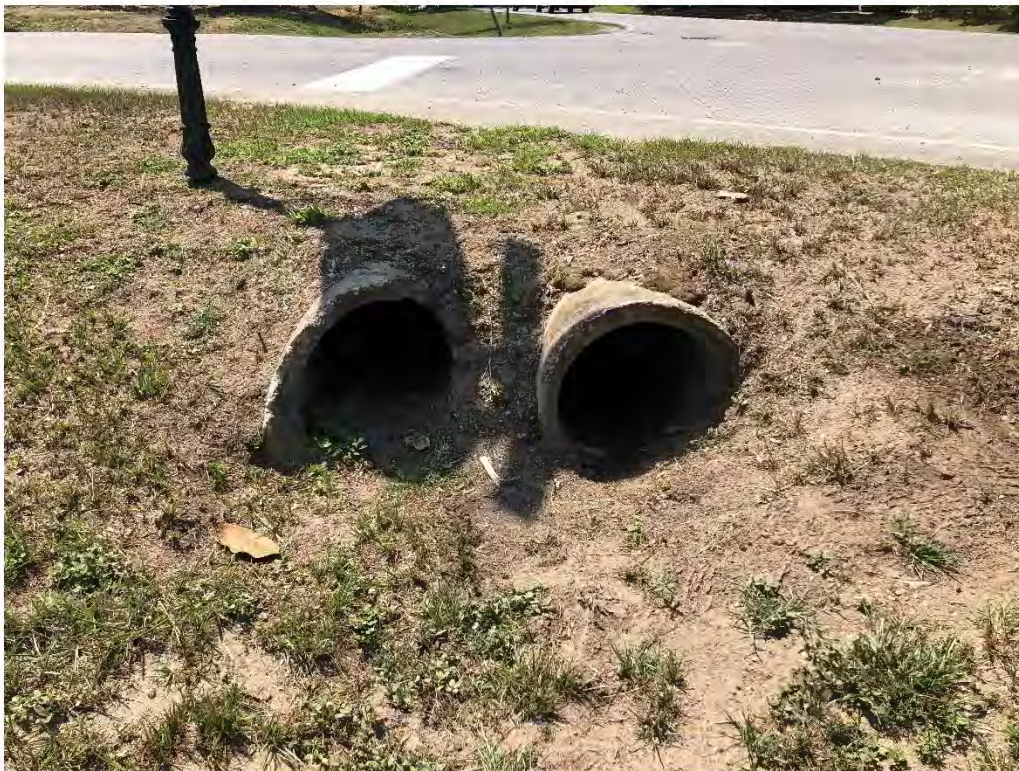
Figure 9590:
Photo taken facing South toward MN-CO-9 at the intersection of HWY 49 and Gates Ave.

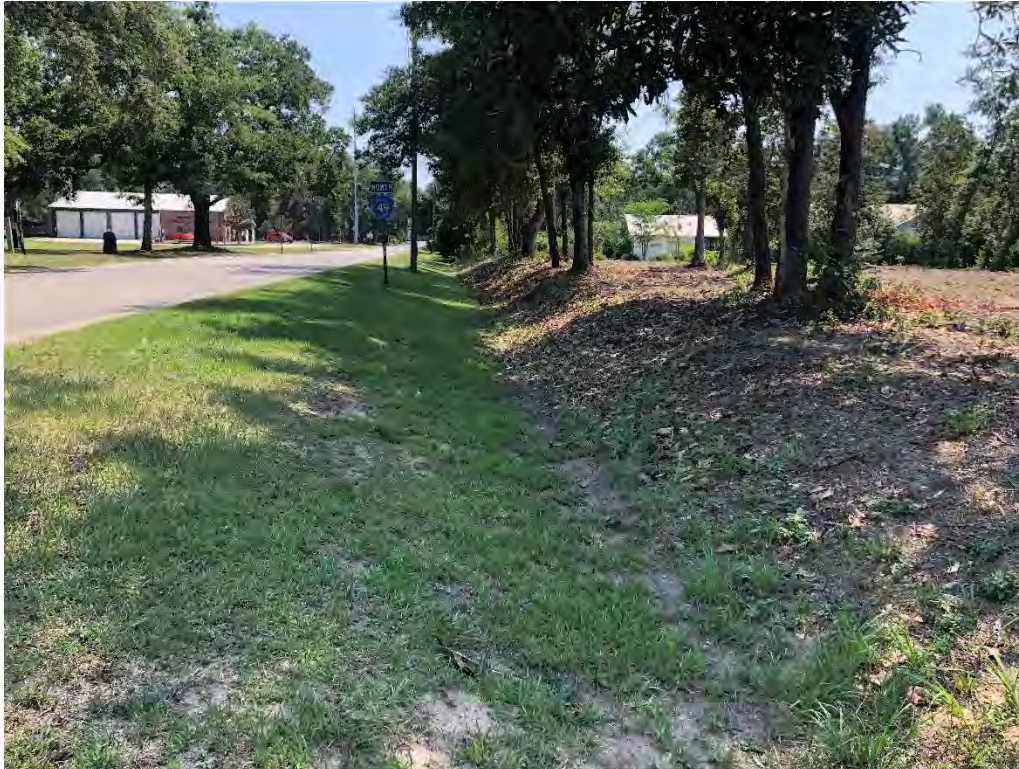
Figure 9591:
Photo taken facing East toward MN-CH-19 at the intersection of HWY 49 and Gates Ave.

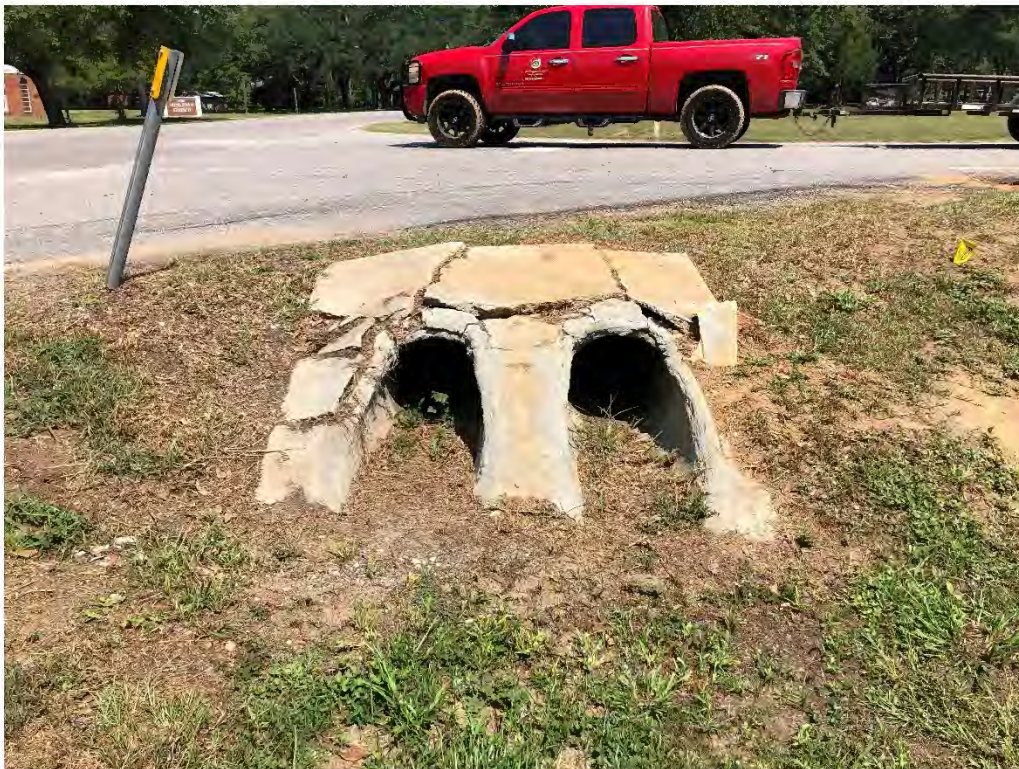
Figure 9592:
Photo taken facing North toward MN-CO-9 at the intersection of HWY 49 and Gates Ave.

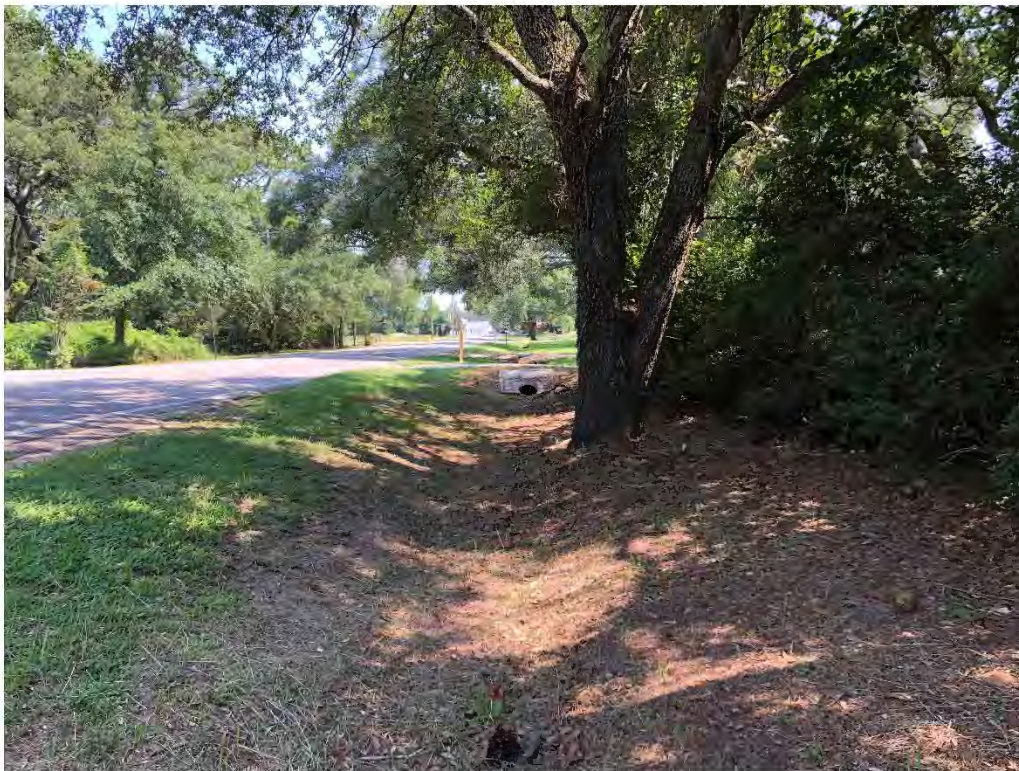
Figure 9596:
Photo taken facing North toward MN-CH-8 along HWY 49.

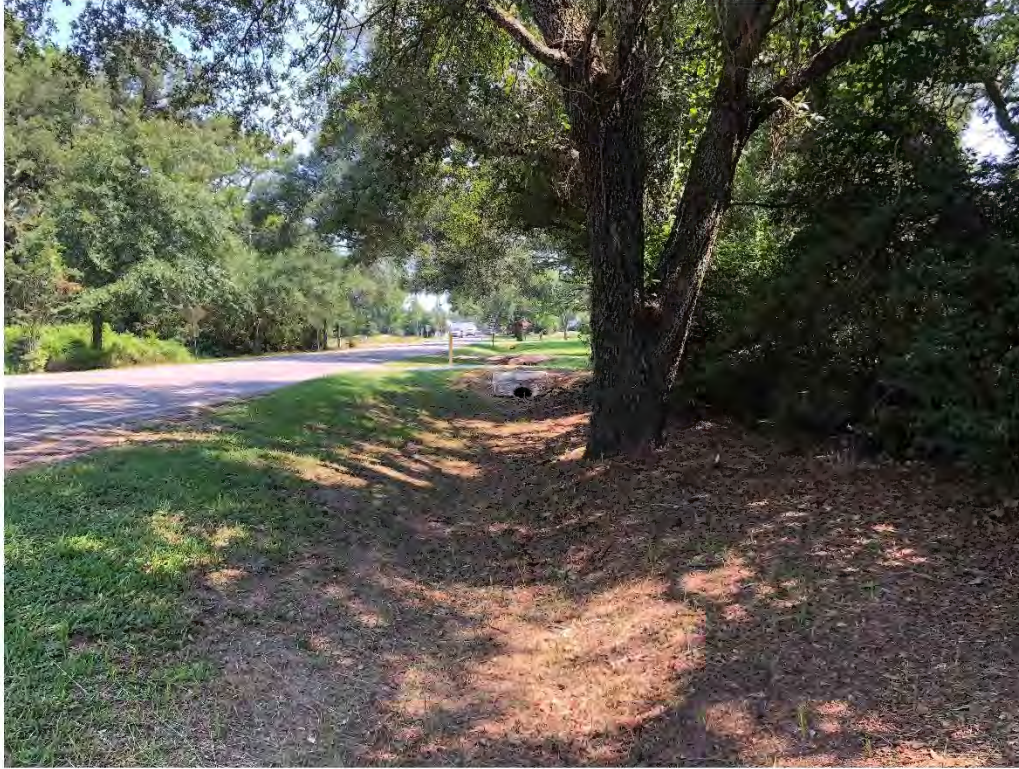
Figure 9597:
Photo taken facing North toward MN-CH-8 along HWY 49.

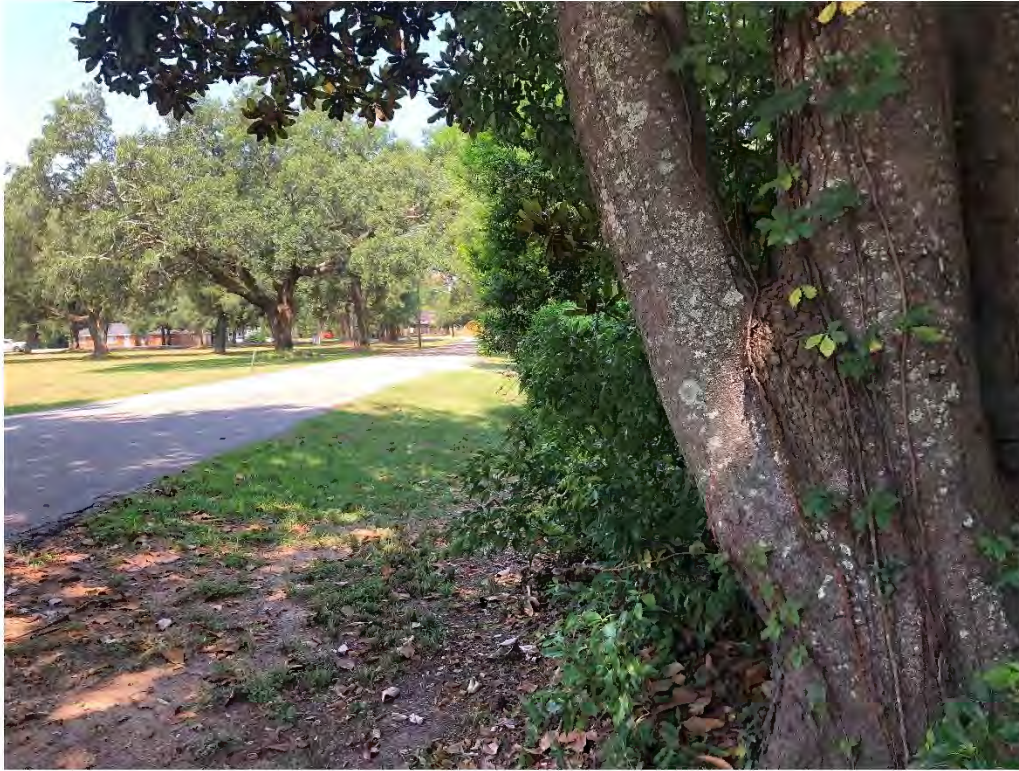
Figure 9601:
Photo taken facing West toward a ditch at the intersection of School Street and Magnolia Ave.

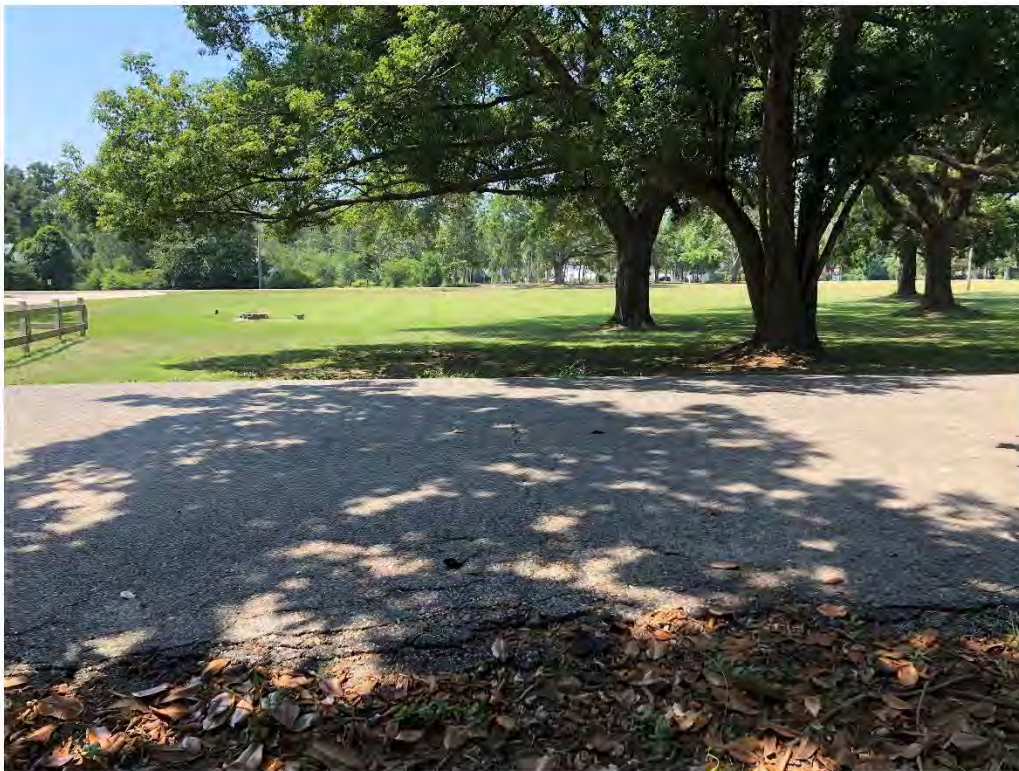
Figure 9602:
Photo taken facing South toward a field at the intersection of School Street and Magnolia Ave.

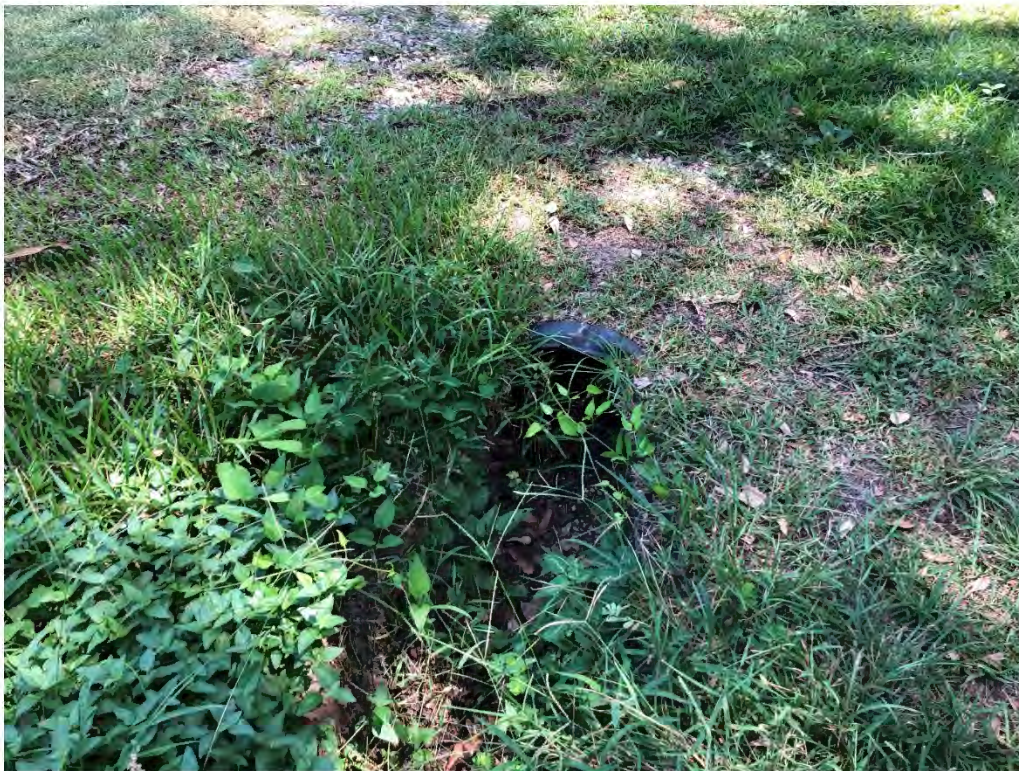
Figure 9604:
Photo taken of a silted pipe at the intersection of School Street and a driveway.

It is recommended to provide maintenance of silted in pipes and ditches, as noted in the photo pages provided in Appendix C. In addition to general maintenance of existing infrastructure, the proposed drainage improvements were consolidated into projects based on category and location. The projects were then ranked based on priority using a MCDA Matrix. All proposed improvements and correlating projects are provided in detail in Appendix H and the proposed projects are summarized below.

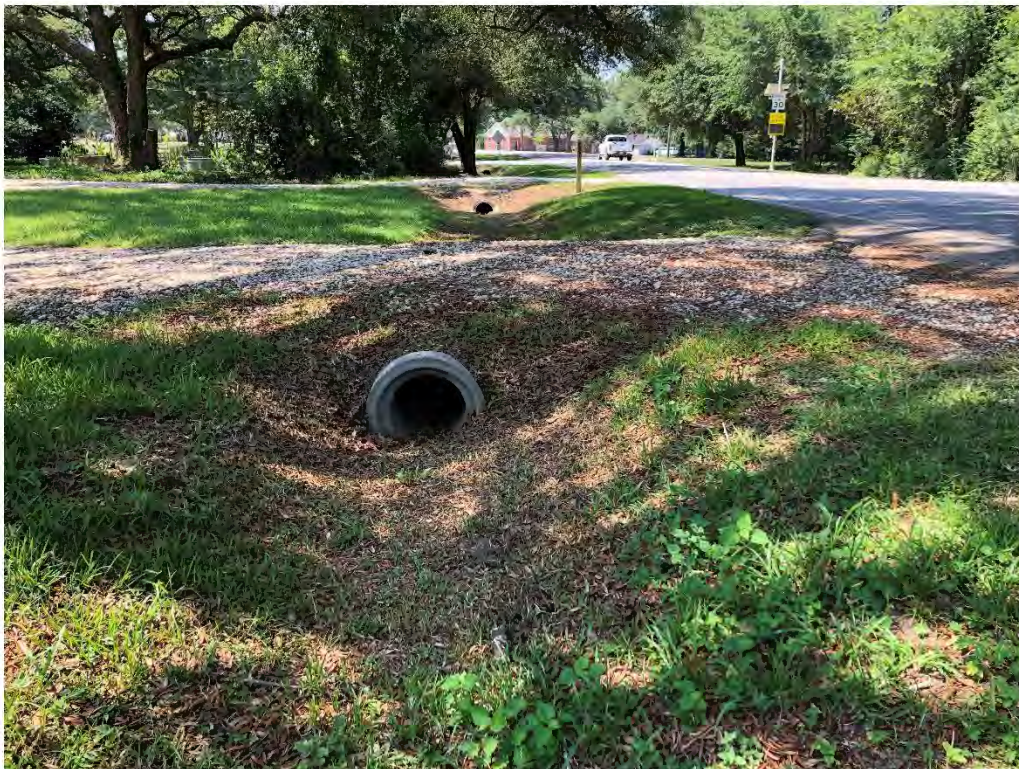
Figure 9610:
Photo taken facing South toward MN-CO-5 at the intersection of HWY 49 and a driveway.

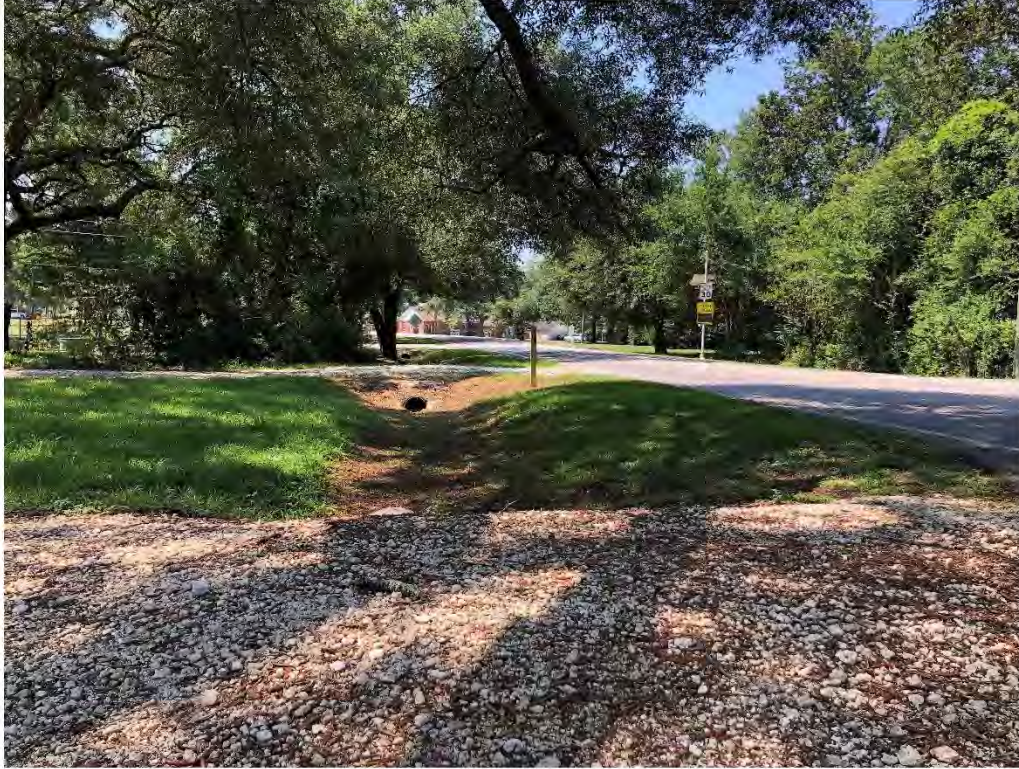
Figure 9611:
Photo taken facing South toward MN-CH-7 at the intersection HWY 49 and a driveway.

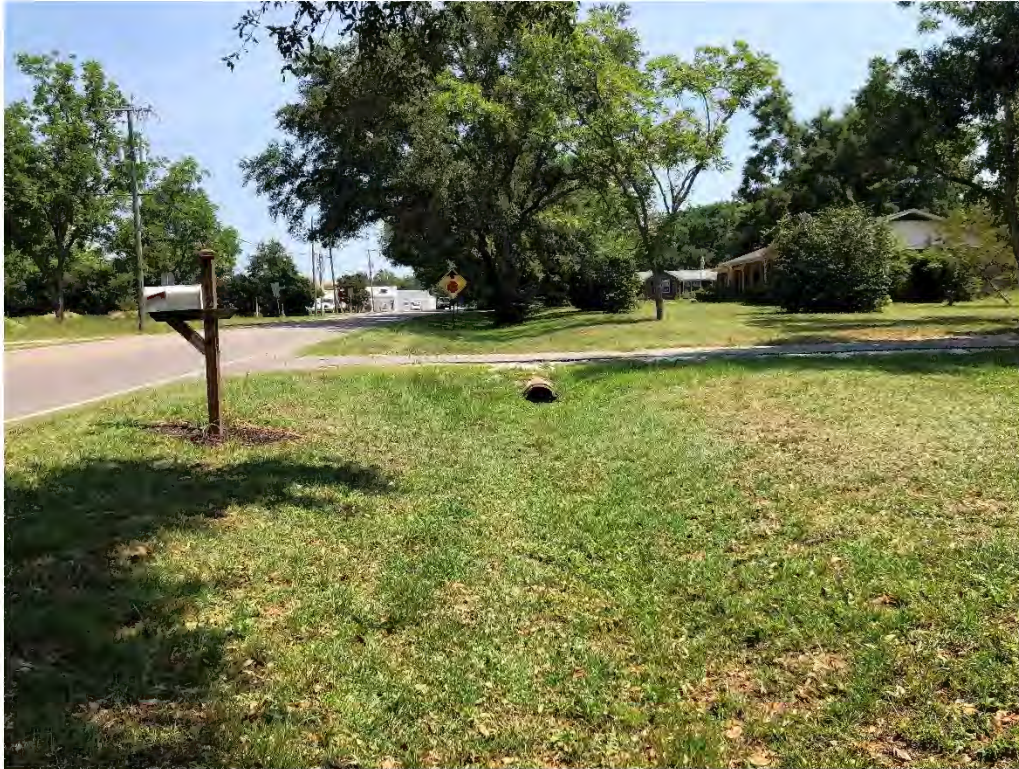
Figure 9613:
Photo taken facing North toward MN-CH-5 along HWY 49.
