Town of Magnolia Springs Comprehensive Drainage Masterplan

Town of Magnolia Springs
Magnolia Springs, Baldwin County, Alabama

VOLKERT

March 2023

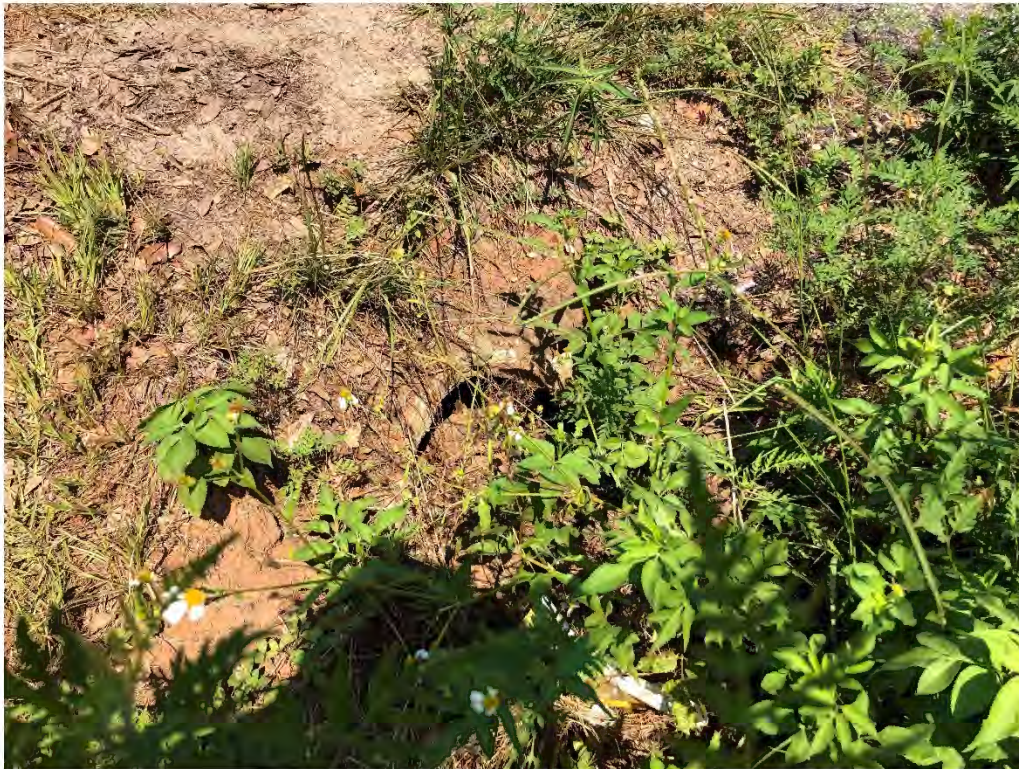
Figure 9615:
Photo taken facing South toward a silted MN-C0-3 at the intersection HWY 49 and a driveway.

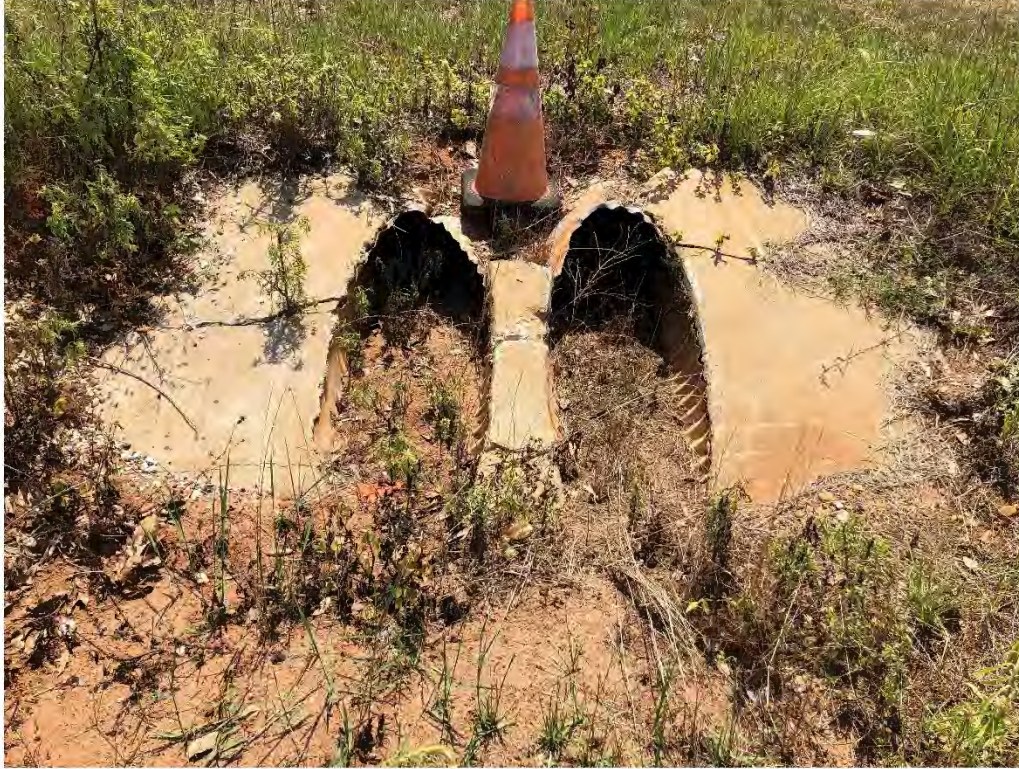
Figure 9616:
Photo taken facing North toward a very silted pipe at the intersection HWY 98 and Schindler Ln.

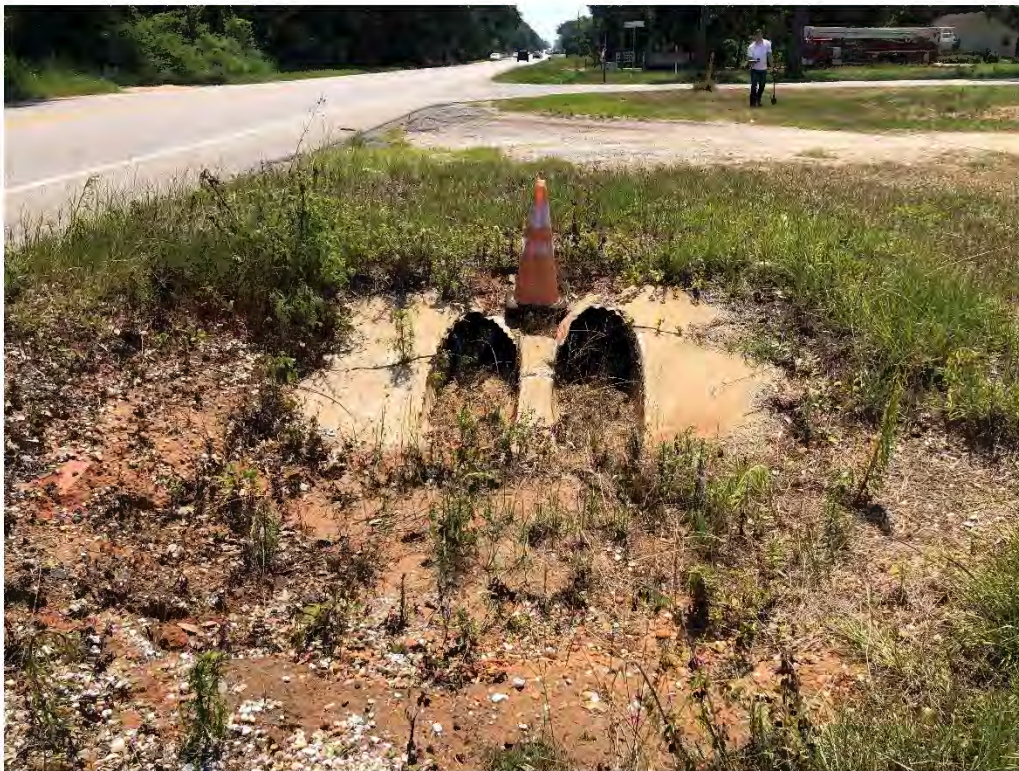
Figure 9617:
Photo taken facing West toward a very silted pipe at the intersection HWY 98 and a driveway.

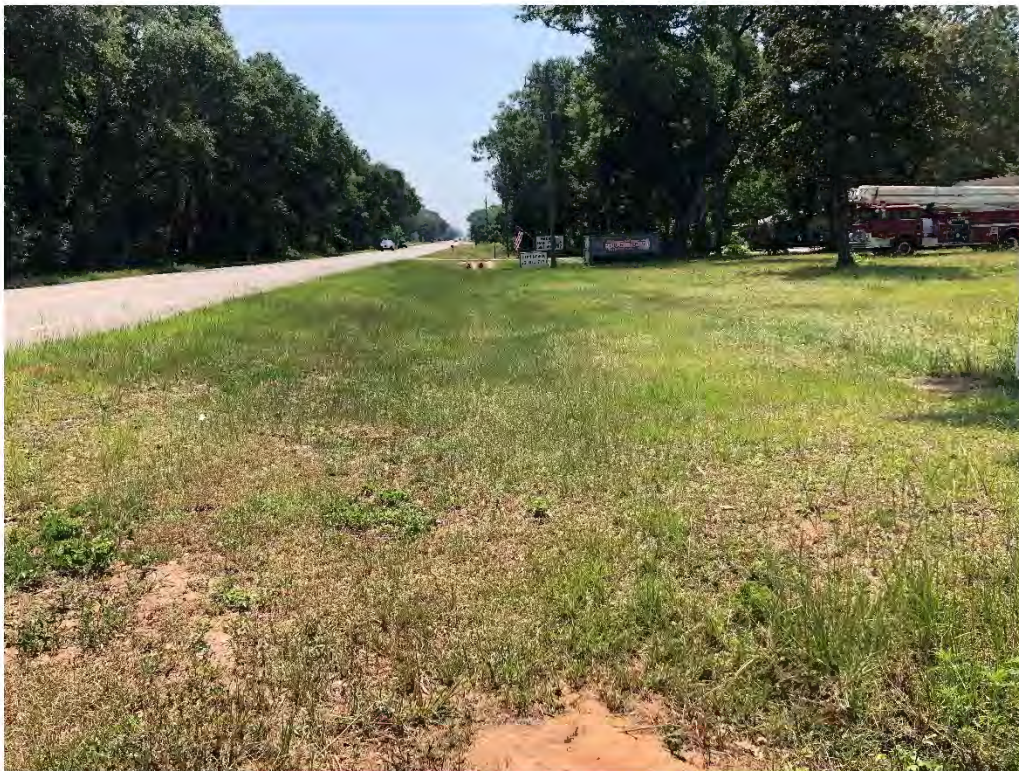
Figure 9619:
Photo taken facing South toward OAK-CH-8 at the intersection HWY 98 and Jessamine St.

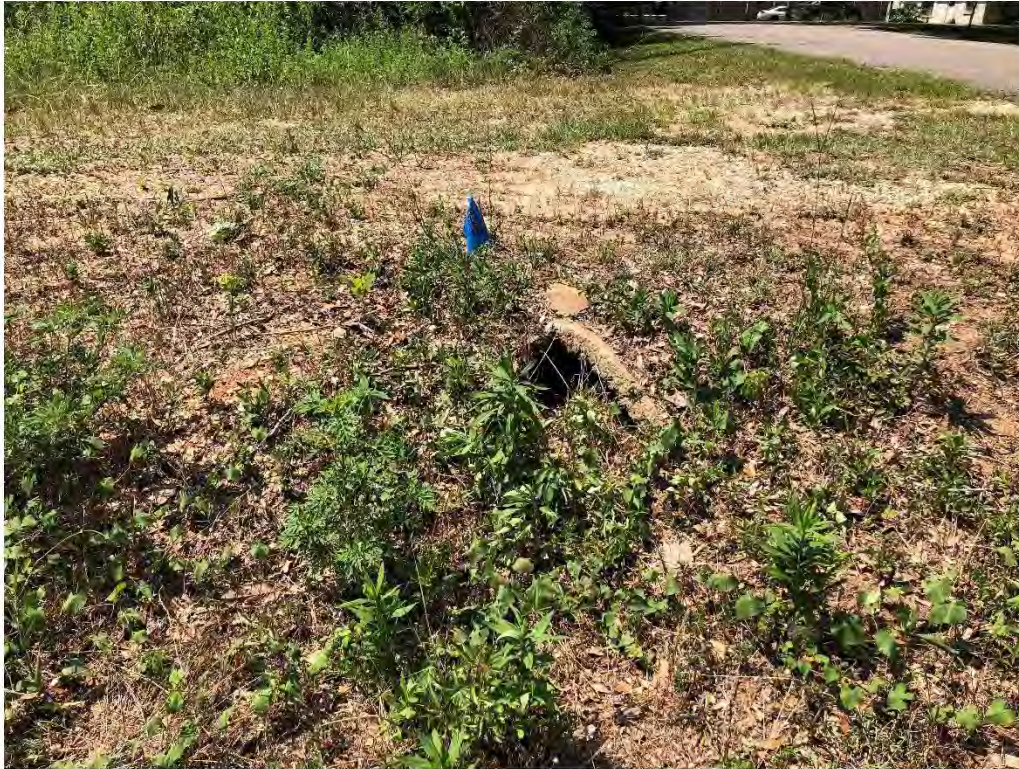
Figure 9622:
Photo taken facing North toward a very silted OAK-CO-5 across Jessamine St.

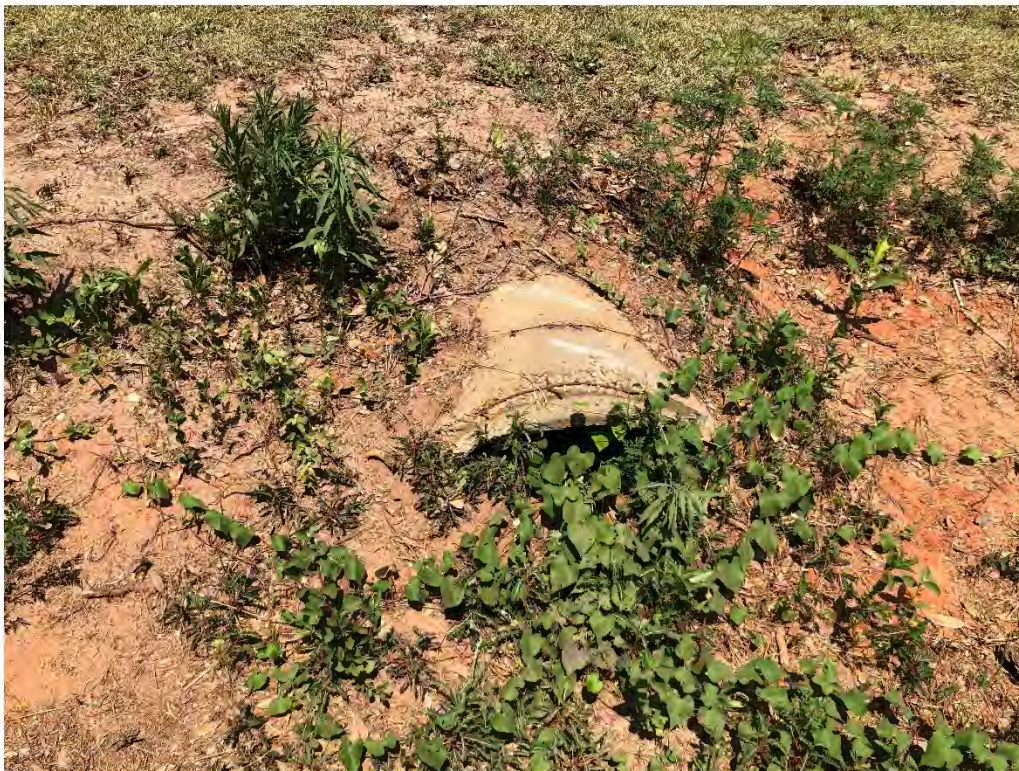
Figure 9623:
Photo taken facing South toward a very silted OAK-CO-7 across Jessamine St.

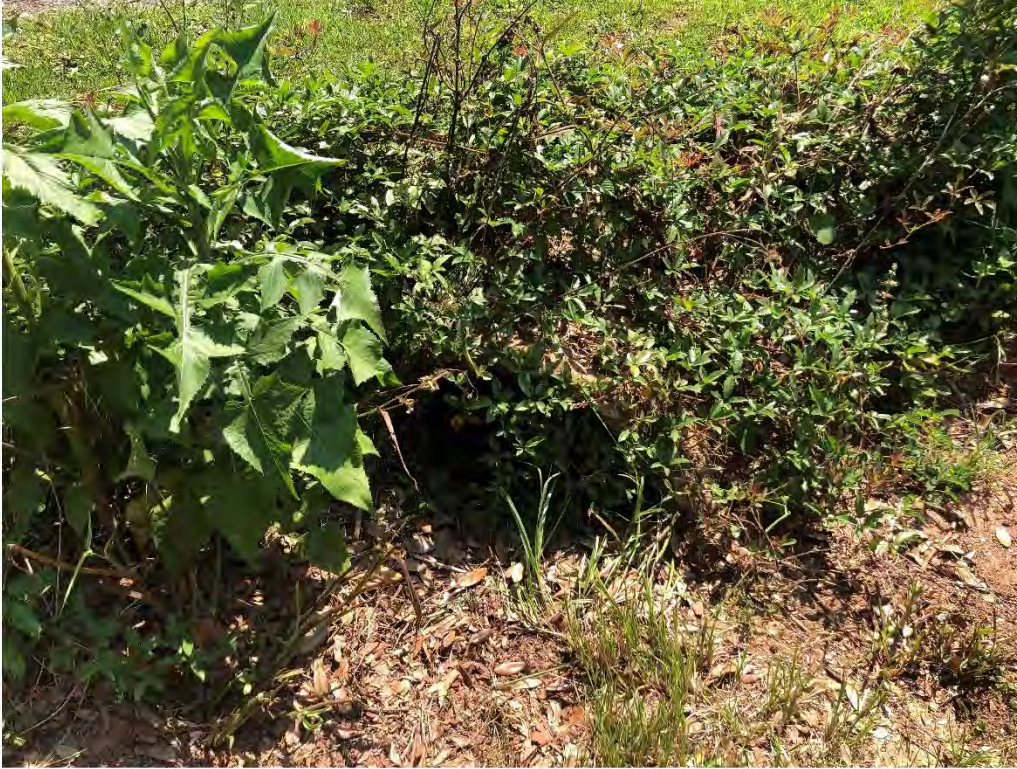
Figure 9629:
Photo taken facing North toward the ditch on the eastern side of Jessamine St.

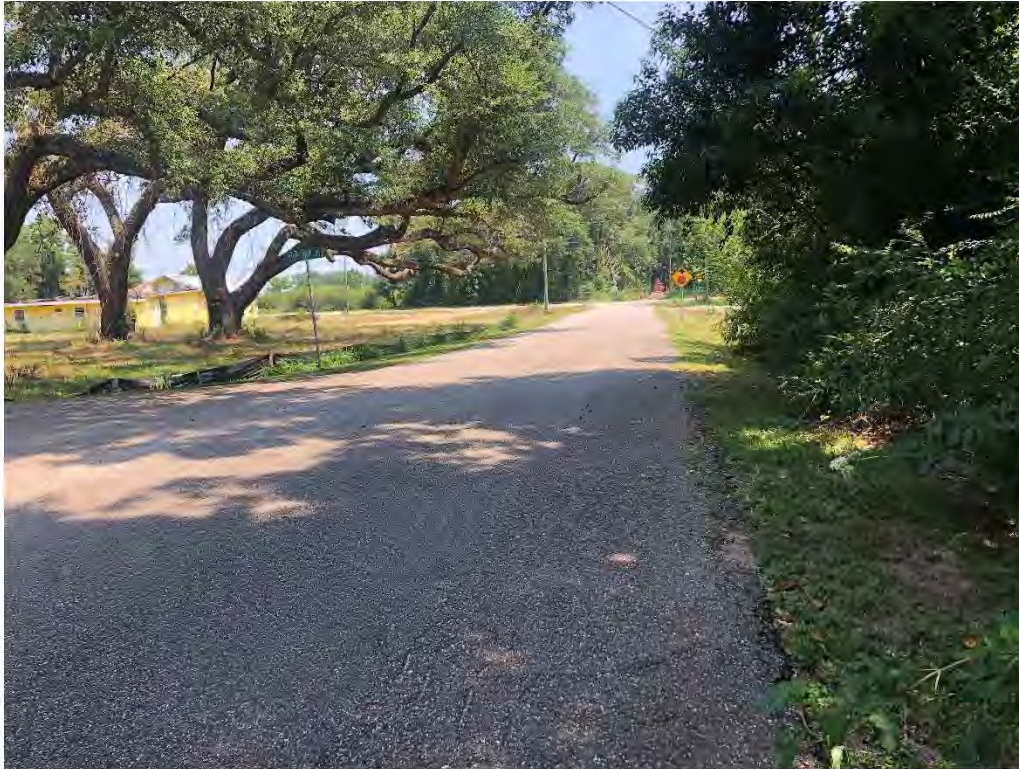
Figure 9632:

Photo taken facing West toward a very silted OAK-CO-8 that crosses Jessamine St.

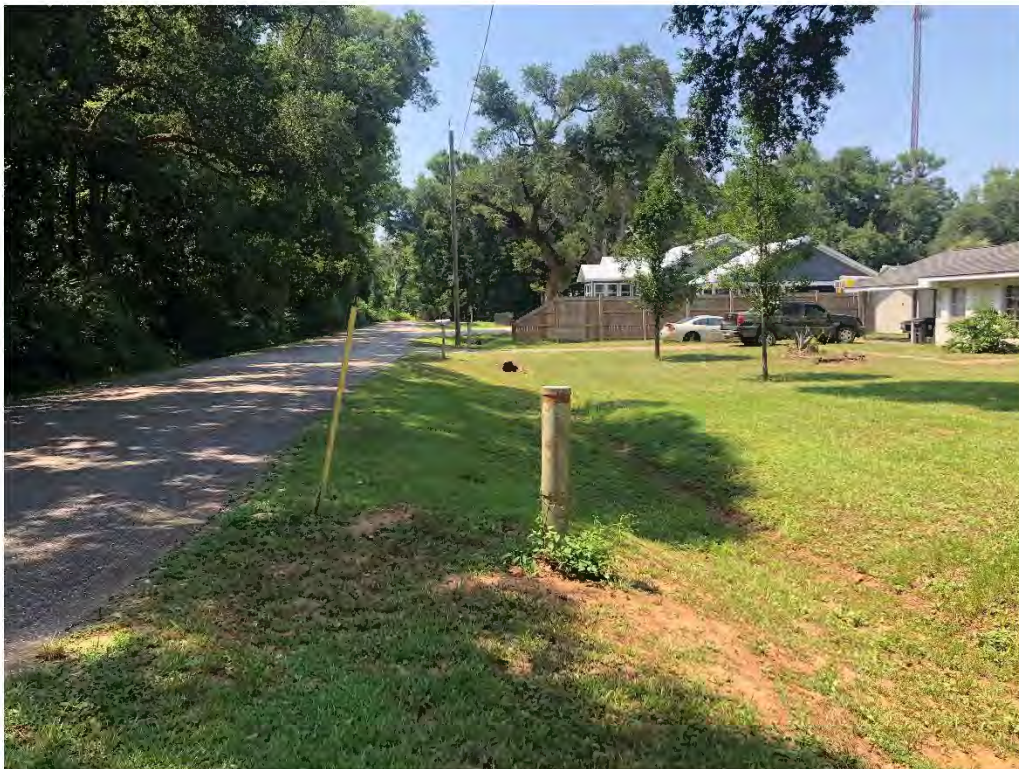
Figure 9635:
Photo taken facing East toward an overgrown OAK-CO-8 that crosses Jessamine St.

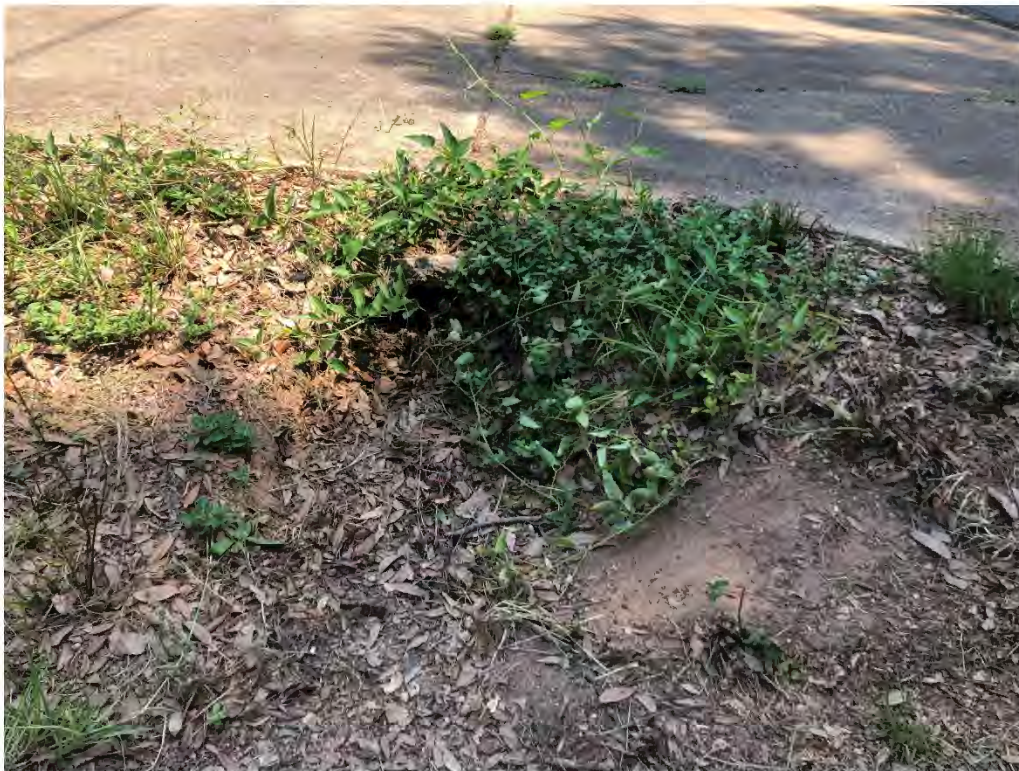
Figure 9637:
Photo taken facing South toward a silted OAK-CO-9 that crosses Jessamine St.

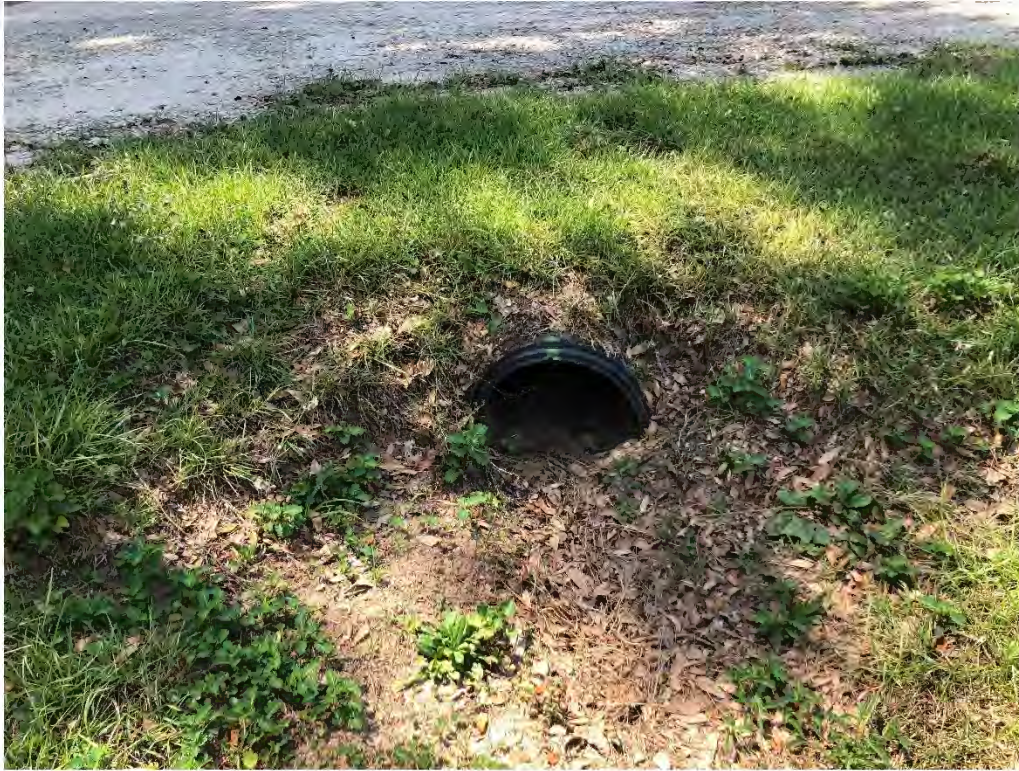
Figure 9638:
Photo taken facing North toward a silted OAK-CO-9 at the intersection of Jessamine St and a driveway.

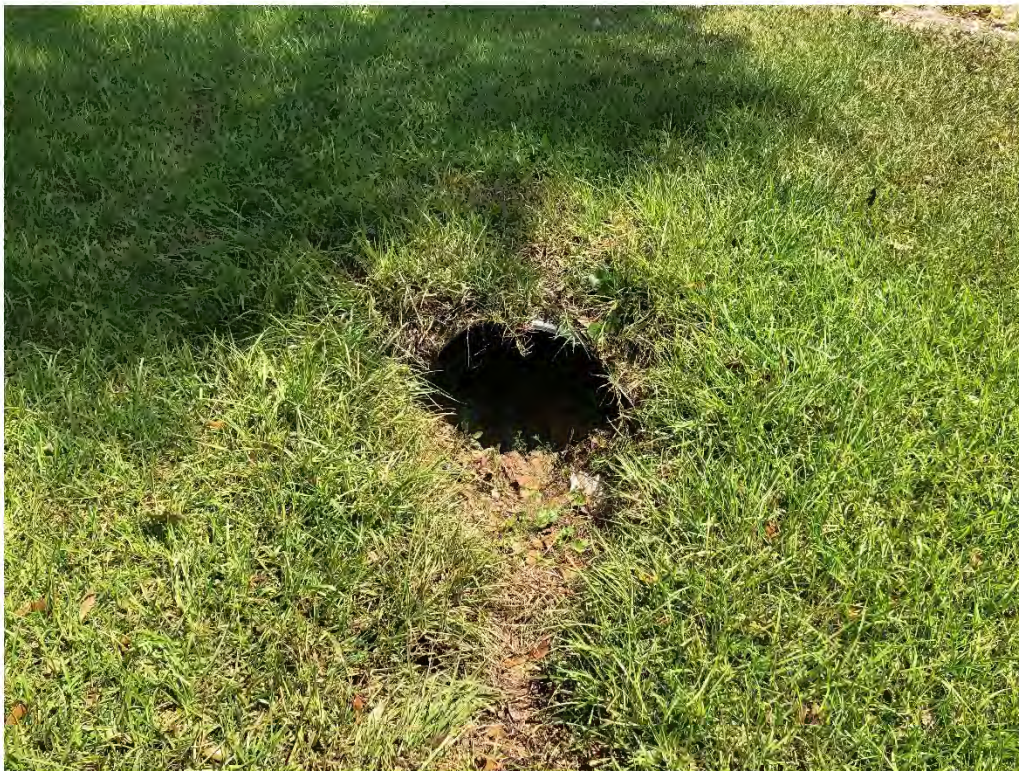
Figure 9639:

Photo taken facing South toward a silted OAK-CO-10 at the intersection of Jessamine St and a driveway.

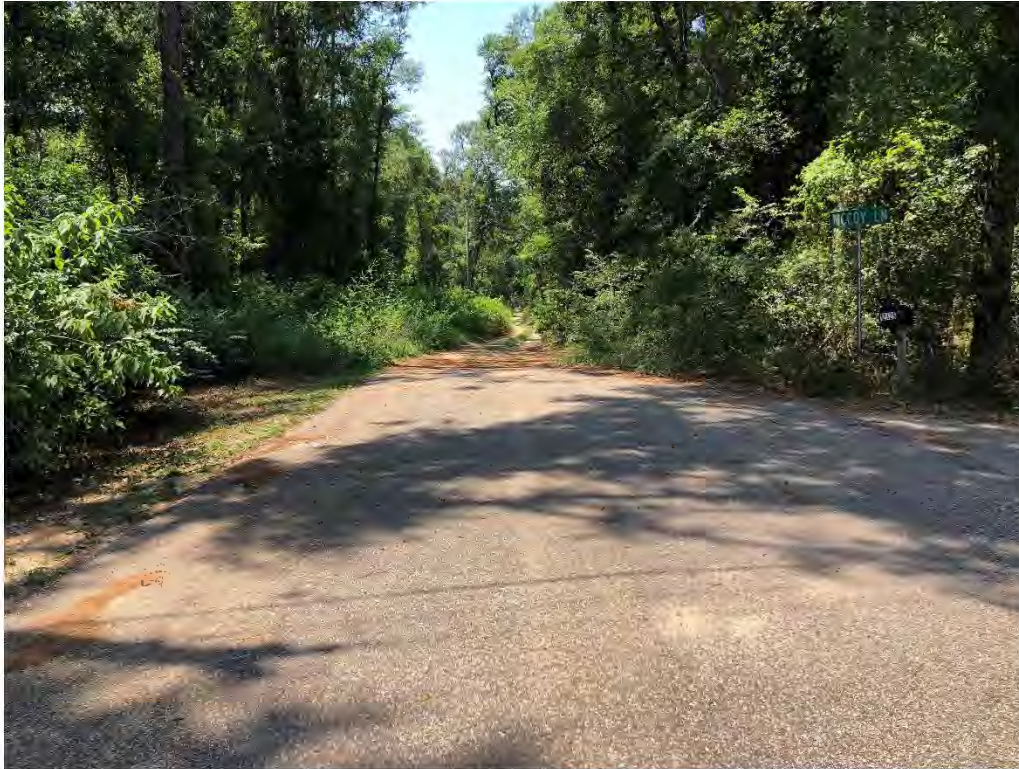
Figure 9640:

Photo taken facing North toward a silted OAK-CO-10 that crosses Jessamine St.

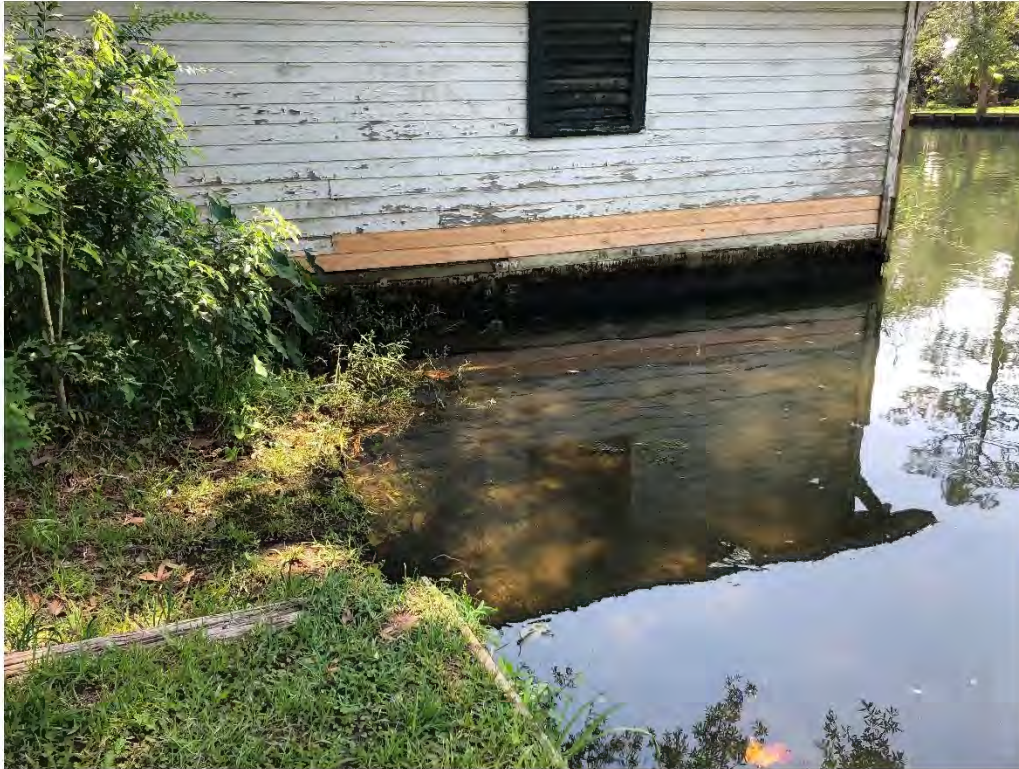
Figure 9642:
Photo taken facing North toward a concrete CH-200 with moderate debris along Jessamine St.

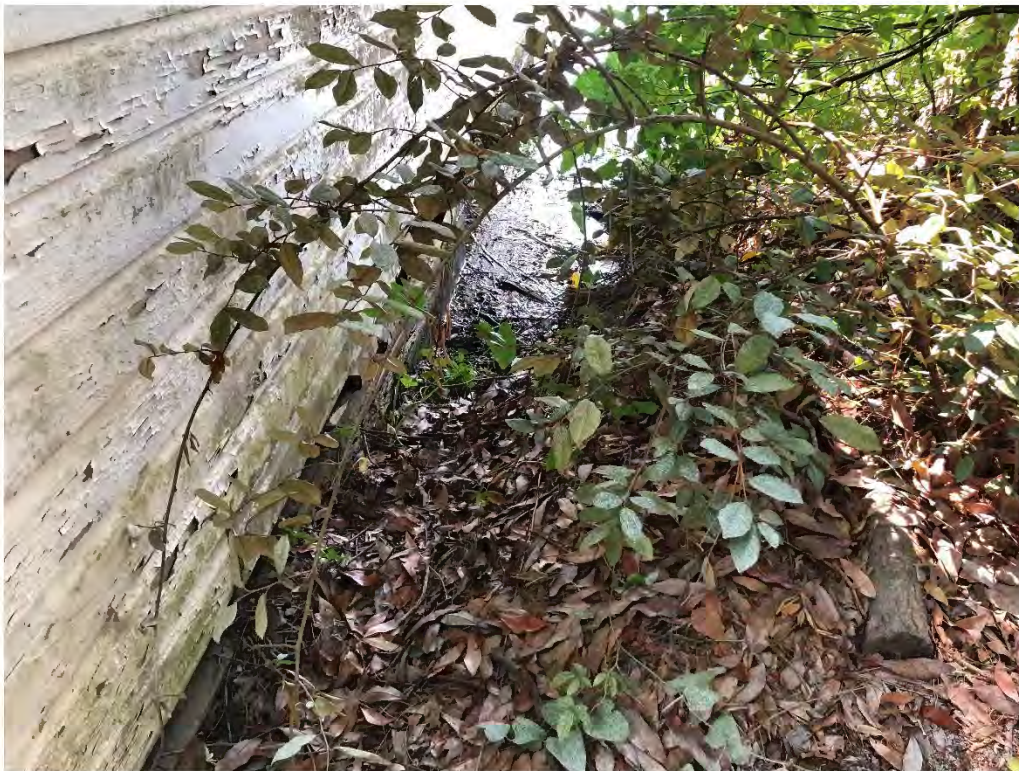
Figure 9643:
Photo taken facing SE toward CH-200 along Jessamine St.

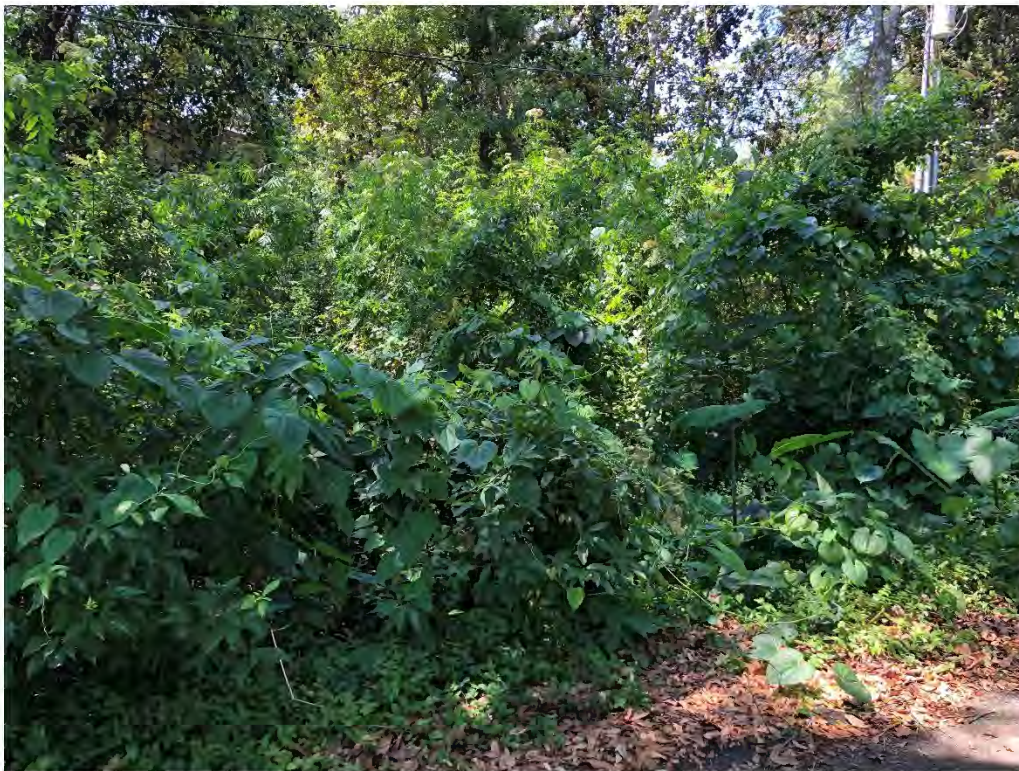
Figure 9647:
Photo taken facing East toward a ditch along McCoy Ln.

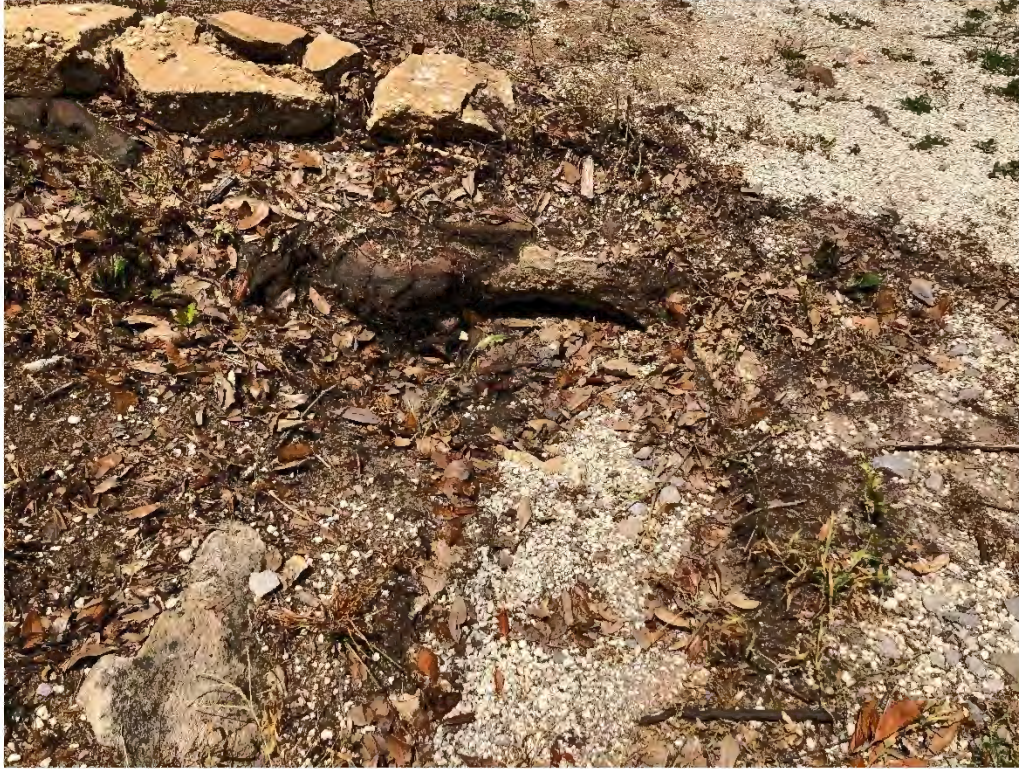
Figure 9648:
Photo of an overgrown OAK-CO-18 that crosses McCoy Ln.

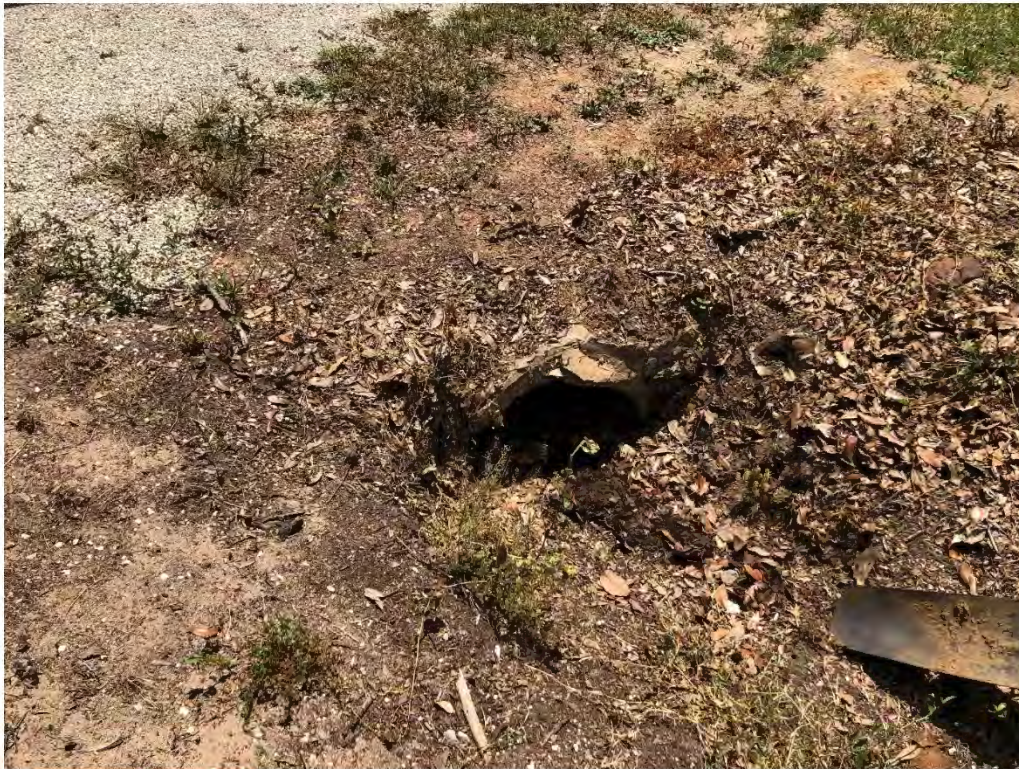
Figure 9656:

Photo taken facing NE toward a very silted OAK-CO-22 at the intersection of Oak St and a driveway.

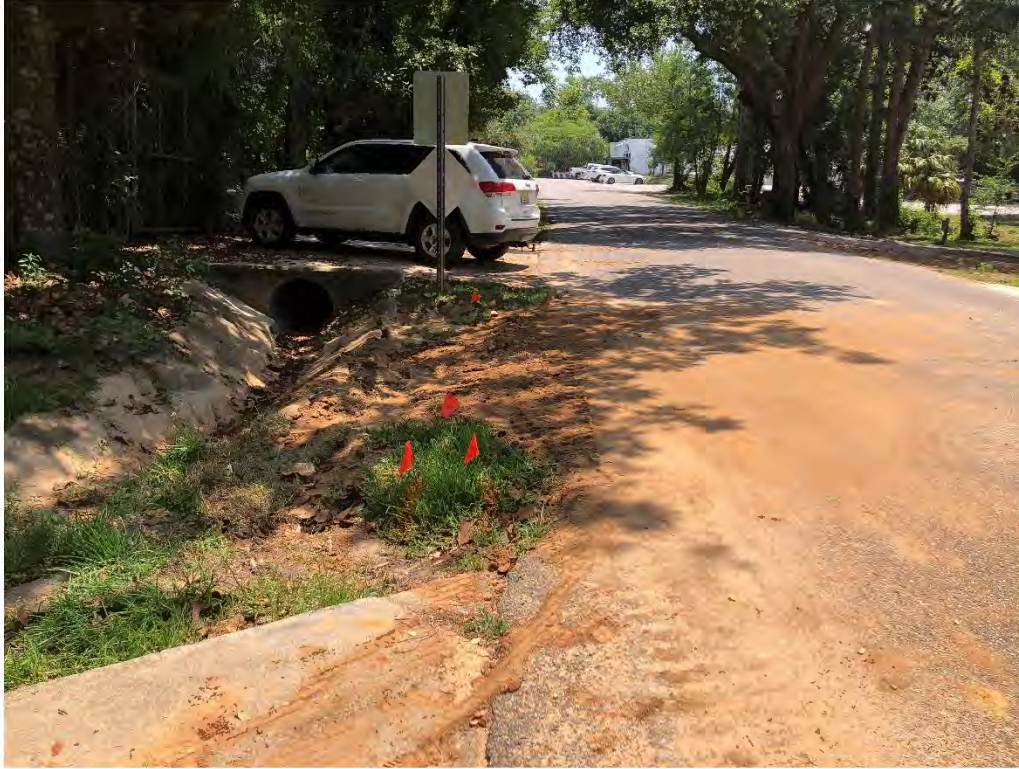
Figure 9662:
Photo taken facing NE toward a silted OAK-CO-25 with erosion around the driveway along Oak St.

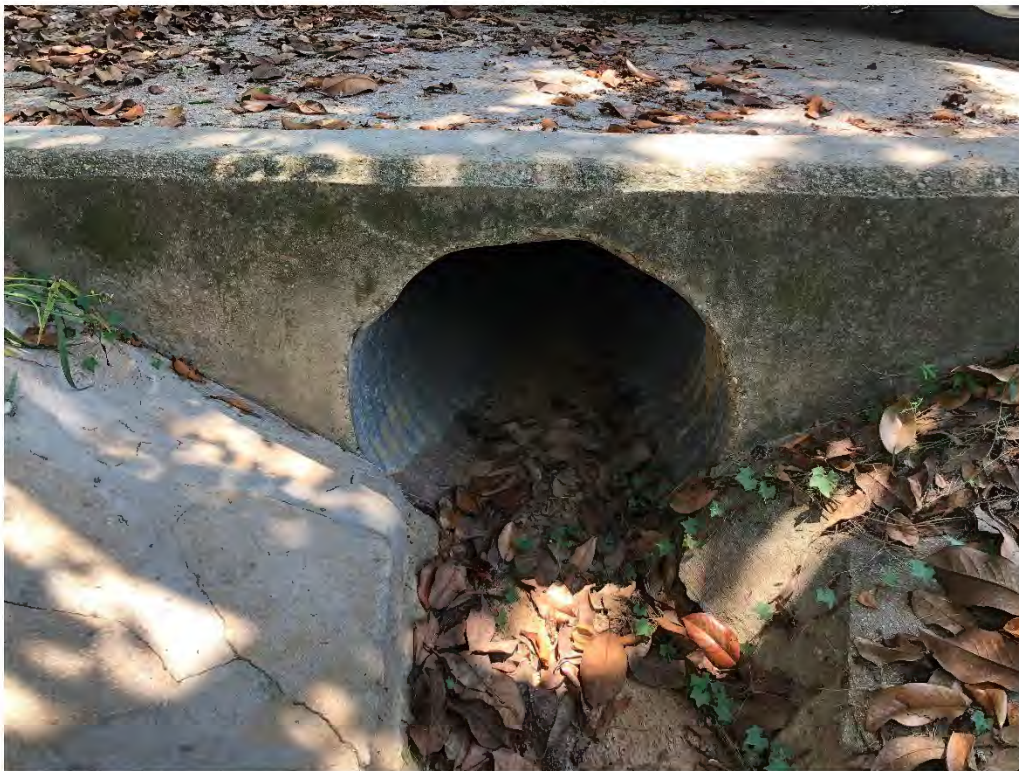
Figure 9664:

Photo taken facing NE toward a crumbling concrete OAK-CH-36 with moderate debris along Oak St.

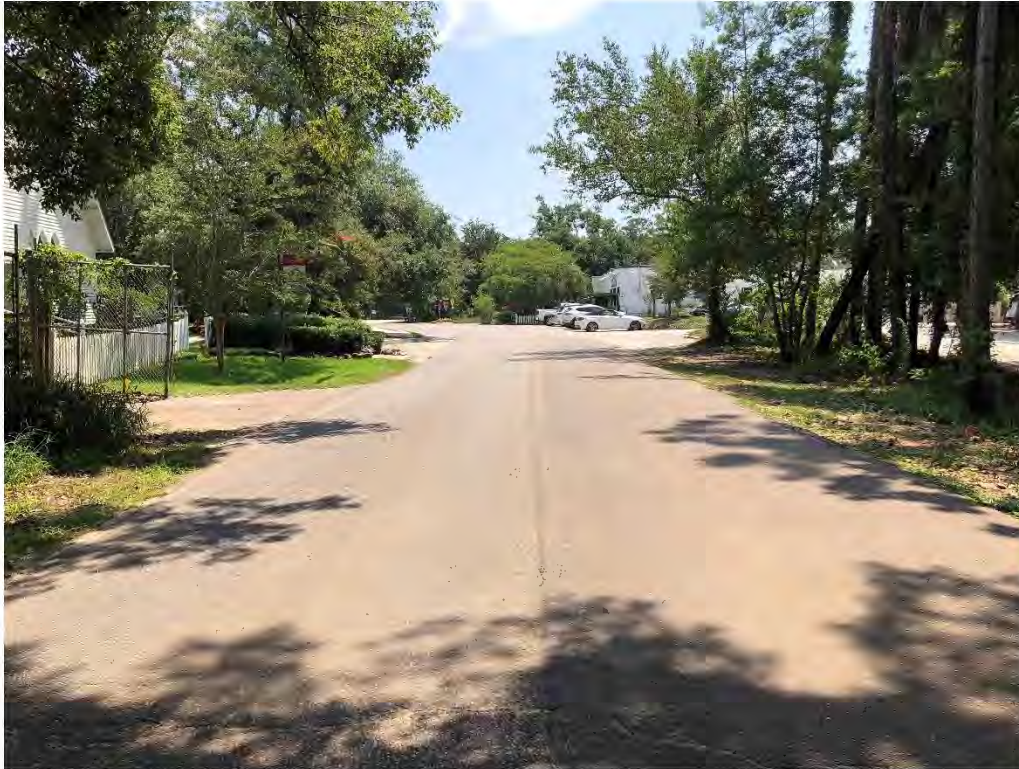
Figure 9669:
Photo taken facing East toward OAK-CH-37 along Oak St.

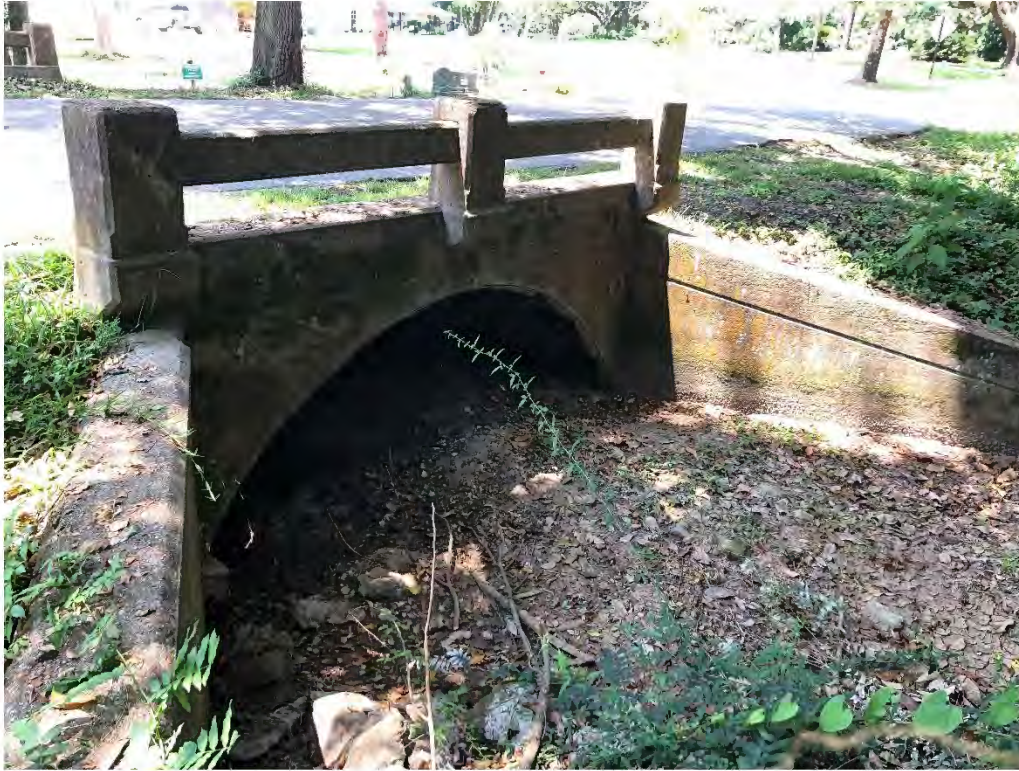
Figure 9671:
Photo taken facing South toward a very silted OAK-CO-26 at the intersection of Oak St and a residential driveway.

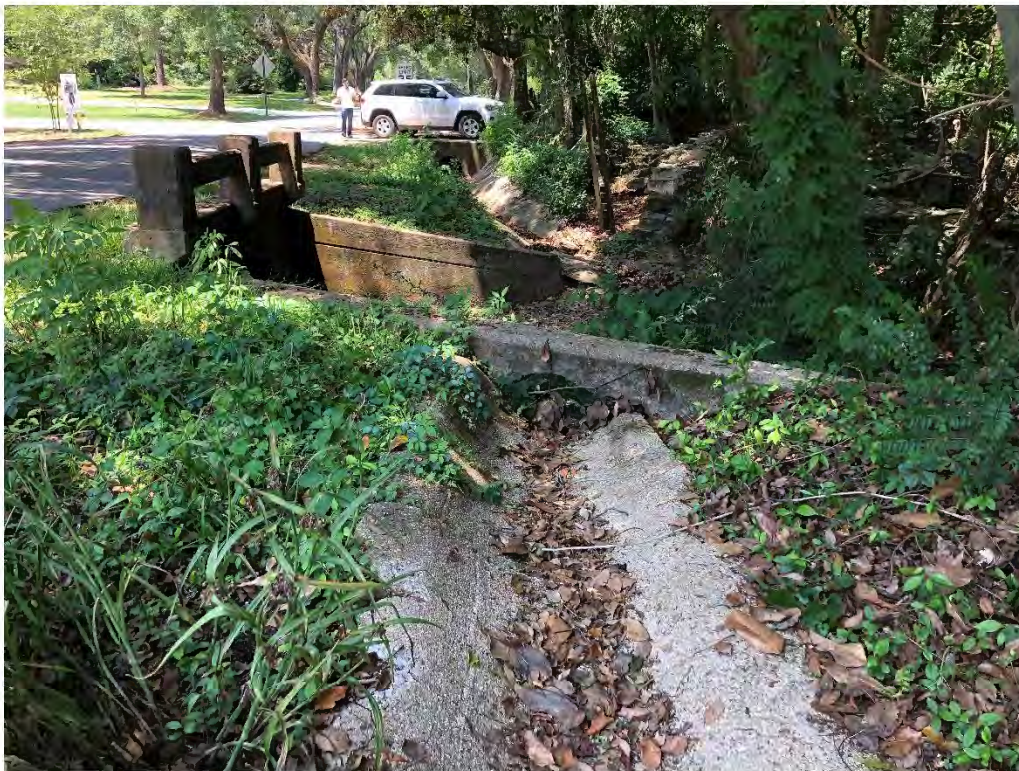
Figure 9672:

Photo taken facing West toward OAK-CH-37 along Oak St.

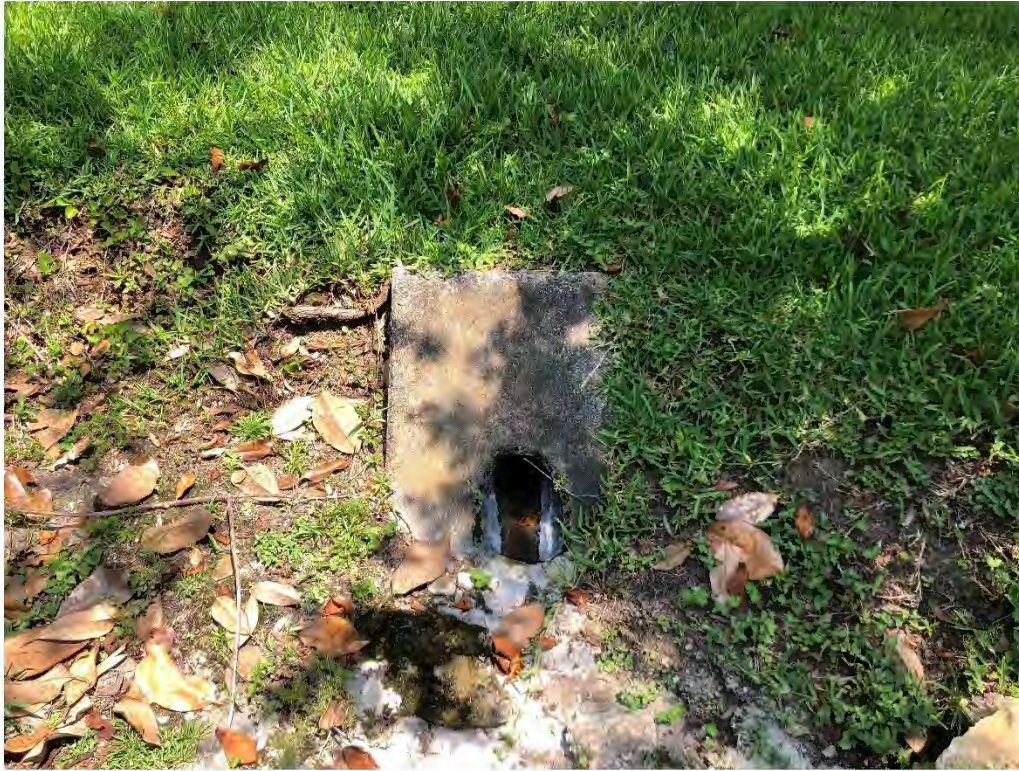
Figure 9674:
Photo taken of small pipe running north-south at the intersection of Oak St and a church path.

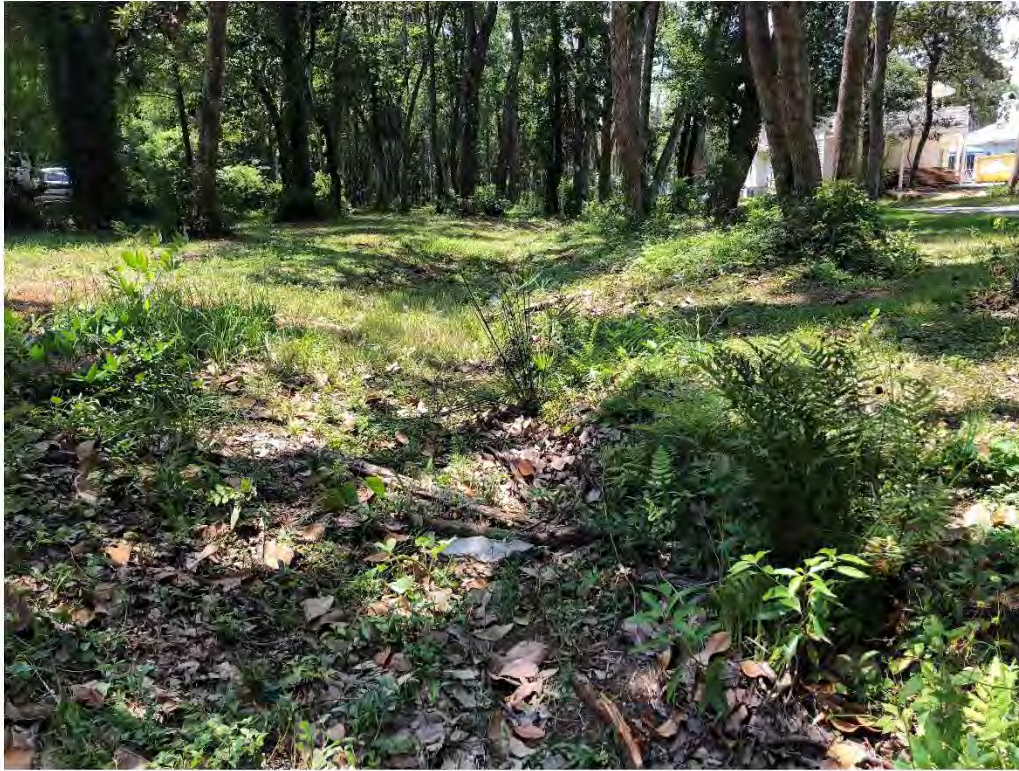
Figure 9676:
Photo taken facing South toward OAK-CH-39 along Oak St.

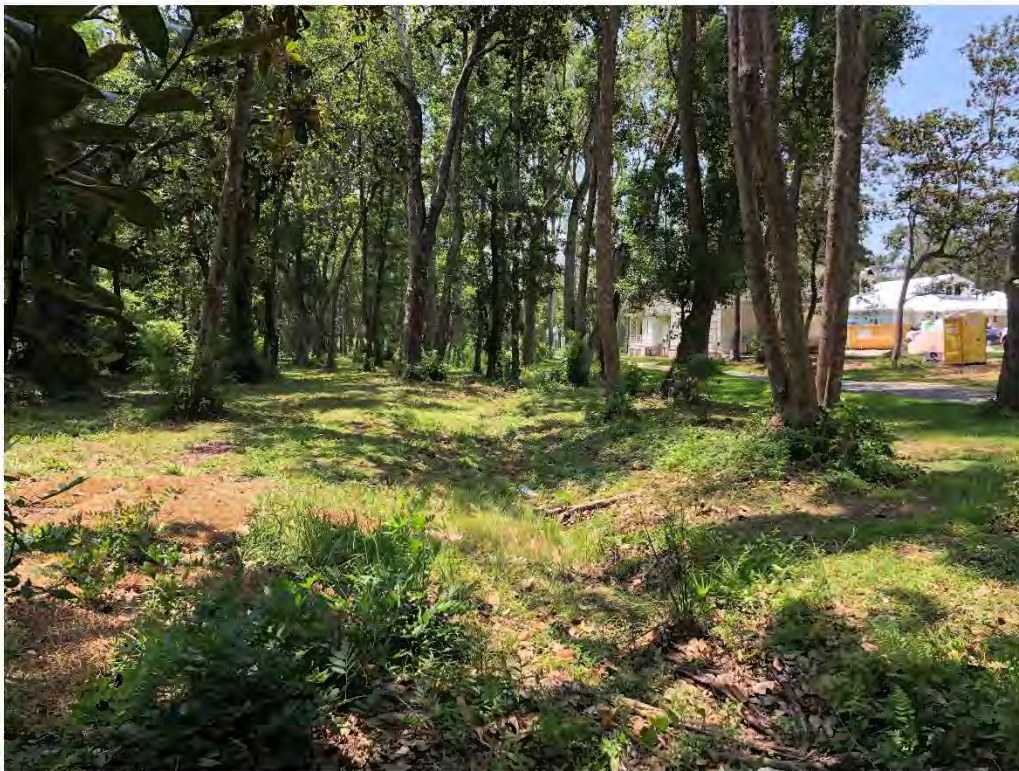
Figure 9677:
Photo taken facing South toward a very silted OAK-CH-39 along Oak St.

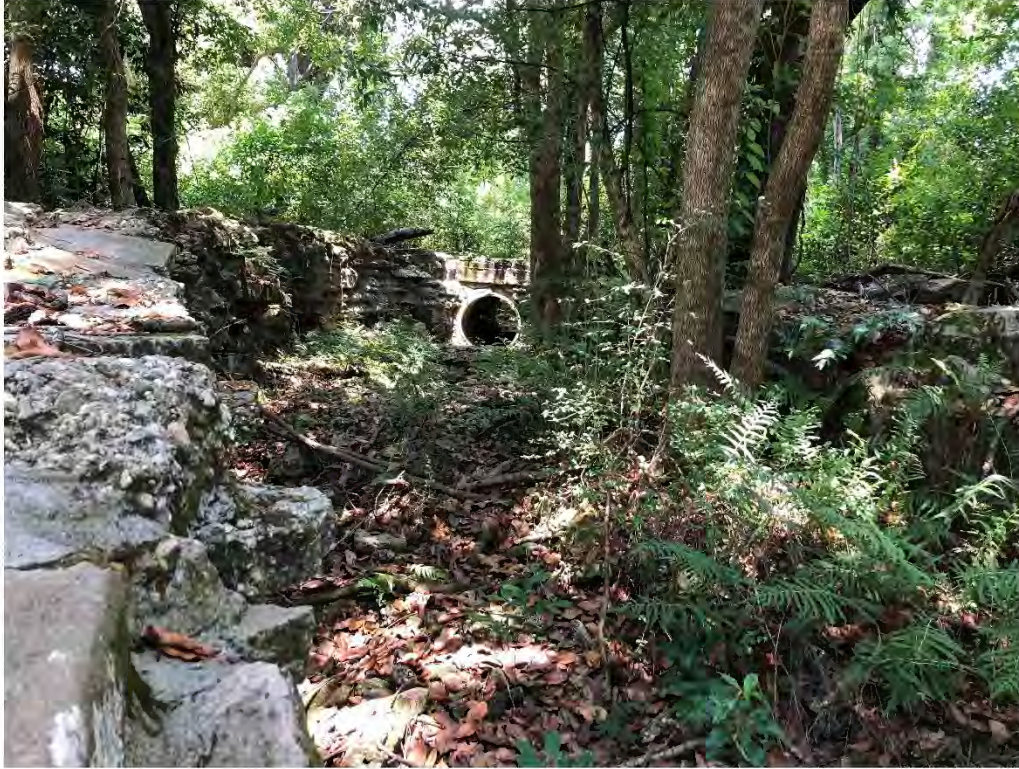
Figure 9678:
Photo taken facing NW toward OAK-CH-33.

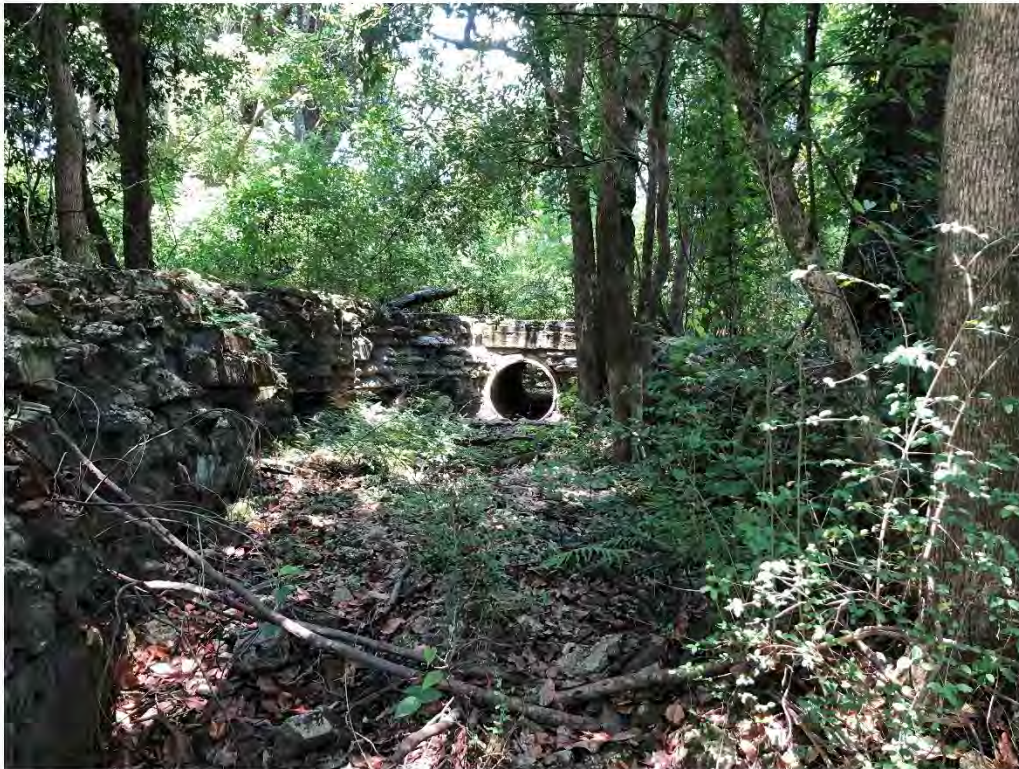
Figure 9679:
Photo taken facing NW toward OAK-CO-24.
