Town of Magnolia Springs Comprehensive Drainage Masterplan

Town of Magnolia Springs
Magnolia Springs, Baldwin County, Alabama

VOLKERT

March 2023

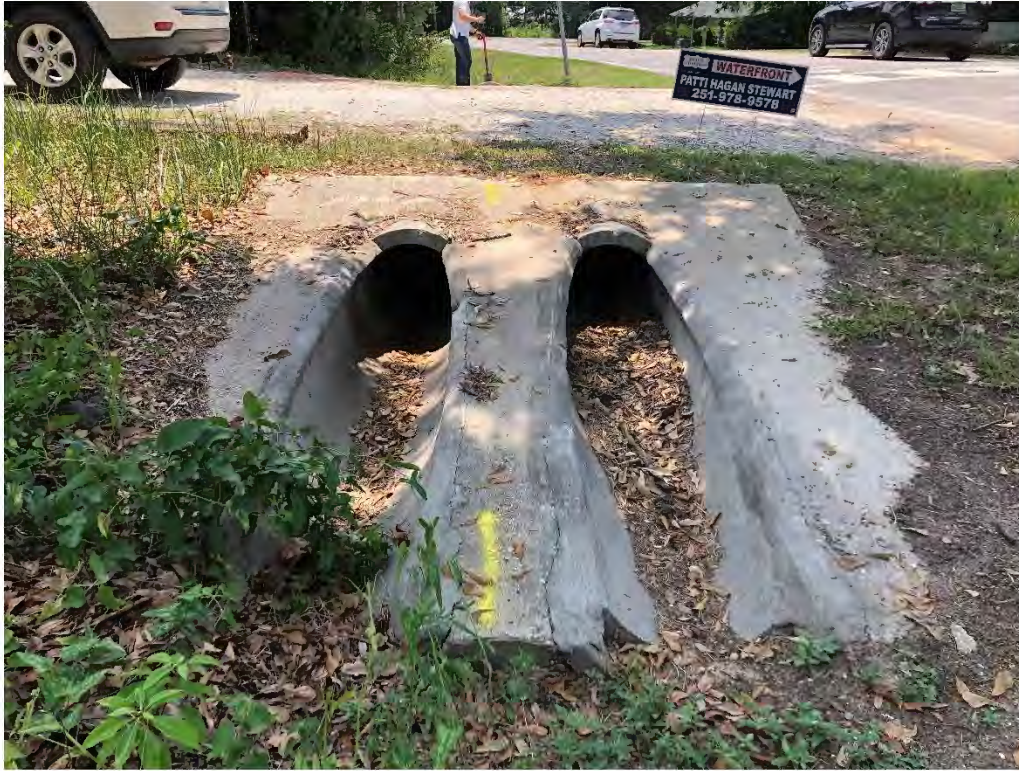
Figure 9680:
Photo taken facing South toward MN-CO-17 at the intersection of HWY 49 and a residential driveway.

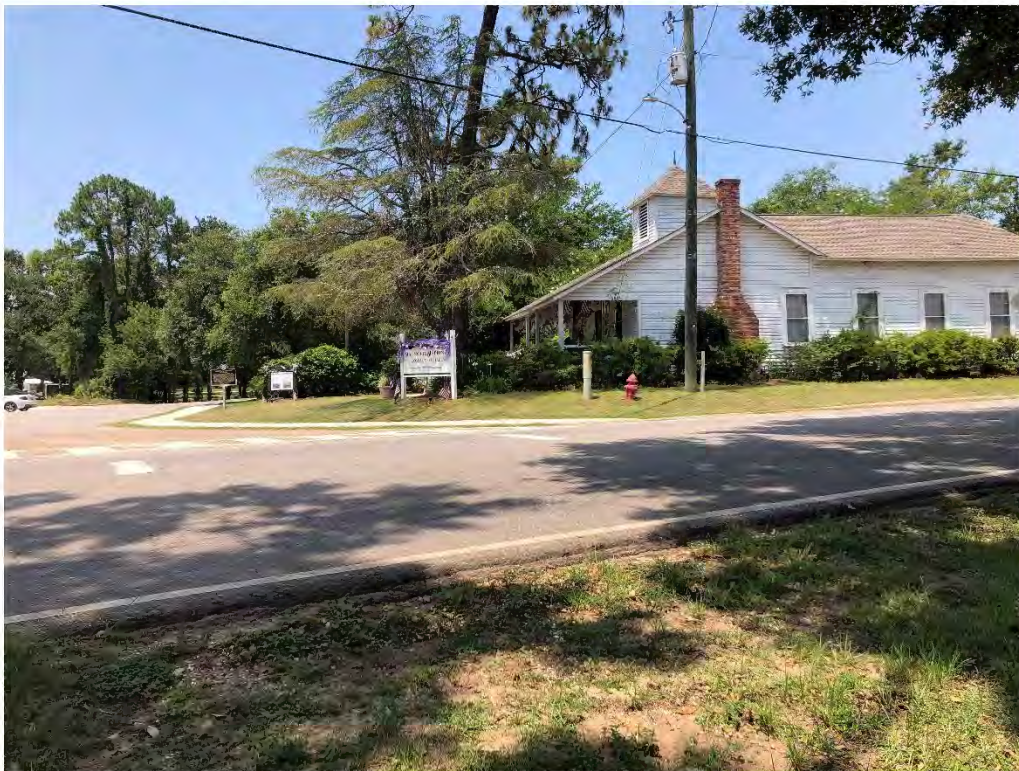
Figure 9682:
Photo taken facing West toward HWY 49.

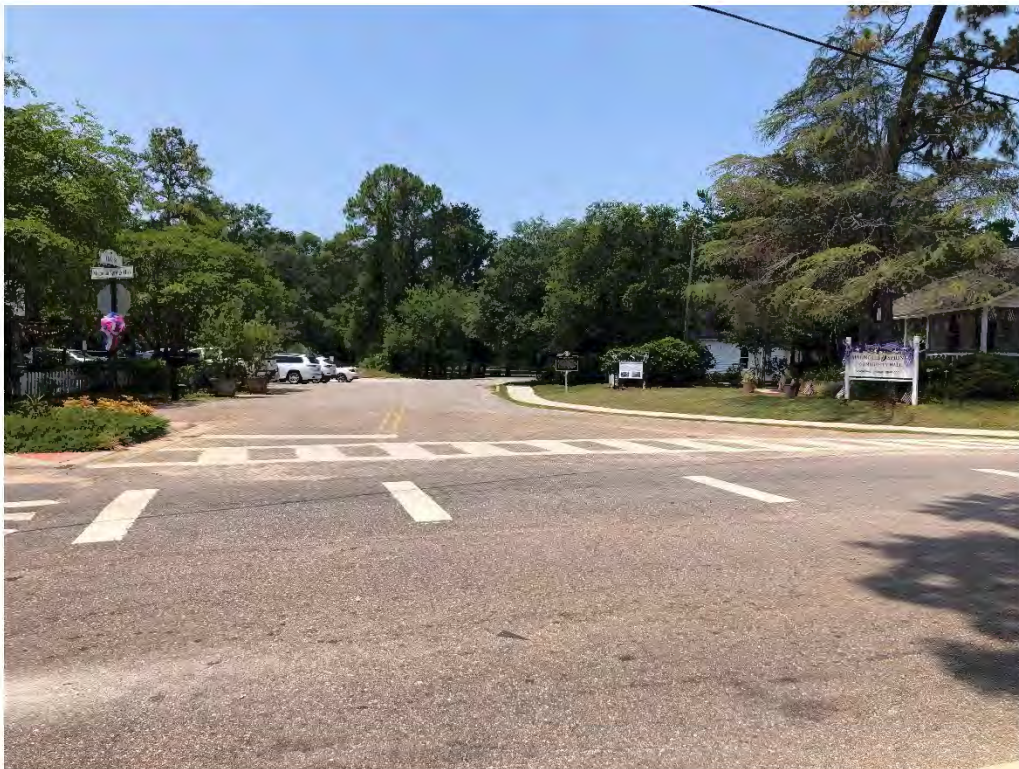
Figure 9684:
Photo taken facing West toward HWY 49.

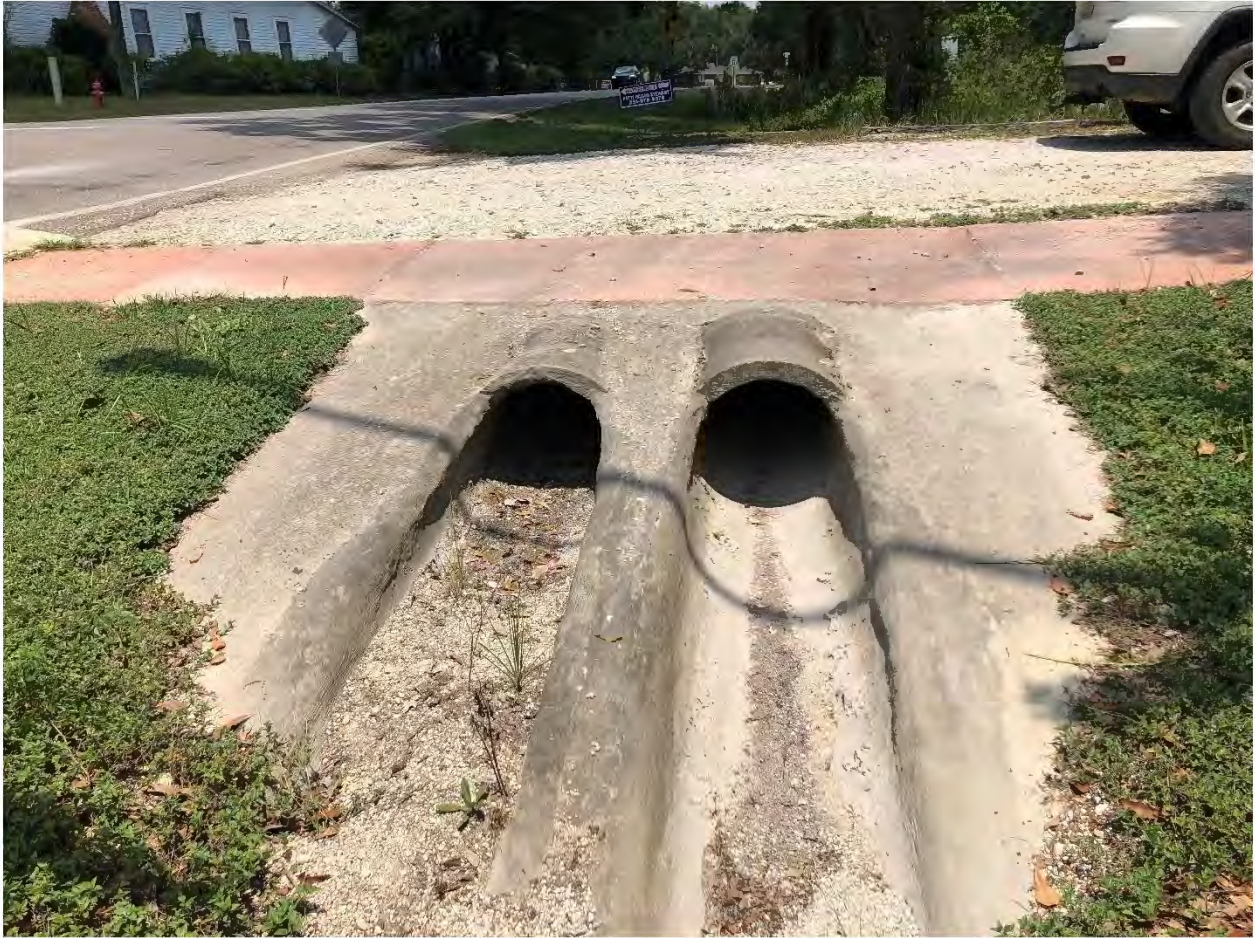
Figure 9685:
Photo taken facing North toward MN-CO-17 at the intersection of HWY 49 and a driveway.

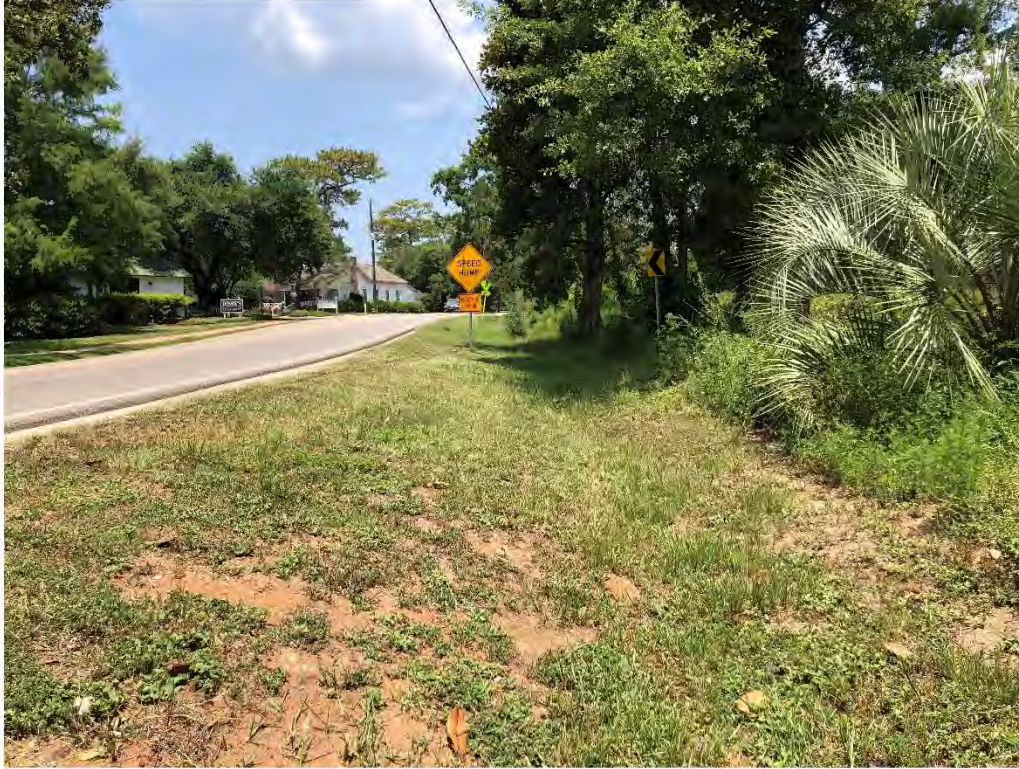
Figure 9688:
Photo taken facing North toward MN-CH-21 along HWY 49.

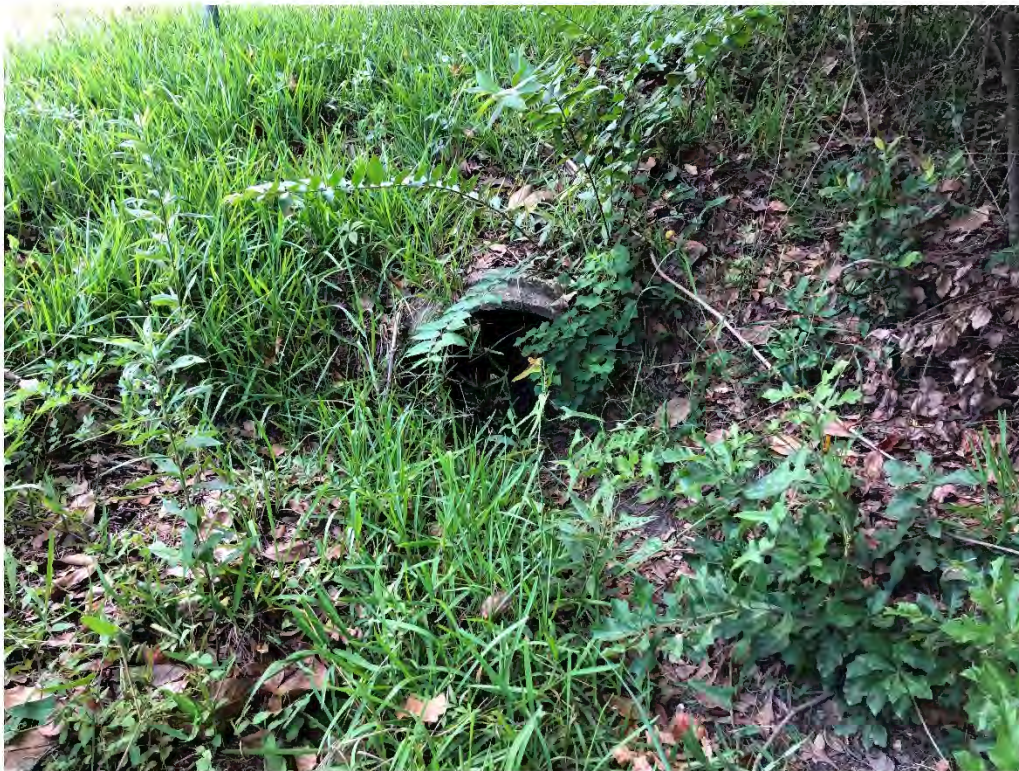
Figure 9689:
Photo taken facing North toward MN-CO-18 across HWY 49.

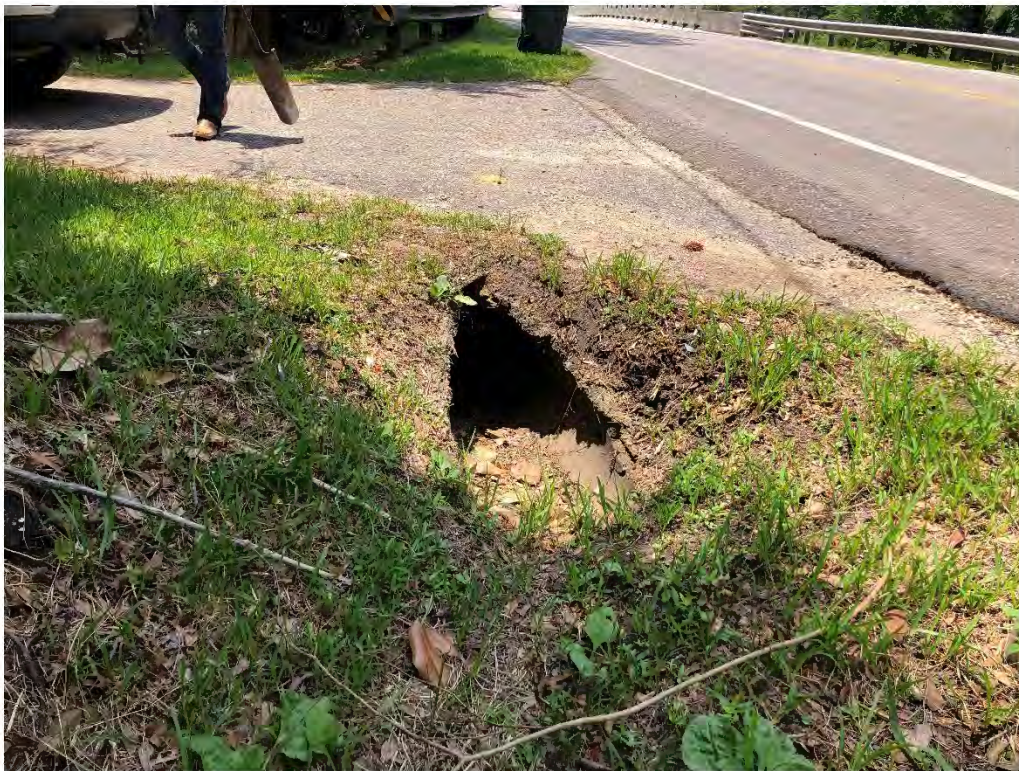
Figure 9691:
Photo taken facing South toward MN-CO-19 across HWY 49.

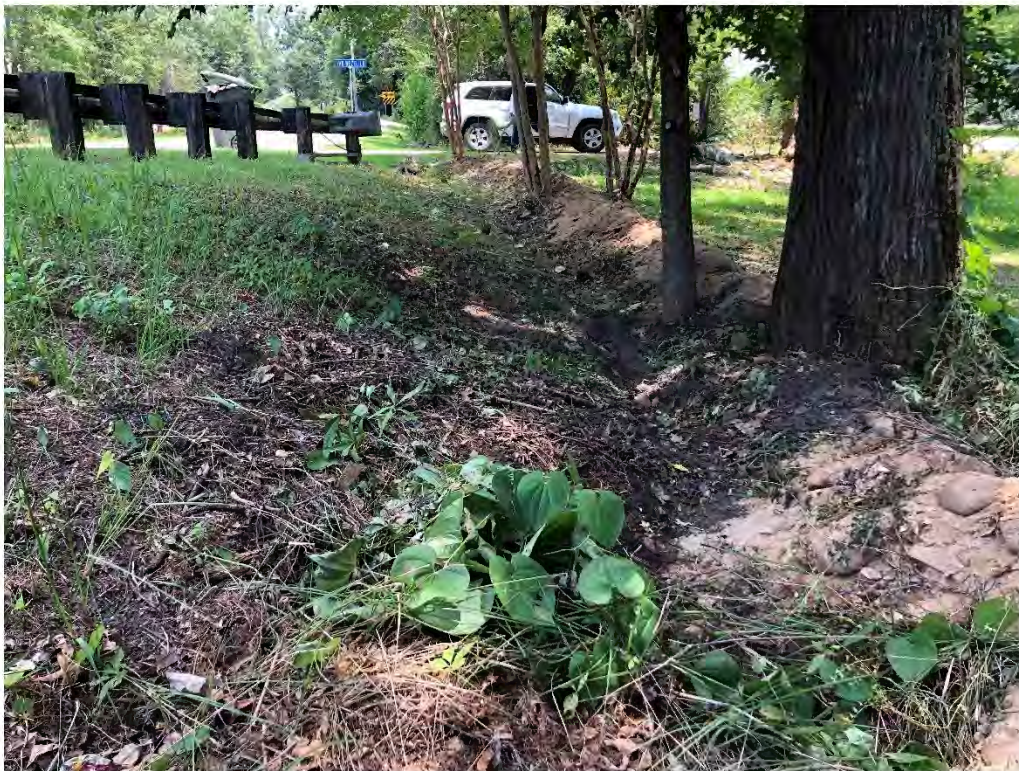
Figure 9694:
Photo taken facing North toward MN-CH-23 along HWY 49.

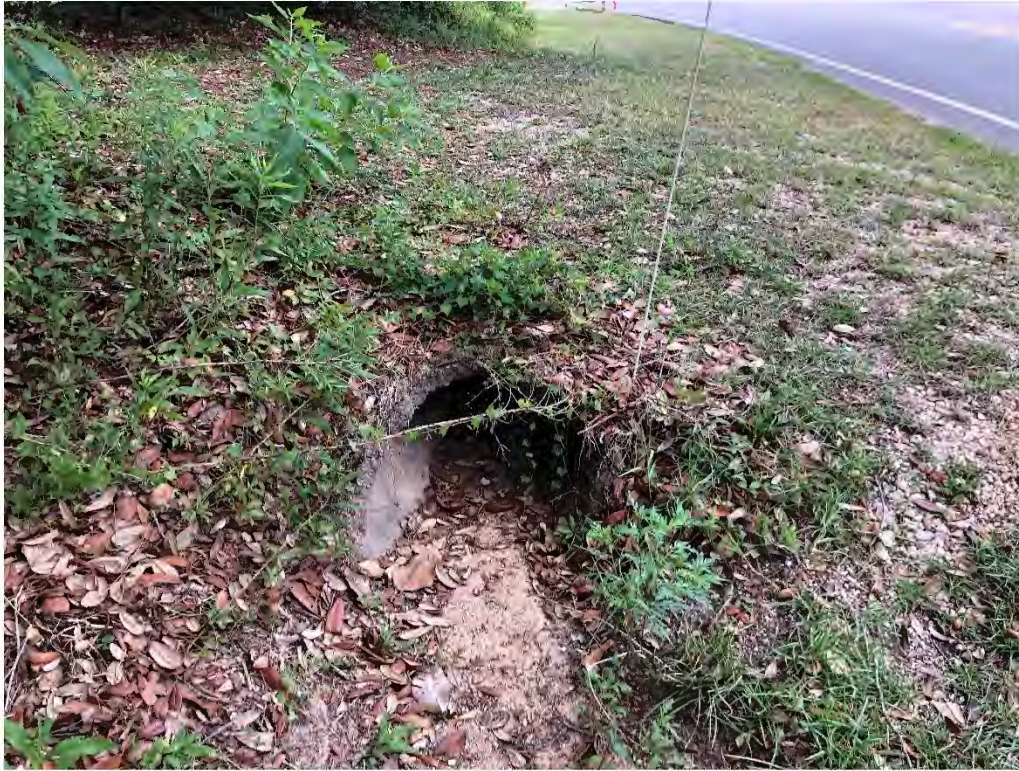
Figure 9697:
Photo taken facing South toward MS-CO-2 along HWY 49.

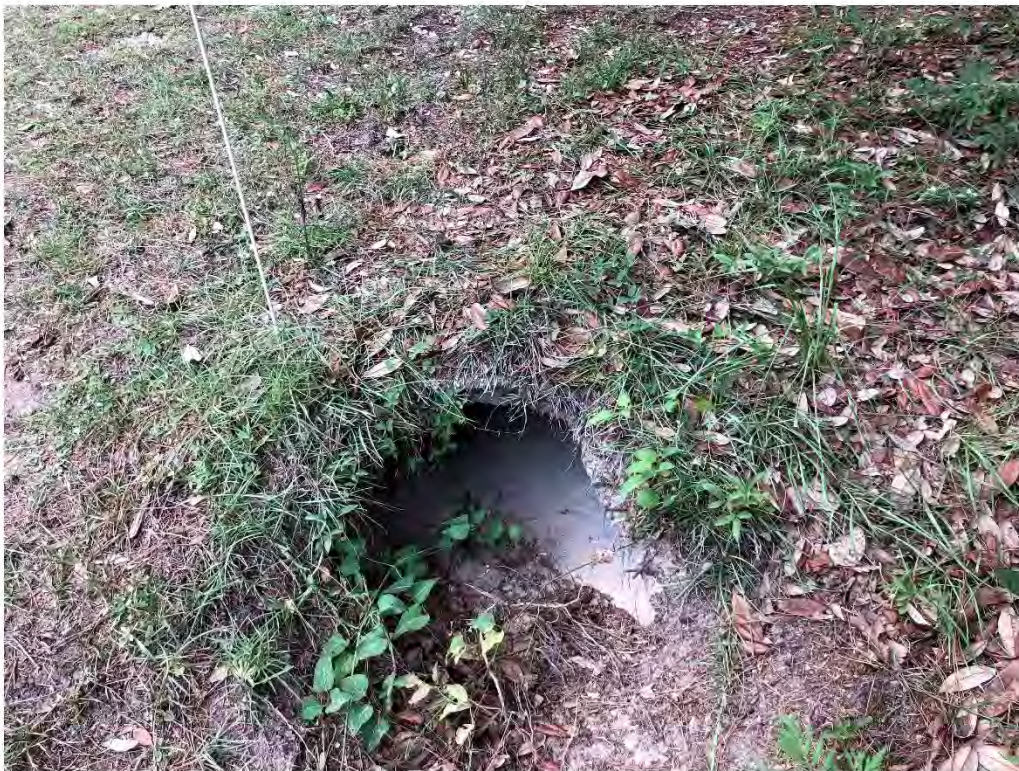
Figure 9698:
Photo taken facing North toward MS-CO-2 along HWY 49.

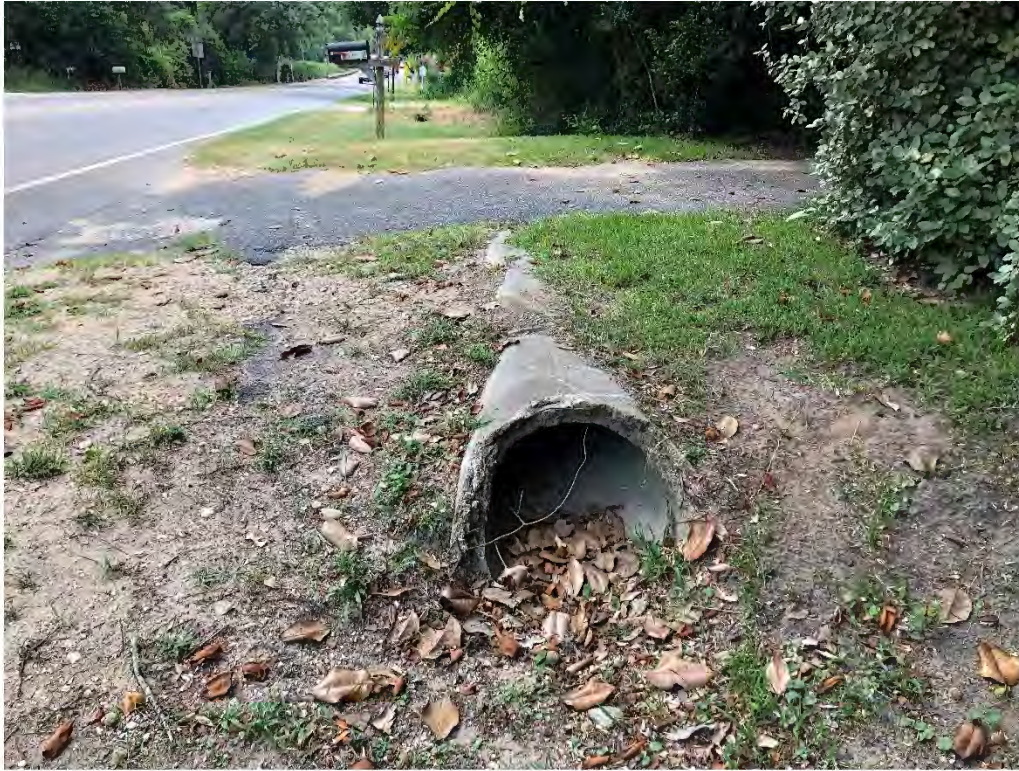
Figure 9699:
Photo taken facing South toward MS-CO-3 along HWY 49.
